**Development of In-Place
Permeability Criteria for HMA
Pavement in Wisconsin
SPR # 0092-06-02**

**Robert Schmitt and Samuel Owusu-Ababio
University of Wisconsin-Platteville
James Croveti
Marquette University
Allen L. Cooley
Burns Cooley Dennis Inc.**

February 2007

WHRP 06-15

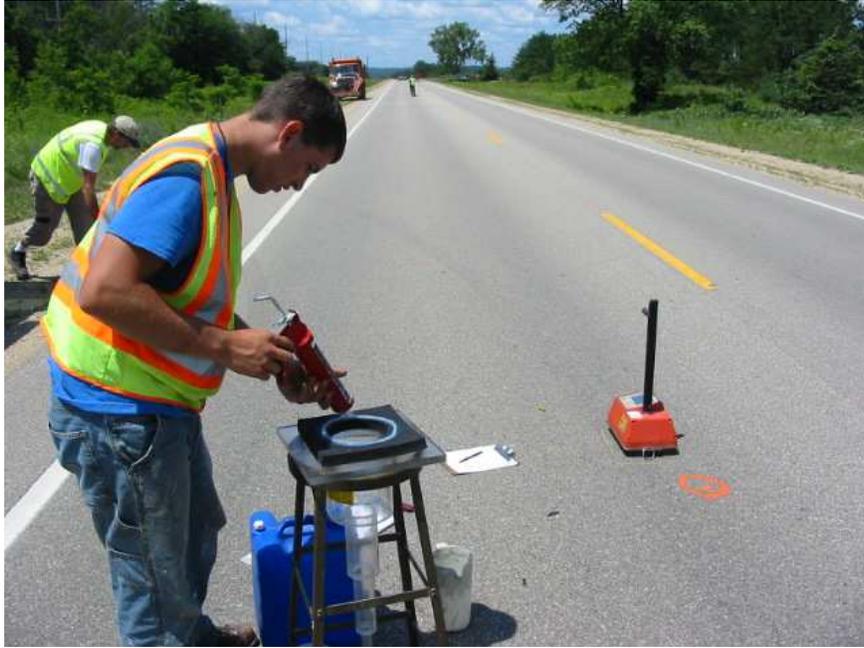
Figure 4.1 Applying Sealant to Rubber Gasket for Water Permeability Test

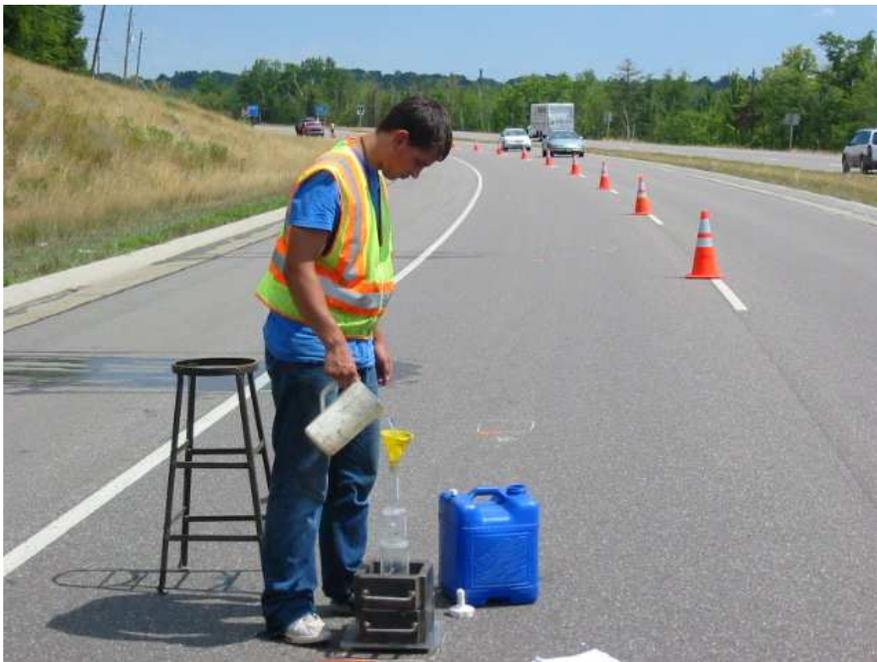
Figure 4.2 Filling NCAT Water Permeameter

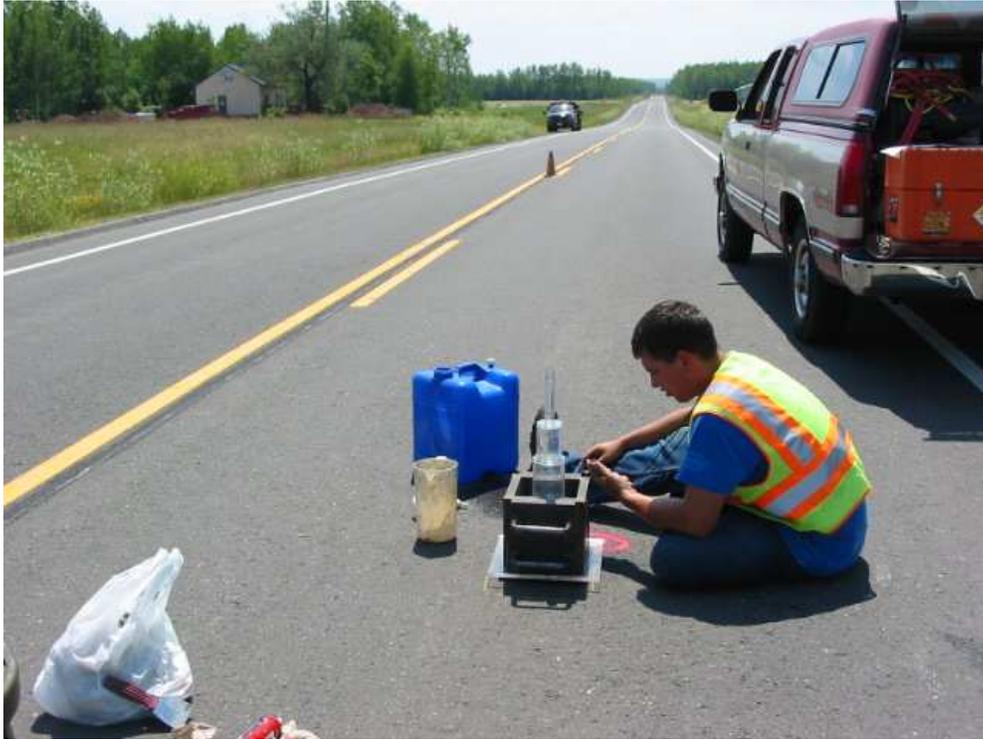
Figure 4.3 Measuring Falling Head in NCAT Water Permeameter

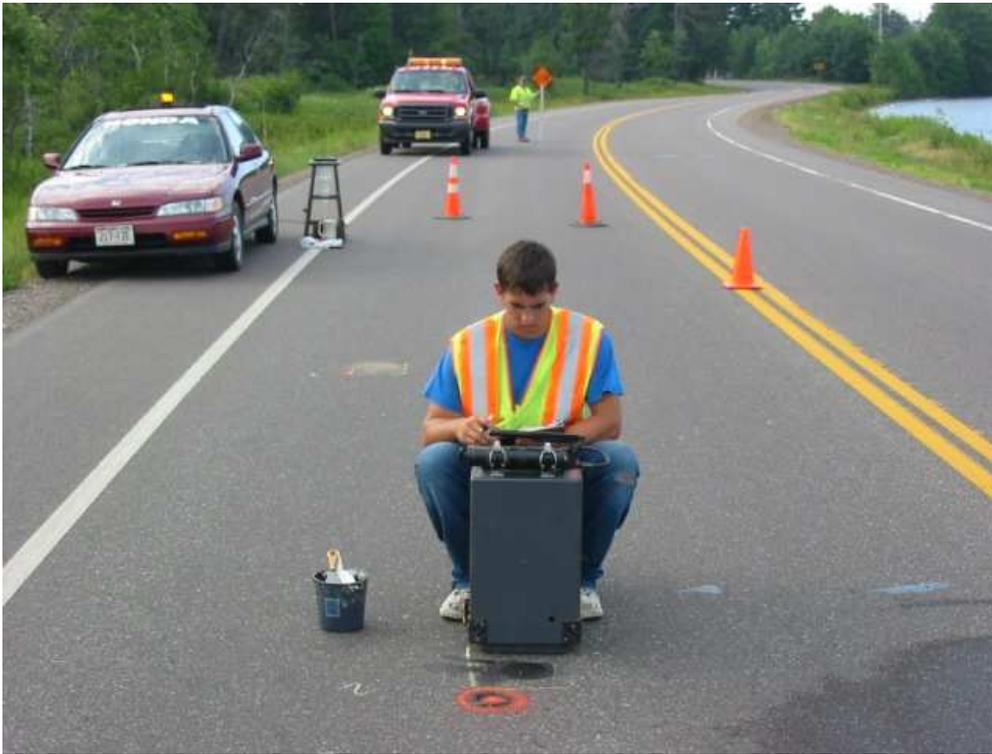
Figure 4.4 Conducting Air Permeameter Test with ROMUS Device

Air permeability testing was conducted using the ROMUS device at 20 test sites on each project, where 8 of 20 sites were comparative sites with the NCAT water permeameter. Air permeability testing was conducted after water permeability testing, with test locations offset 6 to 12 inches longitudinally to avoid the wet pavement surface. Figure 4.4 illustrates operation of the ROMUS device in this study.

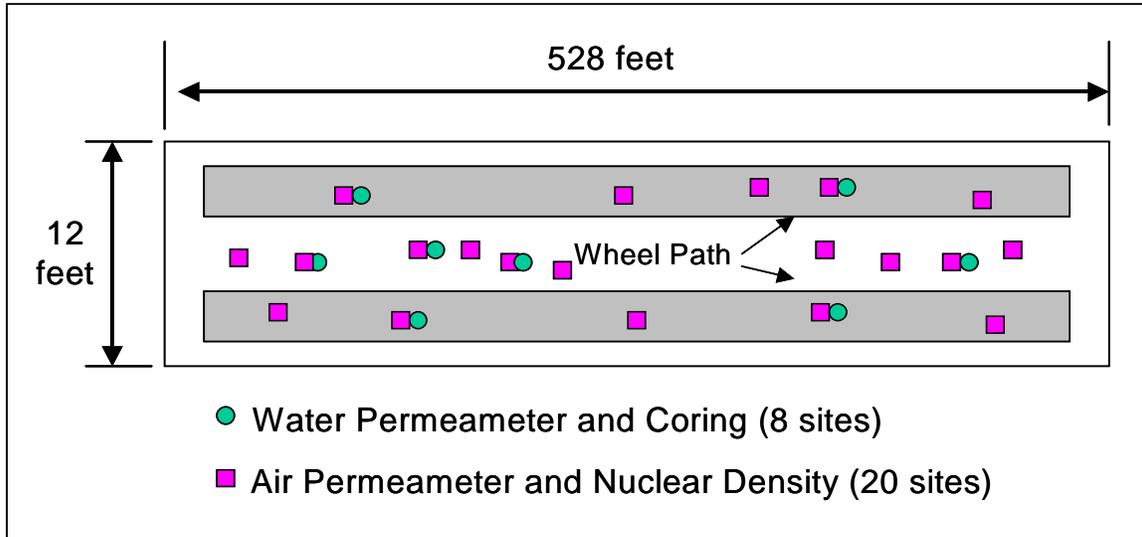
Figure 4.5 Test Site Schematic

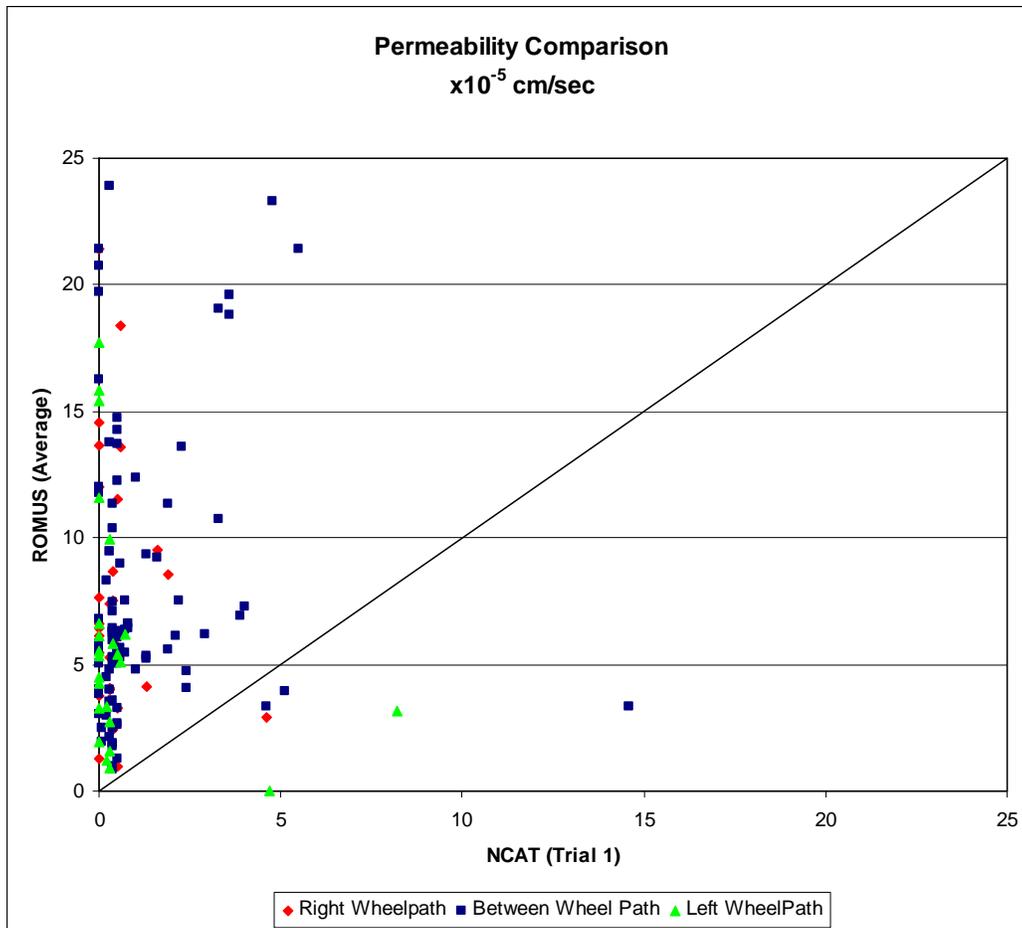
Figure 5.1 Comparison of Permeability Methods and Wheelpath Location

From Figure 5.1, air and water permeability was very low, not exceeding $25 \times 10E-5$ cm/sec with the air permeameter and $15 \times 10E-5$ cm/sec with the water permeameter. Except for 2 out of 160 test sites, water permeability values were less than $5 \times 10E-5$ cm/sec, thus the pavements were nearly impermeable. Air permeameter values had a higher order of magnitude than the water permeameter with a majority of points above the line-of-equality. Also, water permeability values between wheel paths were generally higher than in the wheel paths.

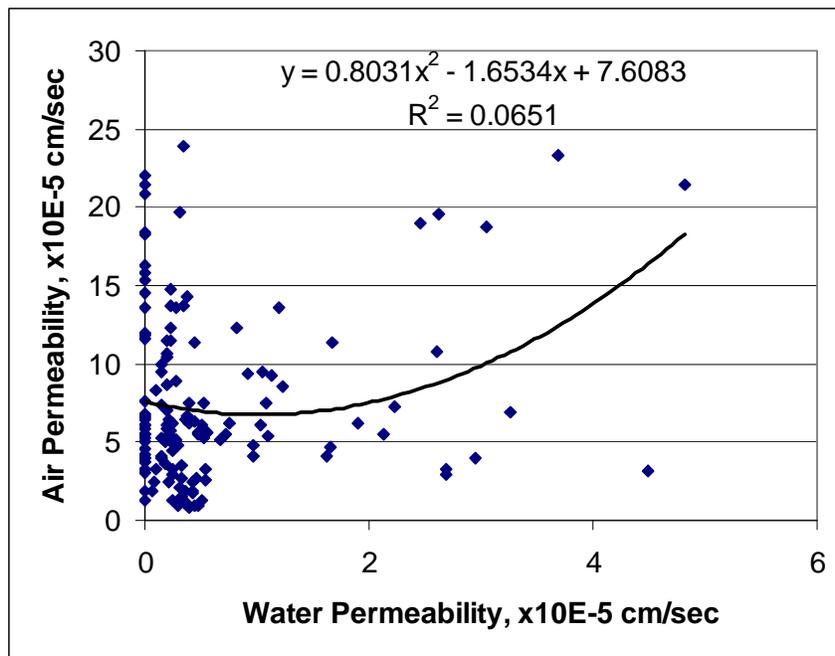
A polynomial least-squares regression line was fitted with the air and water permeability data and is shown in Figure 5.2. Similar to the 2002 WHRP permeability-density study, the rate of pavement permeability with the ROMUS device was generally a factor of 10 greater than the NCAT device. Tests measuring a zero permeability value with the NCAT device yielded values from 1 to $22 \times 10E-5$ cm/sec with the ROMUS device. Although the regression line indicated an upward trend, there was significant amount of scatter as denoted by the $R\text{-squared} = 6.5\%$, and a reasonable model using other fitting techniques having a substantial $R\text{-squared}$ could not be constructed.

Figure 5.2 Comparison of Permeability Methods and Wheelpath Location

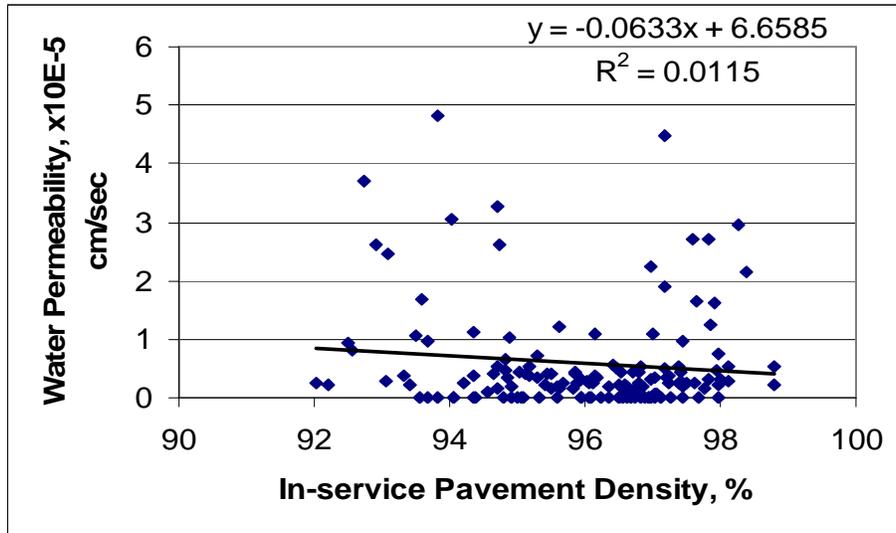
Permeability results were plotted against the in-service pavement density, as shown in Figure 5.3 and 5.4, respectively. As shown in Figure 5.3, the pavement was nearly impermeable with water permeability values less than 5×10^{-5} cm/sec, and no trend was observed between permeability and density. By comparison, the 2002 WHRP permeability-density study found that no trend existed for fine-graded gravel-source mixes, but a trend was observed for fine-graded limestone-sourced mixes (Russell et al. 2004). Also by comparison, NCHRP 9-27, a comprehensive density-permeability study that evaluated 37 mixtures, found that variability of permeability among mixtures was very high with some more permeable at 90 to 92% density and others not (Brown et al. 2004). Both studies concluded that the permeability-density relationship is mixture specific with respect to as-constructed pavement density, say in the range of 90% to 93%, while this study measured higher-density pavements that had been exposed to years of vehicle traffic. The insignificant linear regression equation in Figure 5.3 further supports that there is no relationship between water permeability and in-service pavement density for values ranging from 92% to 99%. In Figure 5.4, air permeability trended downward with an increase in density, while water permeability had no discernible trend.

Figure 5.3 Relationship of Water Permeability and In-Service Pavement Density

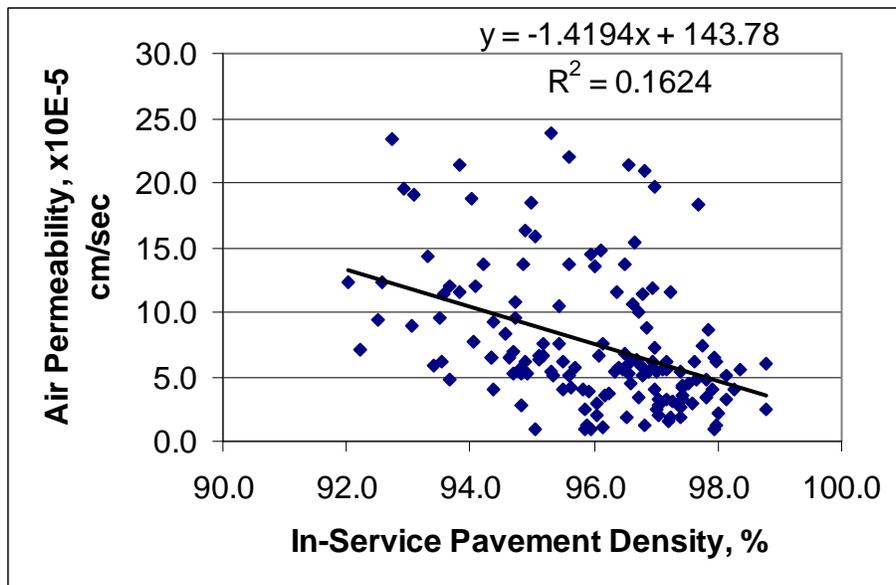
Air permeability results were plotted against in-service pavement density, and fitted with a linear regression line, as shown in Figure 5.4. The regression model R-squared = 16% supports a downward trend where an increase in density yielded lower air permeability values. This finding agrees with the 2002 WHRP study where pavement density had an effect on air permeability, in the range of 90% to 93% density (Russell et al. 2004). The totality of Figures 5.1 through 5.4 highlights differences between the ROMUS and NCAT devices for measuring pavement permeability, and their relationship with pavement density for values above 92% density.

Figure 5.4 Relationship of Air Permeability and In-Service Pavement Density

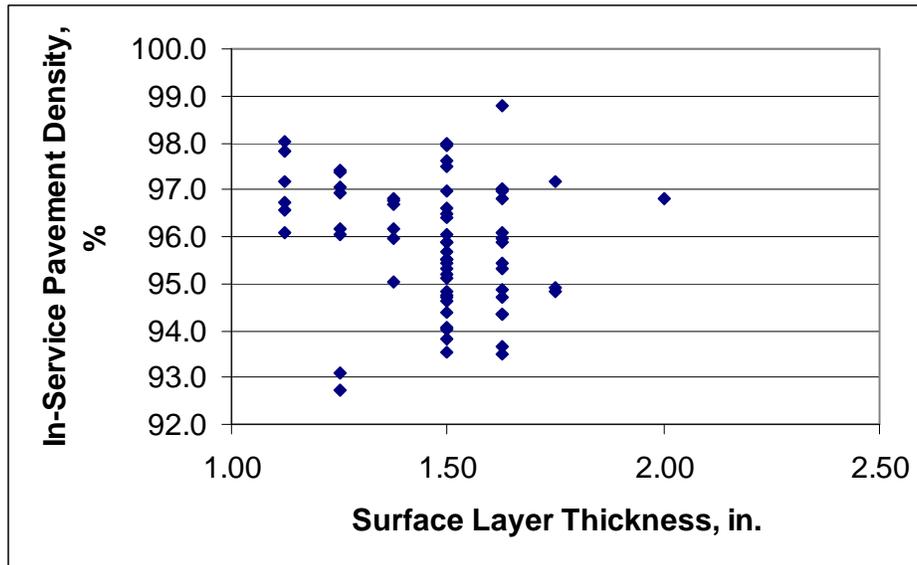
The collected field data were summarized for the relationship between pavement surface layer thickness and both pavement density and permeability results. Figure 5.5 plotted surface layer thickness with in-service pavement density, and no trend was observed. As the layer thickness increased, the in-service density slightly decreased. Each thickness increment had scatter in pavement density.

Figure 5.5 Relationship of Surface Layer Thickness and In-Service Pavement Density

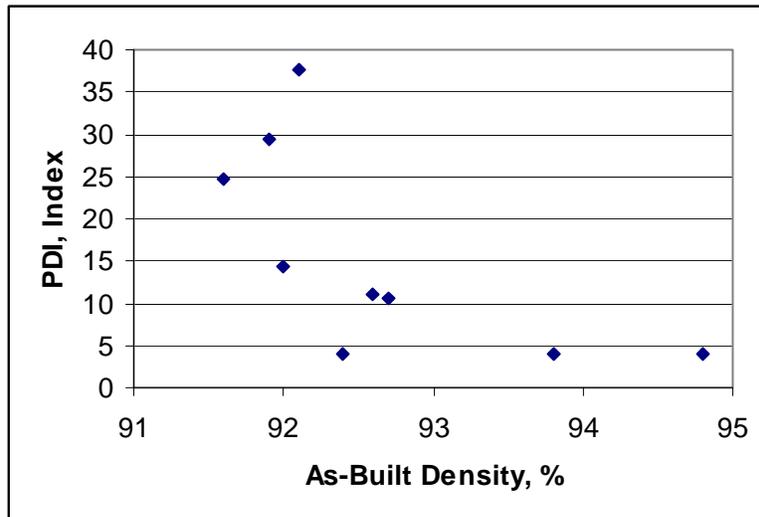
Figure 6.1 As-Built Density and PDI

Based on the results of Figures 6.1 through 6.14, the PDI index and extent of both transverse and longitudinal cracking were related to as-built pavement density, while there was no relationship between in-service density and the range of performance measures, including the PDI and individual distresses.

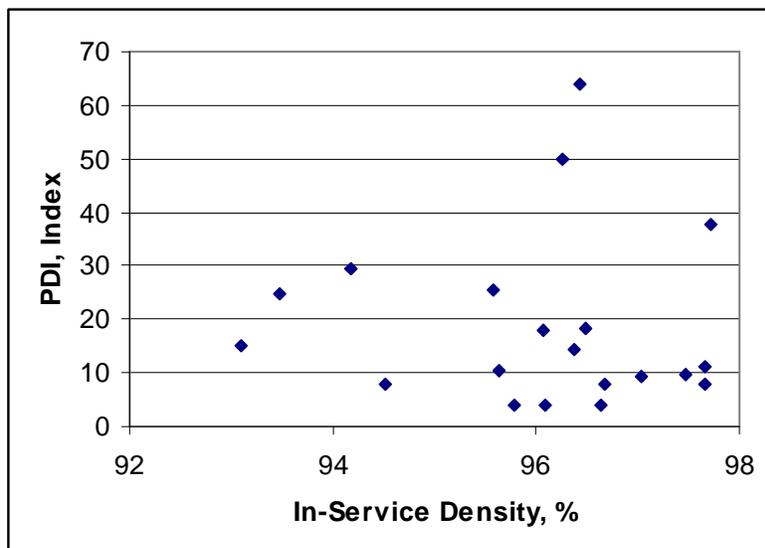
An important feature of Figure 6.2 was that in-service densities were generally dispersed around a median of 96% density, indicating that an appropriate Ndes level is being used during the mixture design process. It is recommended that further monitoring be conducted to verify that Ndes values correlate with in-service density.

Figure 6.2 In-Service Density and PDI

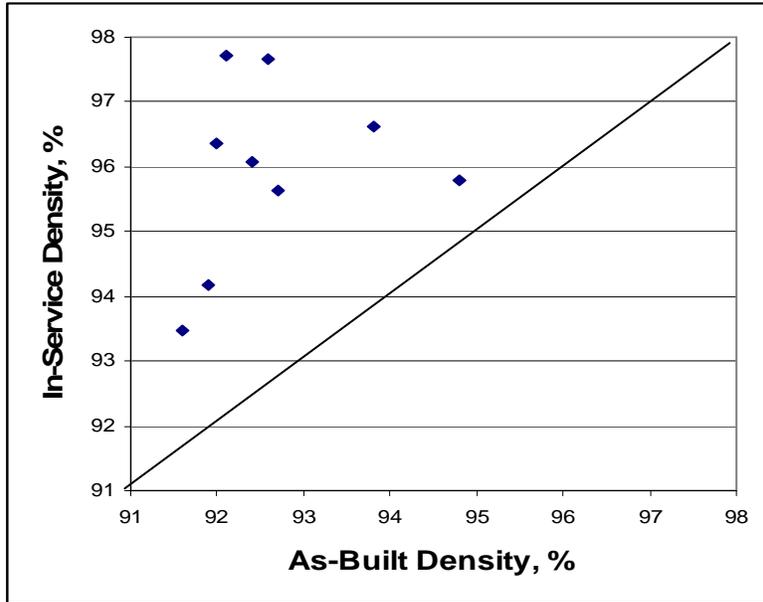
To gain an understanding of densification of pavements with time and traffic, as-built density was plotted against in-service density in Figure 6.3. Only 9 data points were used since as-built density data was provided for 9 of 20 projects. This figure shows that density generally increased 2 to 5% between as-built and in-service periods. Figure 6.4 plots age and PDI, where there was no definitive trend, with the exception of the large PDI at 11 years of age with the STH 59 project (paired with lower PDI, STH 11 project). The experimental design purposely selected lower and higher performing pavements for a same age and traffic level, so the result in Figure 6.4 was expected.

Figure 6.3 Comparison of As-Built and In-Service Density from 9 Projects

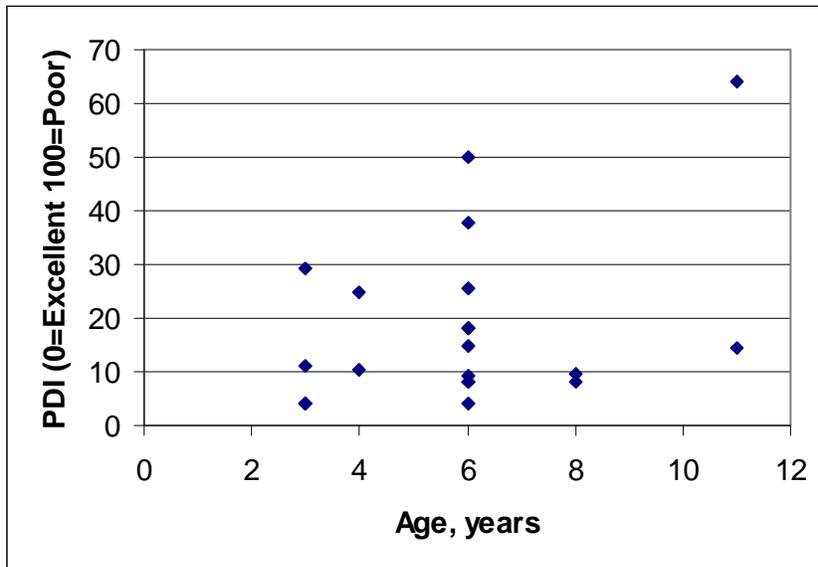
Figure 6.4 Relationship of Age and PDI

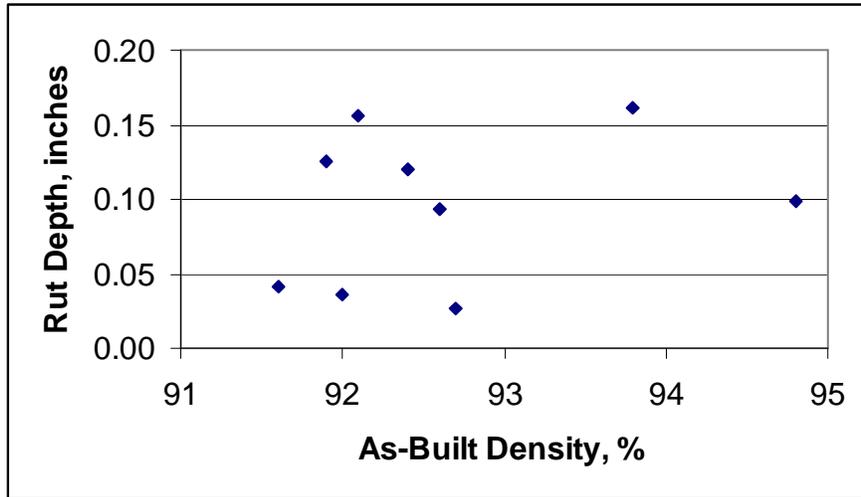
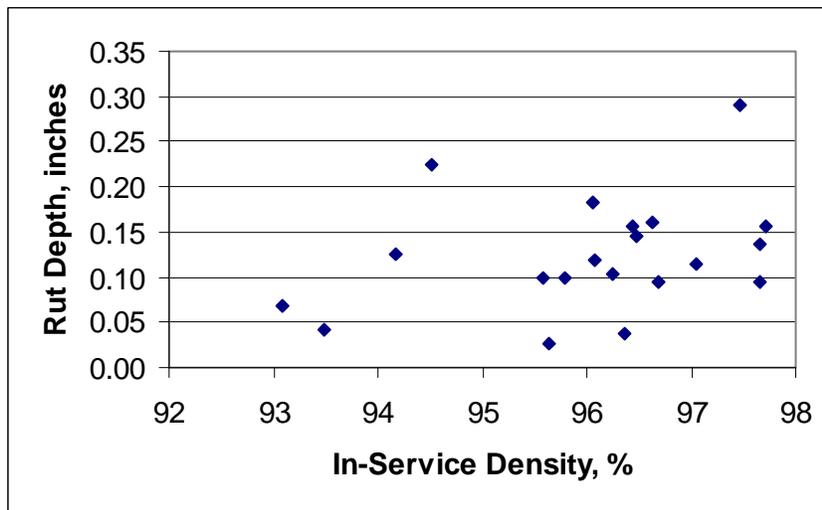
Figure 6.5 and 6.6 relate rut depth with density. Both plots had random scatter and no definitive trend.

Figure 6.5 As-Built Density and Average Rut Depth

Figure 6.6 In-Service Density and Average Rut Depth

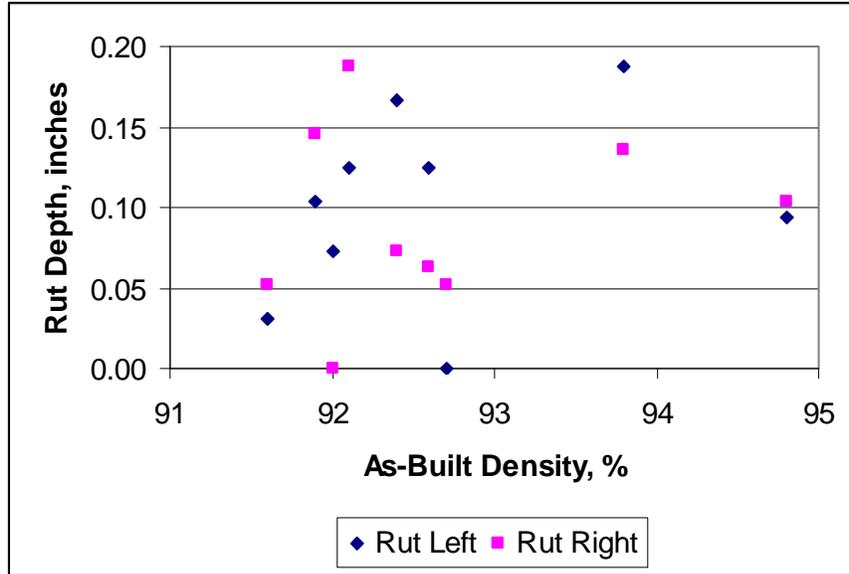
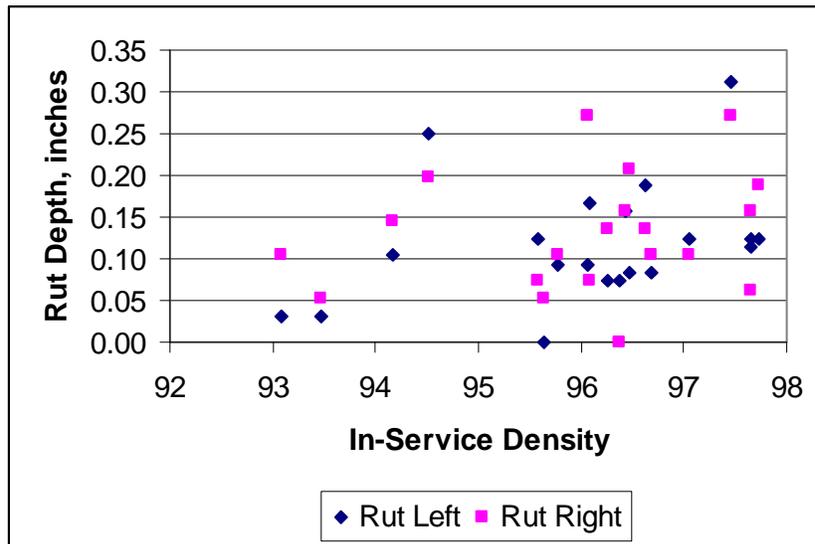
Rut depth data were stratified by wheel path location (left and right) to assess any potential effect (see Figures 6.7 and 6.8). From this stratification, no clear delineation between wheel path location and density could be found.

Figure 6.7 As-Built Density and Rut Depth by Wheel Path

Figure 6.8 In-Service Density and Rut Depth by Wheel Path

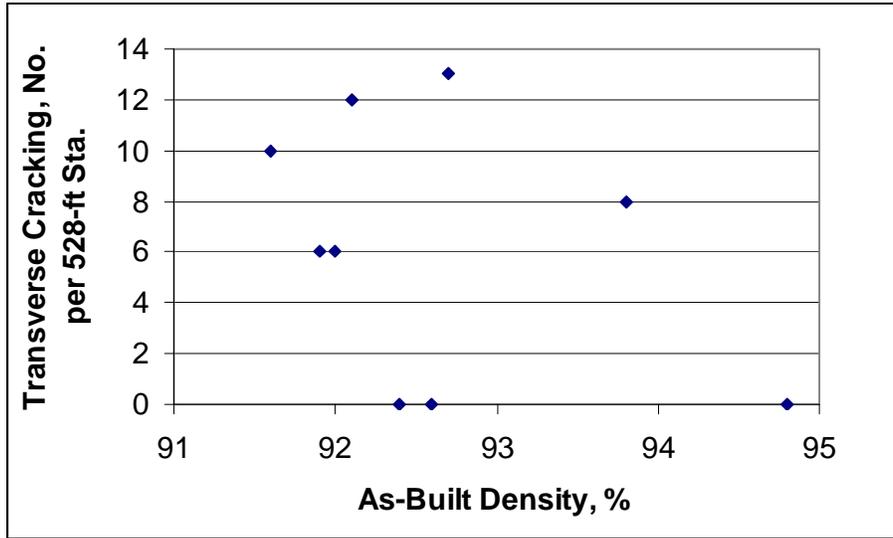
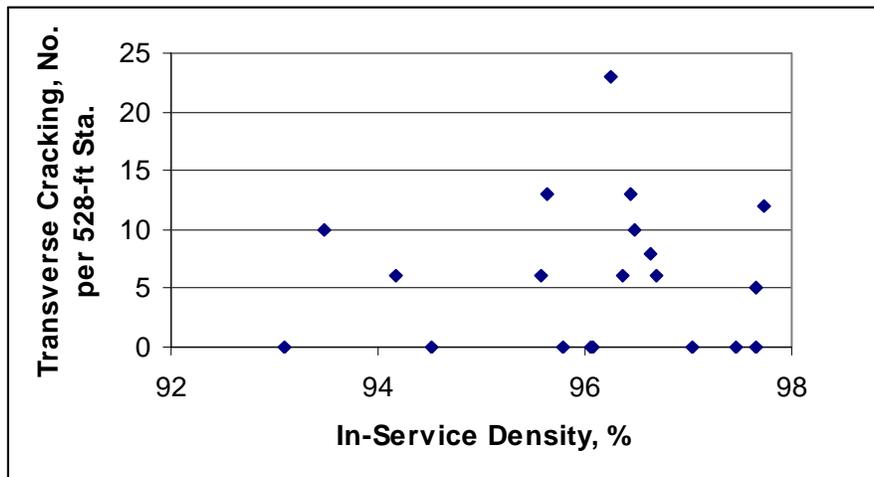
Transverse cracking was observed on several projects, and the extent (number of cracks per 528-foot test section length) was plotted against density (Figures 6.9 and 6.10). A slight positive trend was observed for in-service density, while as-built density may have had an influence but there were limited data points. It appeared that lower as-built density may cause a greater frequency in cracking.

Figure 6.9 As-Built Density and Transverse Cracking Extent

Figure 6.10 In-Service Density and Transverse Cracking Extent

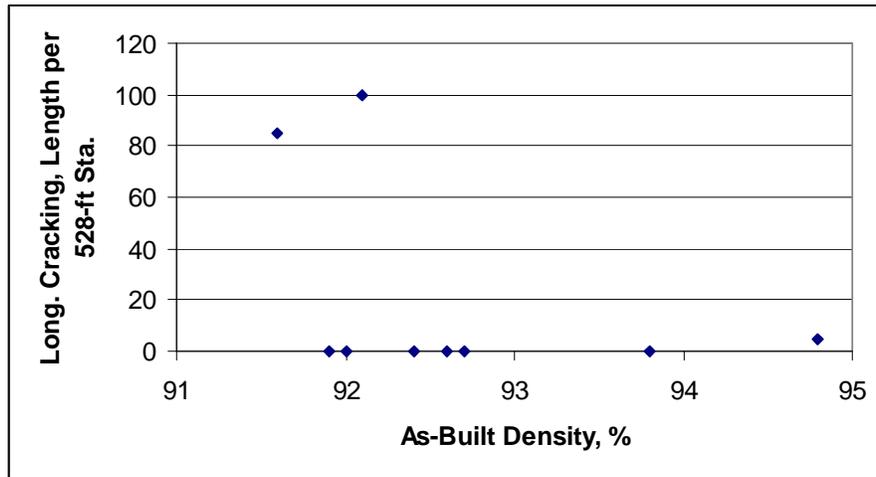
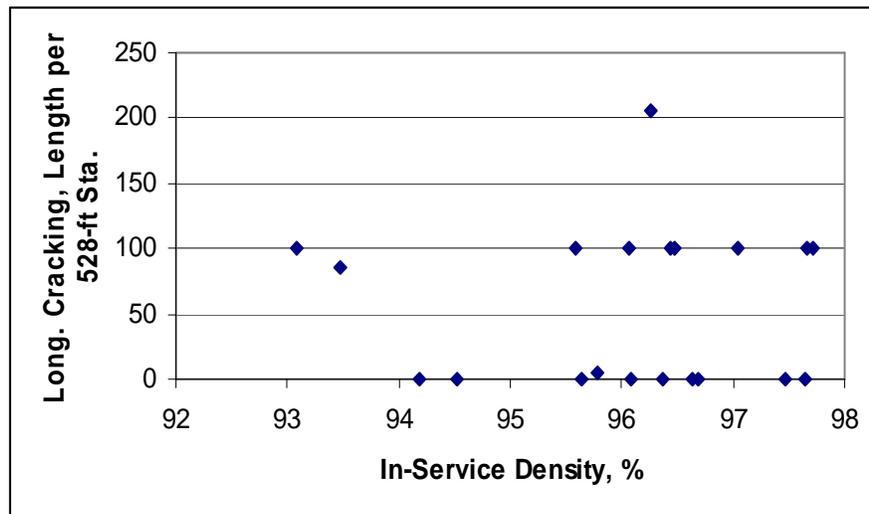
Nearly all longitudinal cracking was measured in either the right or left wheel path. Longitudinal cracking extent (L.F. per 528-foot test section length) was compared with density, as shown in Figures 6.11 through 6.12. There appeared to be greater extent of cracking for as-built densities lower than 92%, and no relationship was observed across a wide range of in-service densities.

Figure 6.11 As-Built Density and Longitudinal Cracking Extent

Figure 6.12 In-Service Density and Longitudinal Cracking Extent

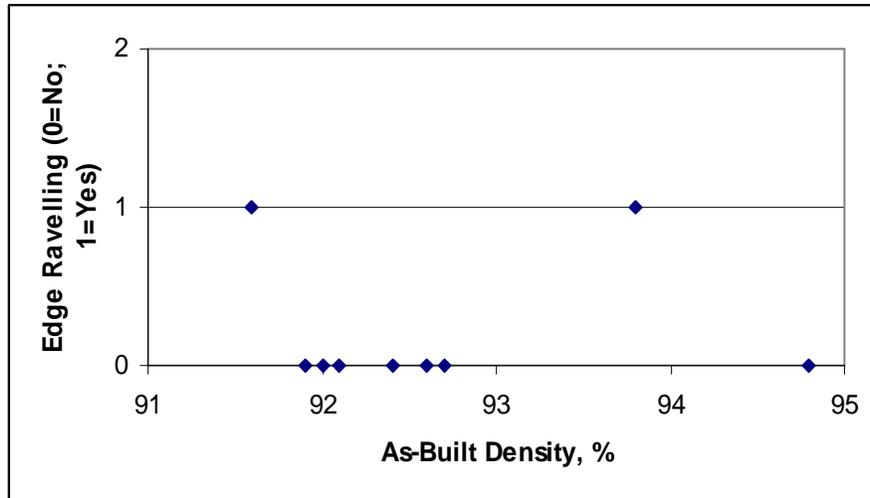
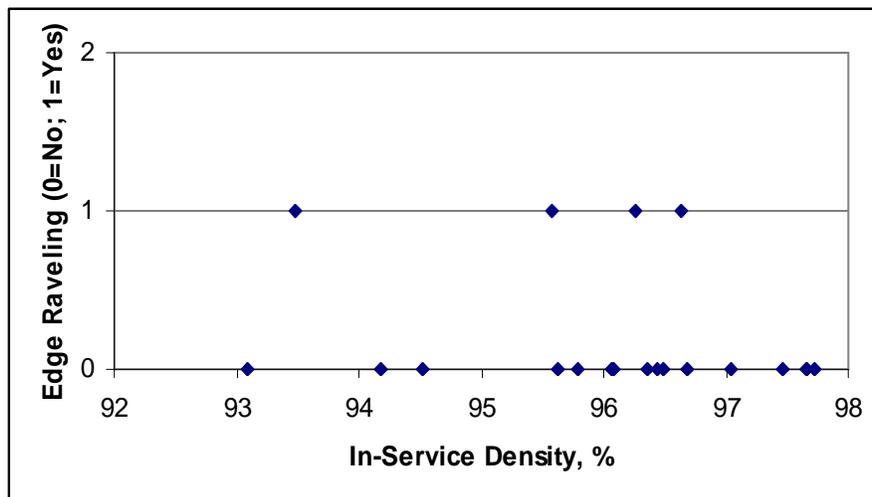
The presence of edge raveling was plotted against density (see Figures 6.13 and 6.14), and no relationship was observed. Edge raveling occurred across a range of as-built and in-service densities.

Figure 6.13 As-Built Density and Edge Raveling Extent

Figure 6.14 In-Service Density and Edge Raveling Extent

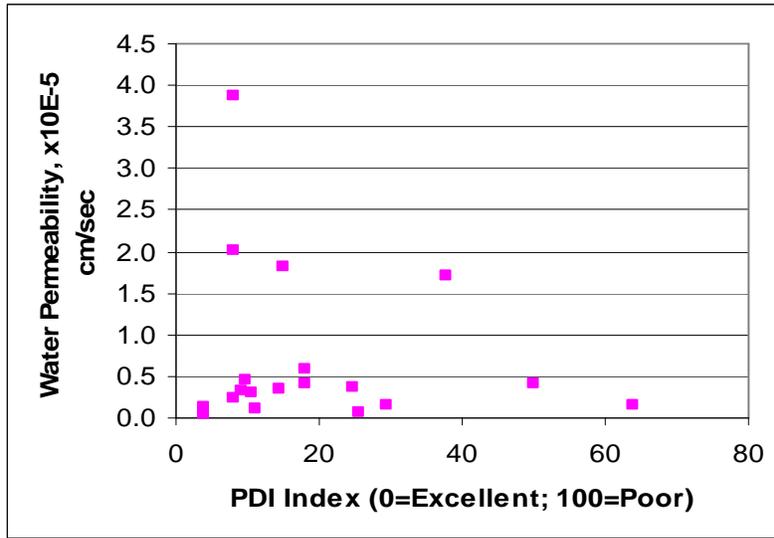
In this section, the relationship of permeability and performance was investigated. The 8 permeability measurements in each 0.1-mile test section were averaged to produce a single value. The same approach from the previous section began by evaluating the PDI and individual distresses. First, Figure 6.15 illustrates PDI versus water permeability, where a downward trend was observed when a datapoint of 4.0×10^{-5} cm/sec was included in the plot. However, without this influential datapoint, no definitive trend existed. Rut depth did not have a definitive relationship with permeability, as illustrated in Figure 6.16.

Figure 6.15 Water Permeability and Pavement Distress Index

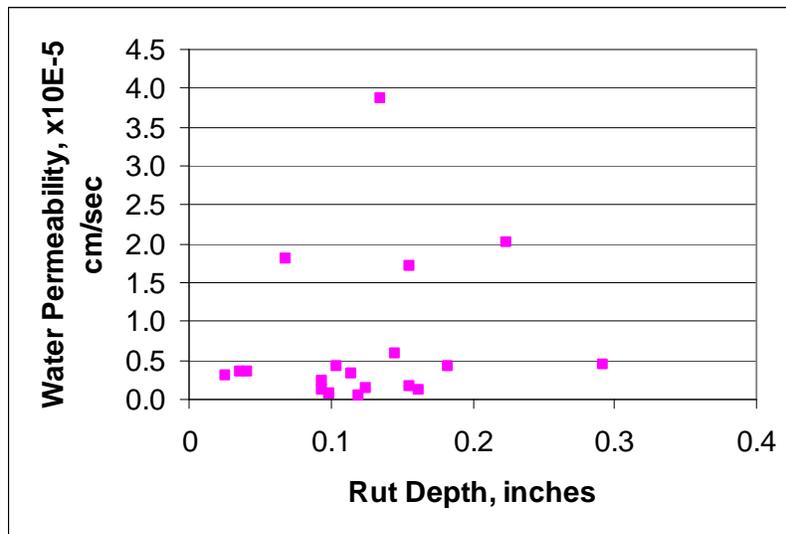
Figure 6.16 Permeability and Rut Depth

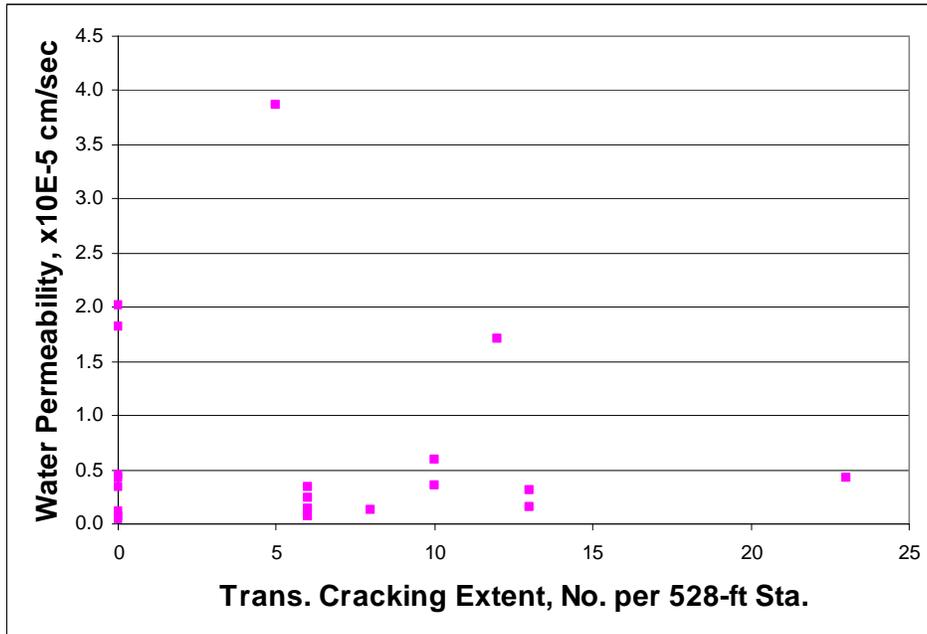
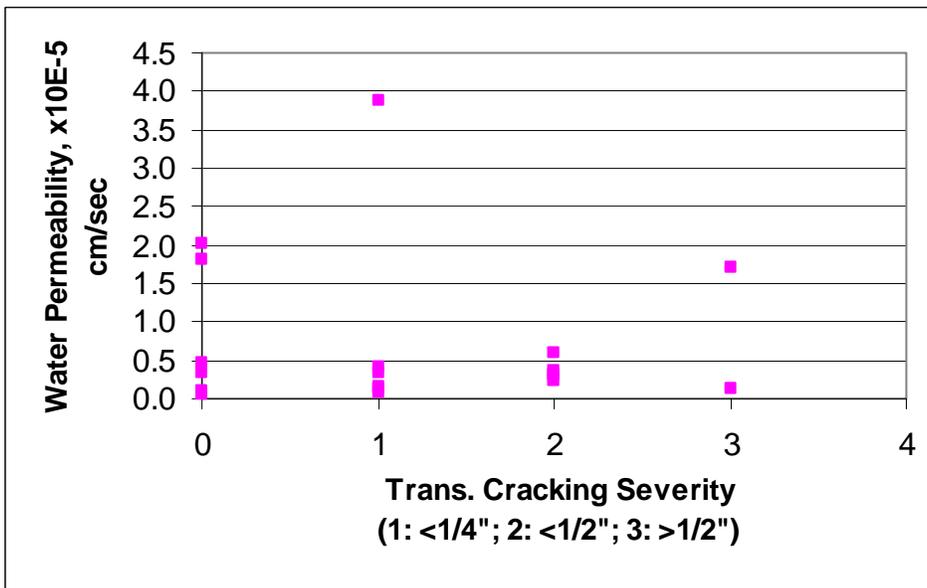
Transverse cracking extent and severity were plotted against permeability, as illustrated in Figures 6.17 and 6.18, respectively. In both cases, no relationship was found.

Figure 6.17 Permeability and Transverse Cracking Extent

Figure 6.18 Permeability and Transverse Cracking Severity

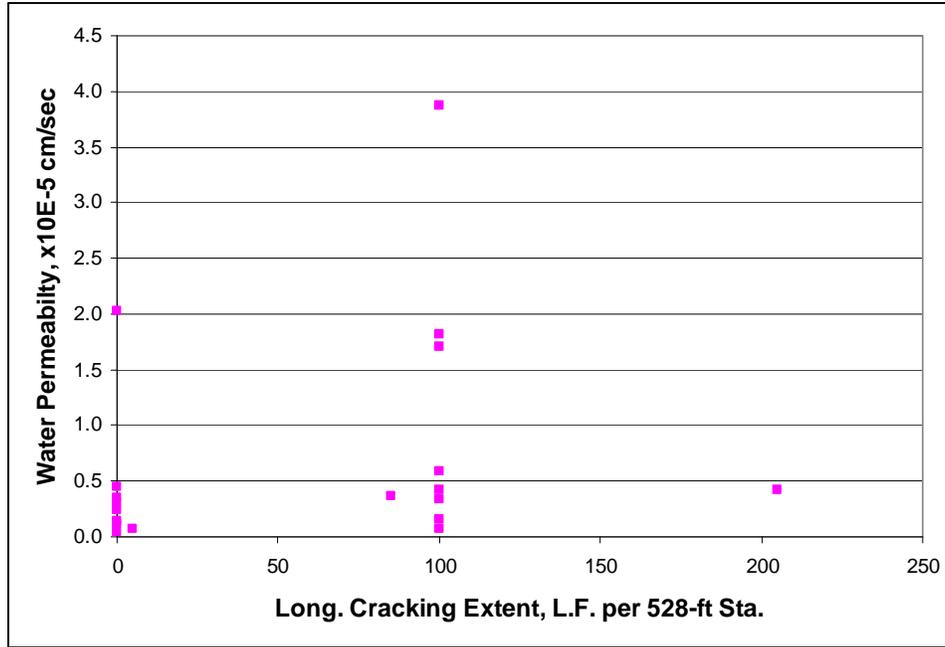
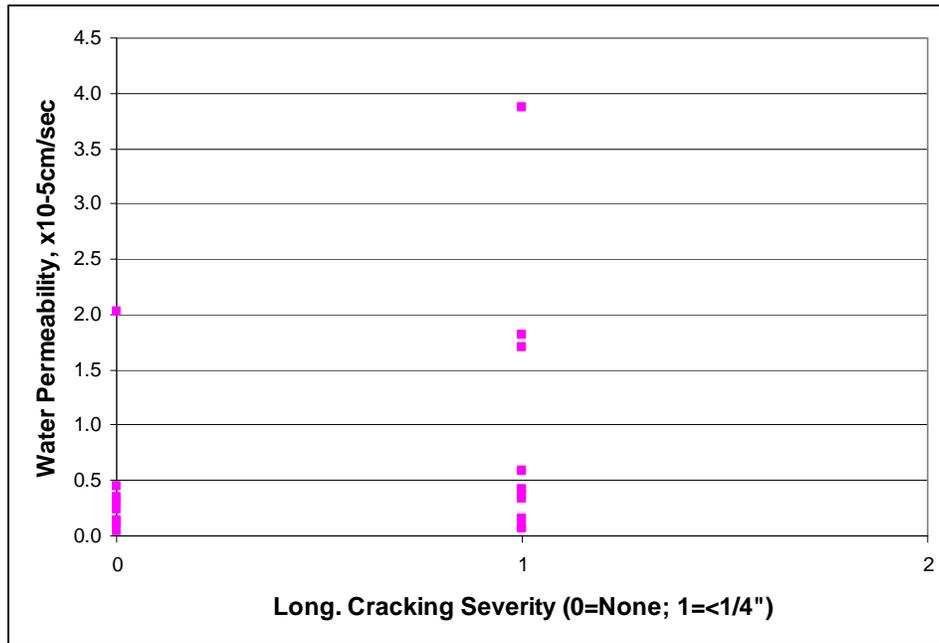
Similar plots were constructed for longitudinal cracking extent and severity, as shown in Figures 6.19 and 6.20, respectively. Water permeability did not have an effect on longitudinal cracking based on the available data.

Figure 6.19 Permeability and Longitudinal Cracking Extent

Figure 6.20 Permeability and Longitudinal Cracking Severity

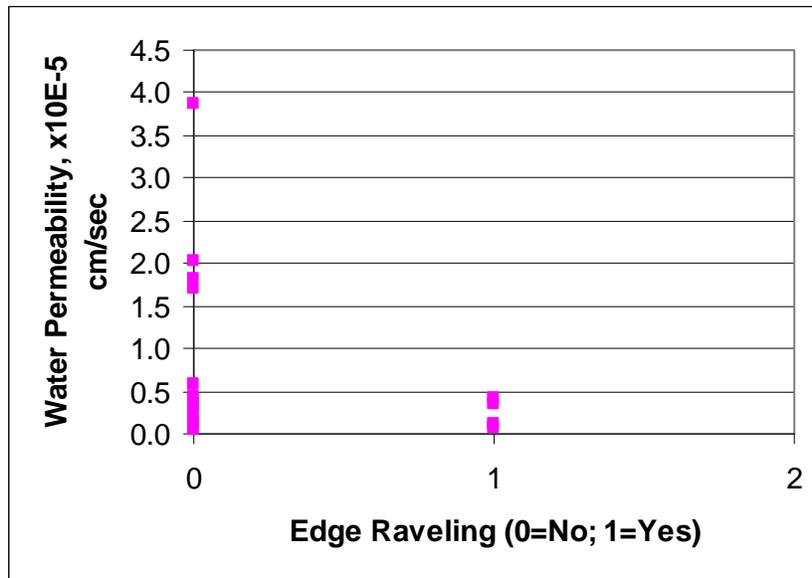
Finally, Figure 6.21 plots edge raveling versus permeability, where permeability values were scattered in the presence of no edge raveling.

Figure 6.21 Edge Raveling and Permeability

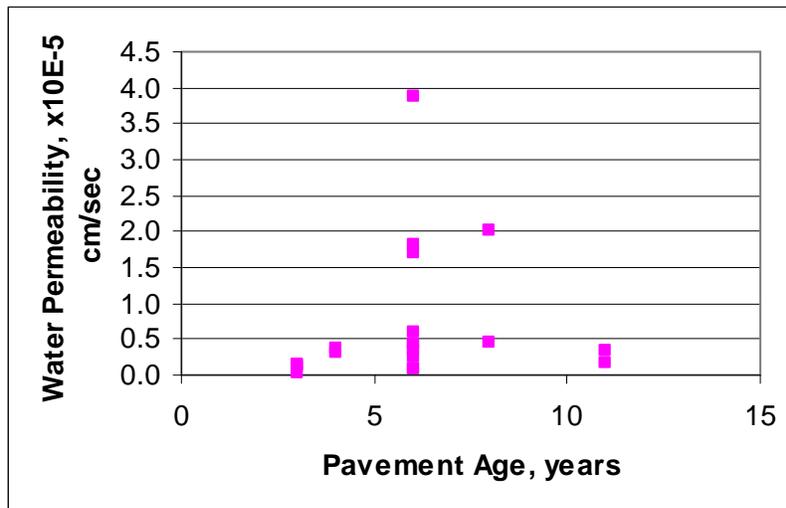
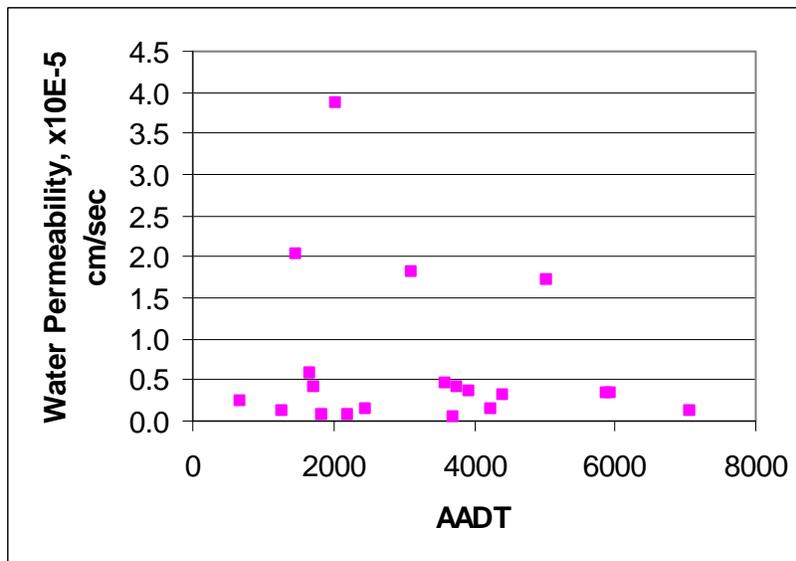
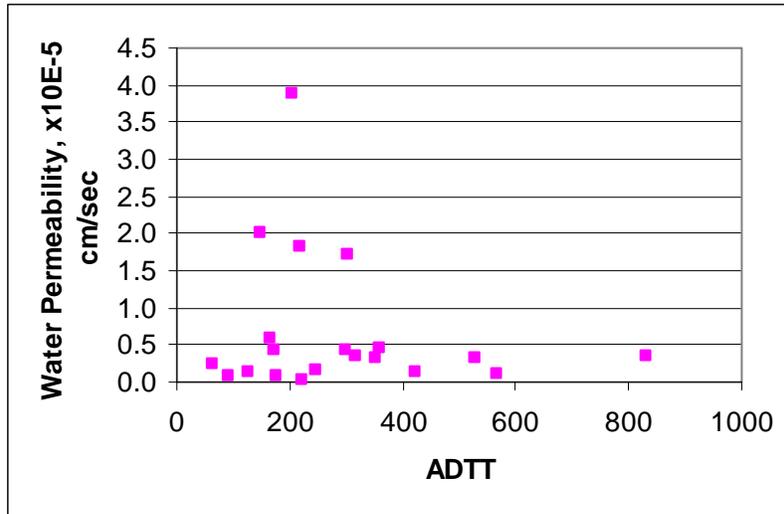
To broaden the understanding of water permeability with project and mixture-specific variables, several plots were created and investigated. Beginning with Figure 6.22, age did not directly influence permeability. Pavements 6 years of age were more permeable than 3- and 4-year old pavements – a possible cause may have been from initial Superpave implementation (different compaction techniques, tender zone, gradation, etc.). Higher traffic levels appeared to reduce permeability, as shown by plots for AADT and ADTT in Figures 6.23 and 6.24, respectively.

Figure 6.22 Water Permeability and Pavement Age

Figure 6.23 Water Permeability and Average Annual Daily Traffic

Figure 6.24 Water Permeability and Average Daily Truck Traffic

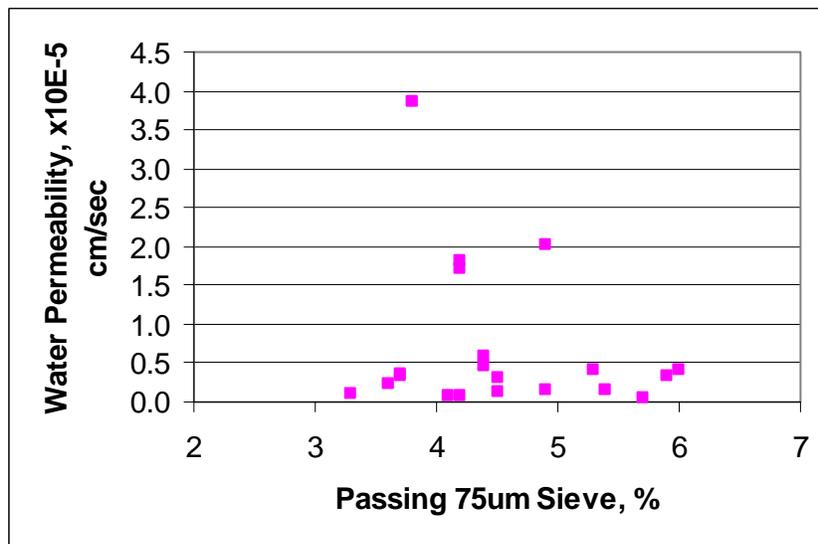
Passing the 75-um sieve had a correlation (Table 6.1), but Figure 6.25 indicates that 1 data point may have had substantial influence on developing a slight downward trend. But, based on the visual analysis, it appeared that the percentage passing 75-um sieve did not impact permeability.

Figure 6.25 Water Permeability and Passing 75um Sieve

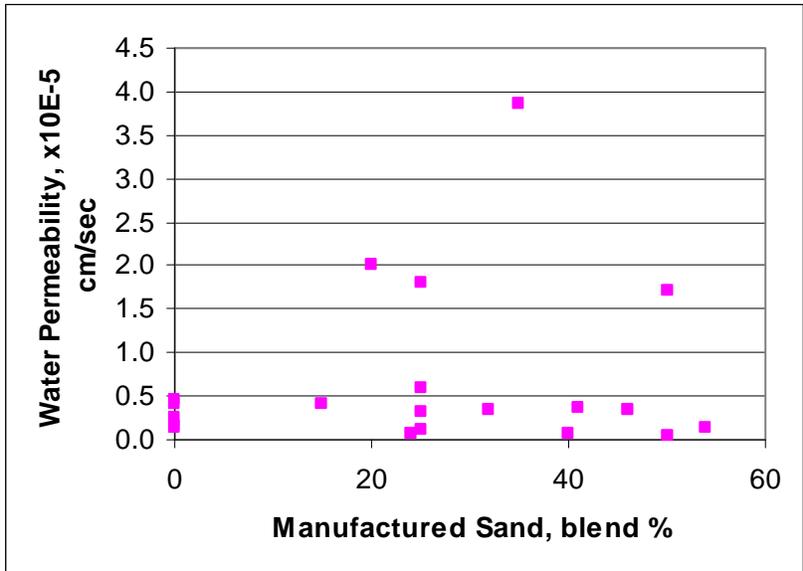
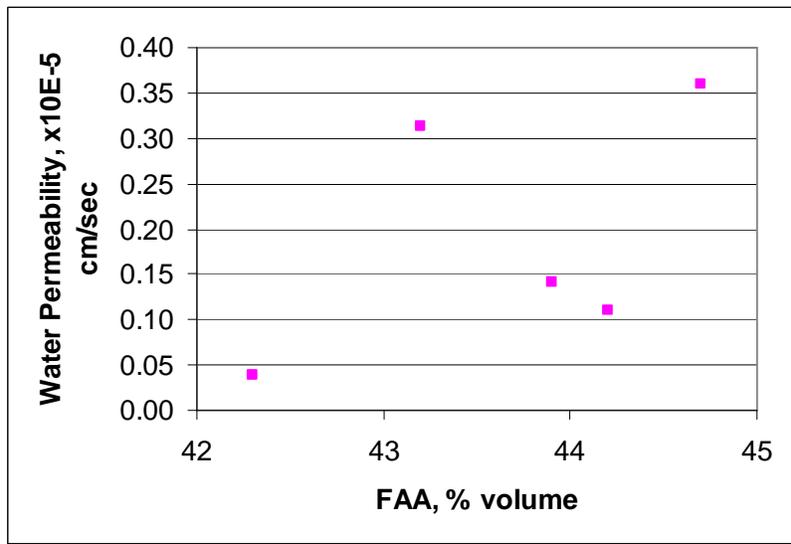
Aggregate angularity has been suggested by the previous WHRP study to affect water permeability (Russell et al. 2004). Figure 6.26 and 6.27 respectively illustrate the effect of manufactured sand (as percentage of aggregate blend) and fine aggregate angularity (FAA). Blend percentage of manufactured sand did not appear to have a definitive trend, however, a positive relationship between water permeability and FAA was disclosed. A concern of Figure 6.27 was the sample size of n=5, however, it was observed with the available data that a possible relationship did exist.

Figure 6.26 Water Permeability and Manufactured Sand Blend Percentage

Figure 6.27 Water Permeability and FAA

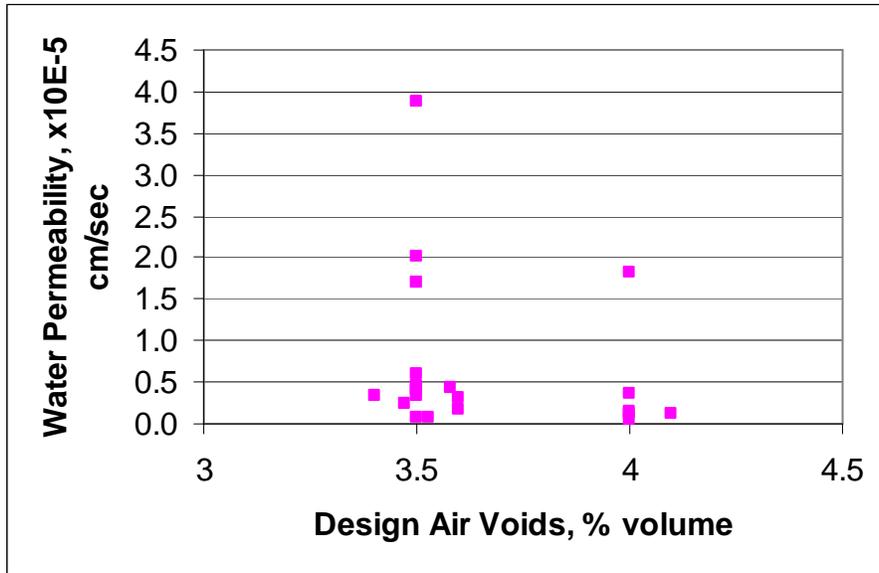
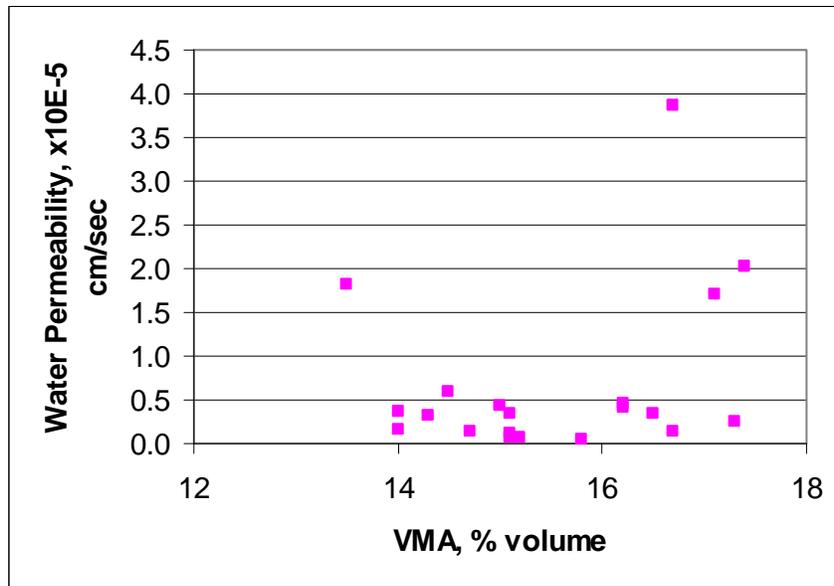
In-place air voids (density) has been proven to affect permeability in some mixtures, thus design air voids were investigated as a potential variable affecting water permeability. In Figure 6.28 the plot indicated that pavements designed at both 3.5% (pre-Superpave) and at 4% (current practice) had no effect. Voids in mineral aggregate (VMA) had a positive relationship with permeability (Figure 6.29). With the absence of one data point with $VMA < 14\%$, a positive relationship existed.

Figure 6.28 Water Permeability and Design Air Voids

Figure 6.29 Water Permeability and Design VMA
