**Development of In-Place
Permeability Criteria for HMA
Pavement in Wisconsin
SPR # 0092-06-02**

**Robert Schmitt and Samuel Owusu-Ababio
University of Wisconsin-Platteville
James Croveti
Marquette University
Allen L. Cooley
Burns Cooley Dennis Inc.**

February 2007

WHRP 06-15

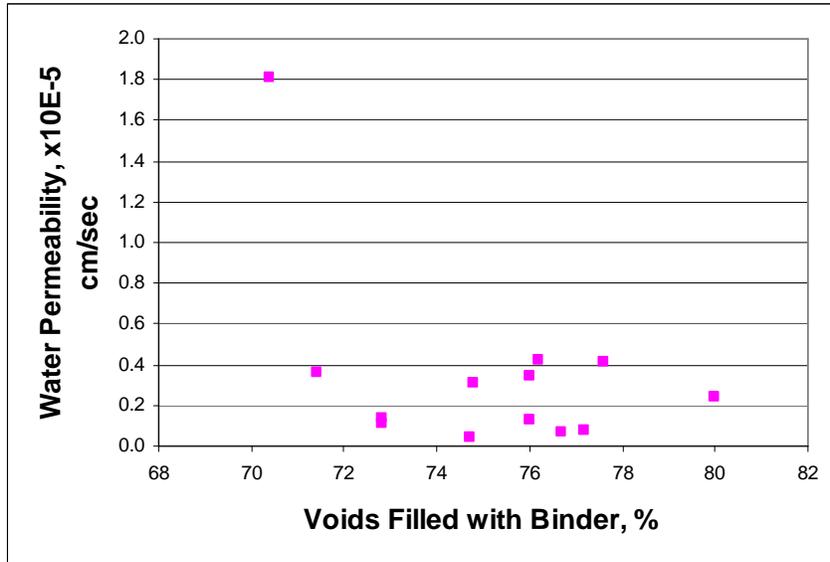
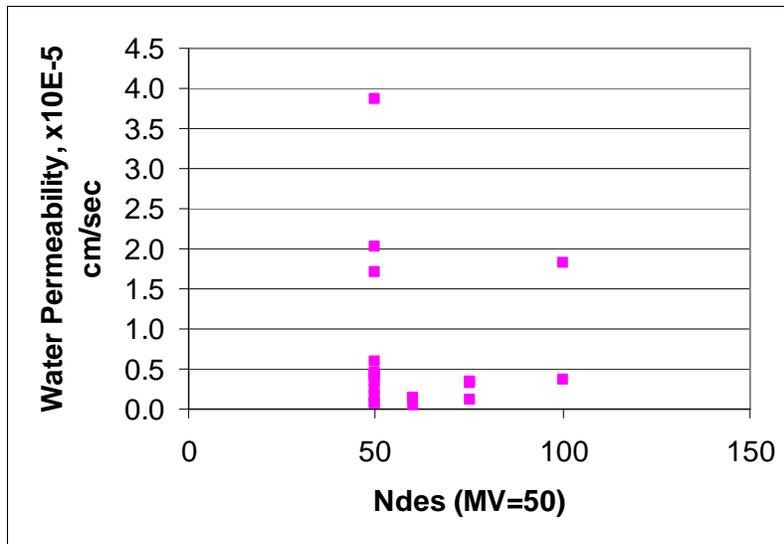
Another important mixture volumetric, voids filled with binder (VFB), was plotted against permeability in Figure 6.30, and no relationship was found. Number of gyrations (Superpave) and number of hammer blows (Marshall) were plotted in Figure 6.31. Type-MV Marshall-designed mixes were designated $N_{des} = 50$. Despite one data point having $N_{des} = 50$ and $k = 4 \times 10E-5$ cm/sec, it appeared that N_{des} did not have an affect on permeability.

Figure 6.30 Water Permeability and Design VFB

Figure 6.31 Water Permeability and N-Design

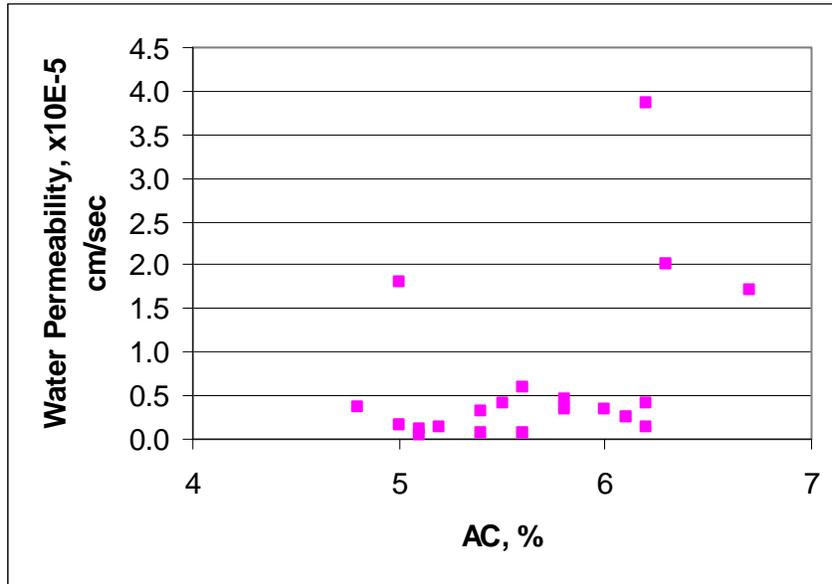
Finally, Figure 6.32 compared design asphalt content (AC) with permeability and no distinguishing relationship was observed. Permeability values of $2 \times 10E-5$ cm/sec were offset at both low and high AC levels. An argument could be made that higher-AC mixes should fill more internal void structure and reduce permeability, however, based on the available data, Figure 6.32 did not support that argument.

Figure 6.32 Water Permeability and Asphalt Content

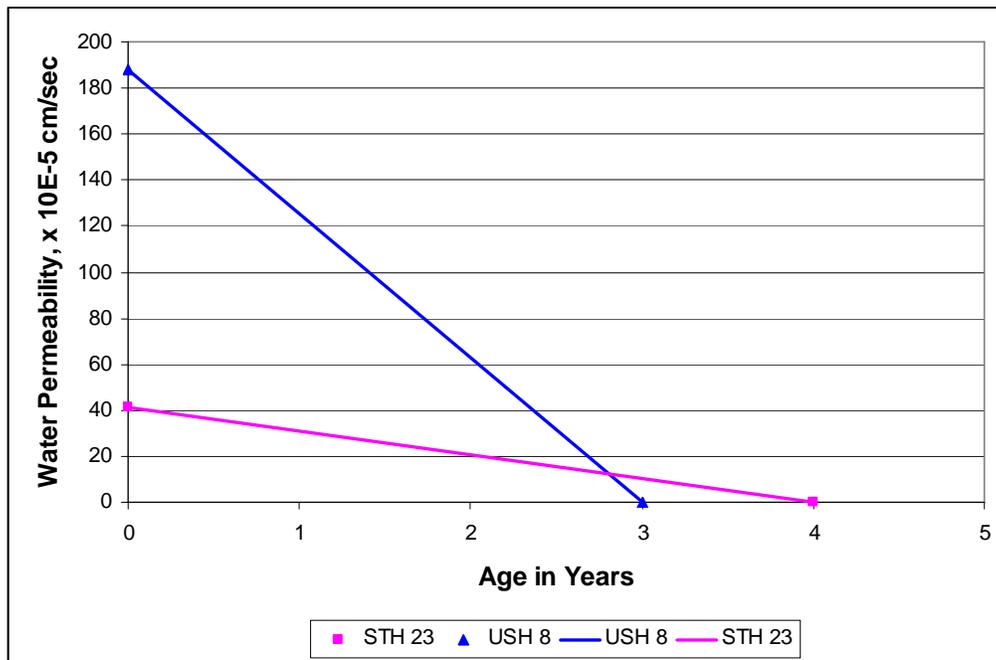
Figure 6.33 plots water permeability at both the time of construction and after 3 or 4 years of traffic. Permeability values dropped from 41 and 188 x 10E-5 cm/sec on the STH 23 and USH 8 projects, respectively, to nearly impermeable values in 3 to 4 years. After a few years of traffic, and infiltration of fine particles and general road grime, these pavements were determined to be nearly impermeable.

Figure 6.33 Relationship of Water Permeability and Age

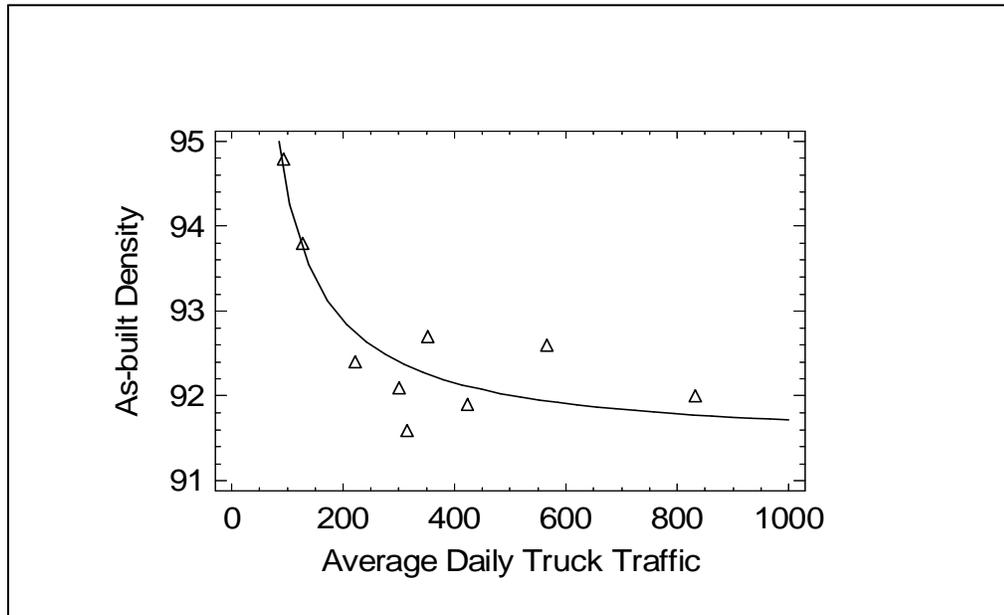
A preliminary analysis involving data plots and simple regression was conducted to examine key mix design variables that influence as-built density. Nine projects (out of twenty) with an average age of 4.8 years had available as-built density data. Using these projects, two key variables including the design truck traffic (a surrogate for mix type) and the VFB were identified to influence the as-built density. The relationships between truck traffic and as-built density, as well as VFB and as-built density are shown respectively in Figures 7.1 and 7.2. Figure 7.1 suggests that as-built density achieved at time of construction appears to decrease non-linearly with increased truck traffic level. This observation may be due to the fact that higher traffic levels generate thicker pavements in design, and may be difficult to compact compared to thinner pavements, which are associated with lower traffic levels. The model representing the relationship shown in Figure 7.1 is represented as Model #1 in Table 7.1.

Figure 7.1 As-built Construction Density versus Truck traffic

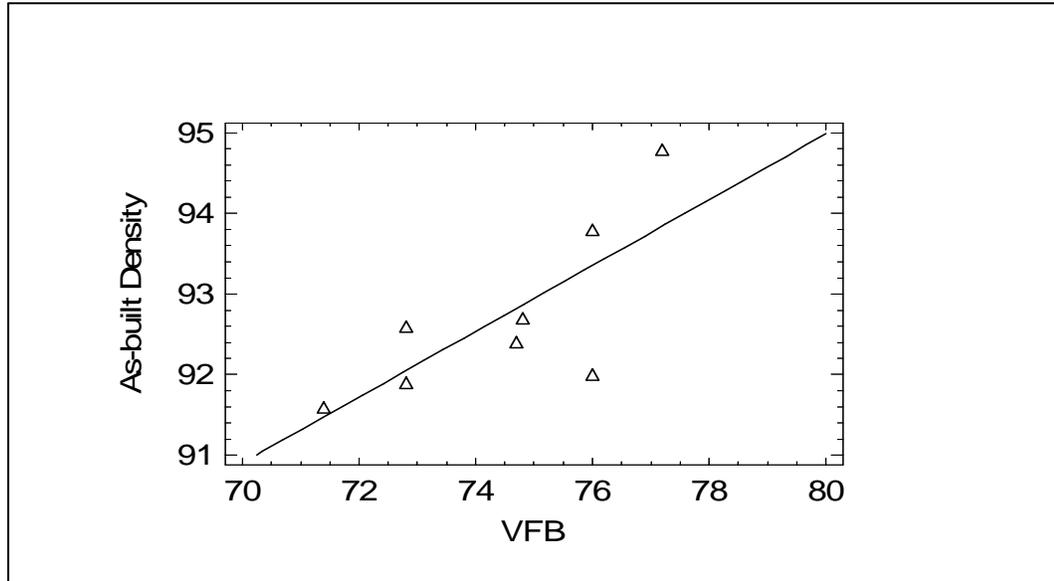
Figure 7.2 shows higher VFB resulted and in higher as-built density. The relationship is depicted as Model #2 in Table 7.1.

Figure 7.2 As-built Density and VFB Relationship

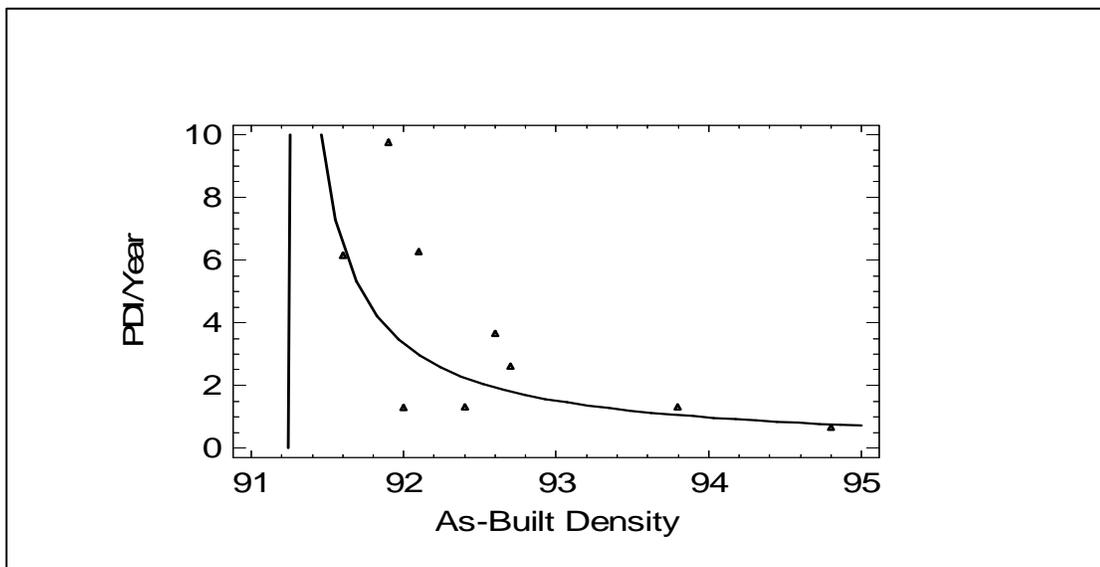
The relationship between as-built density and performance (as indicated by the PDI/year) is shown in Figure 7.3 and represented as Model #3 in Table 7.1. Figure 7.3 suggests that pavements with high as-built densities tend to exhibit better performance.

Figure 7.3 Pavement Performance and As-built Density Relationship

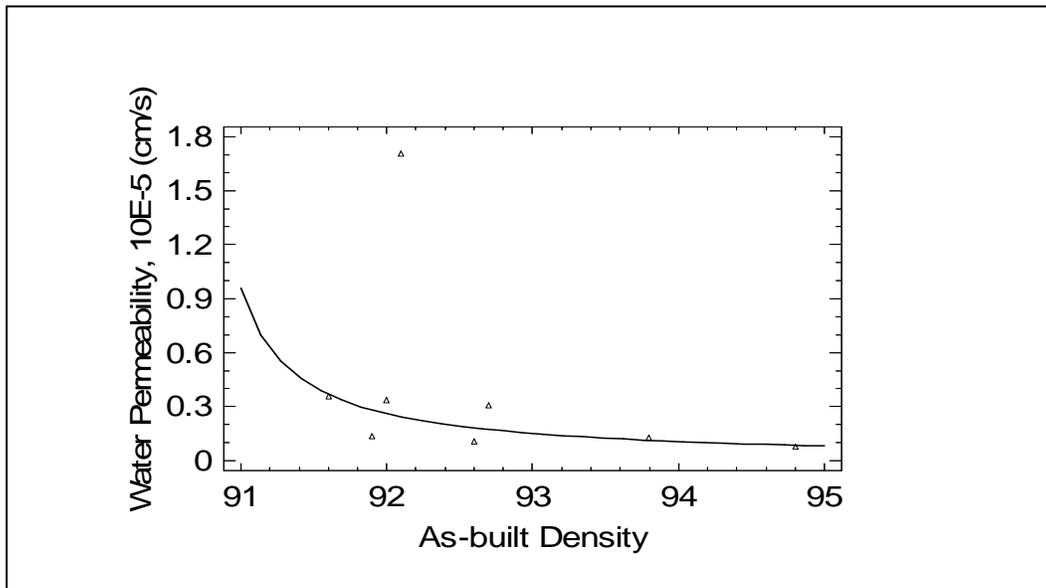
Figure 7.4 shows the relationship between as-built density and in-service water permeability. This relationship is represented in Table 7.1 as Model #4 and supports the hypothesis that higher as-built densities result in less permeable pavements.

Figure 7.4 Water Permeability and As-built Density Relationship

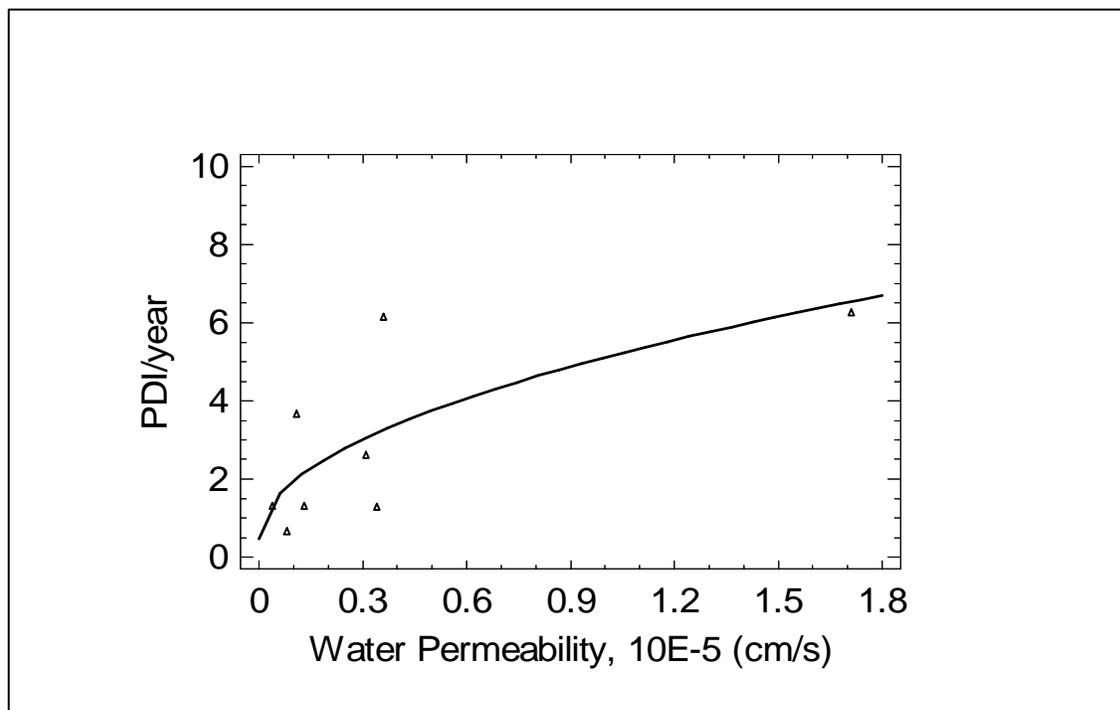
Figure 7.5 shows the relationship between performance and water permeability. This relationship is represented as Model #5 in Table 7.1. Figure 7.5 suggests that water permeability increases in a non-linear fashion with increasing pavement deterioration.

Figure 7.5 Pavement Performance and Water Permeability Relationship

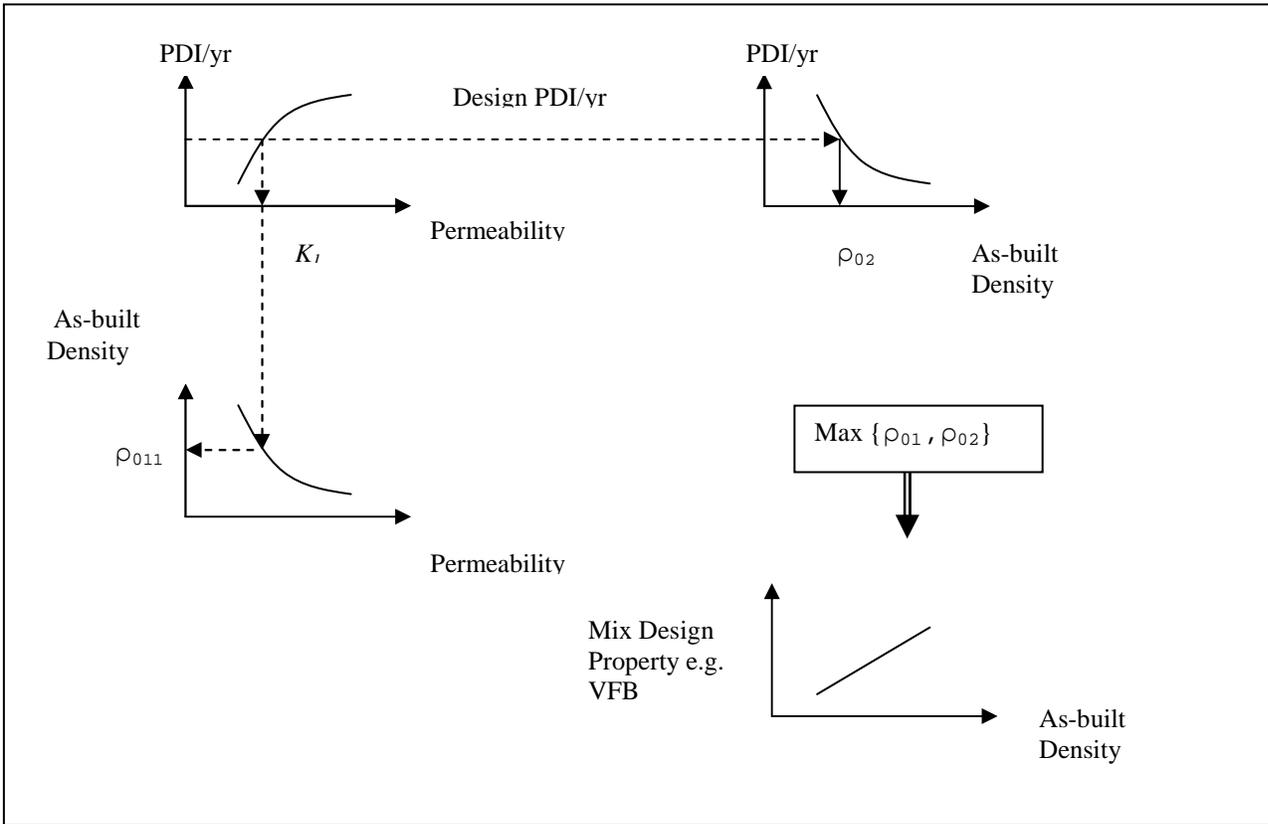
Figure 7.6 Framework for Relating Permeability and Mix Design Properties to Performance

The framework shown in Figure 7.6 is illustrated in Figure 7.7 using the models presented in Table 7.1. In this illustration, a desired PDI/year of 4.0 is assumed as the target PDI/year for preventive maintenance intervention. Using Figure 7.7, an as-built density of 91.5% is triggered for the target PDI/year of 4.0 with a corresponding expected water permeability of $0.60 \times 10E-5$ cm/s. A density of 91.8% is also required to achieve the desired PDI/year of 4.0. Hence, the controlling density to satisfy permeability and PDI requirements is the latter value (91.8%), which is the greater of the two. The corresponding VFB based on the density is approximately 72%.

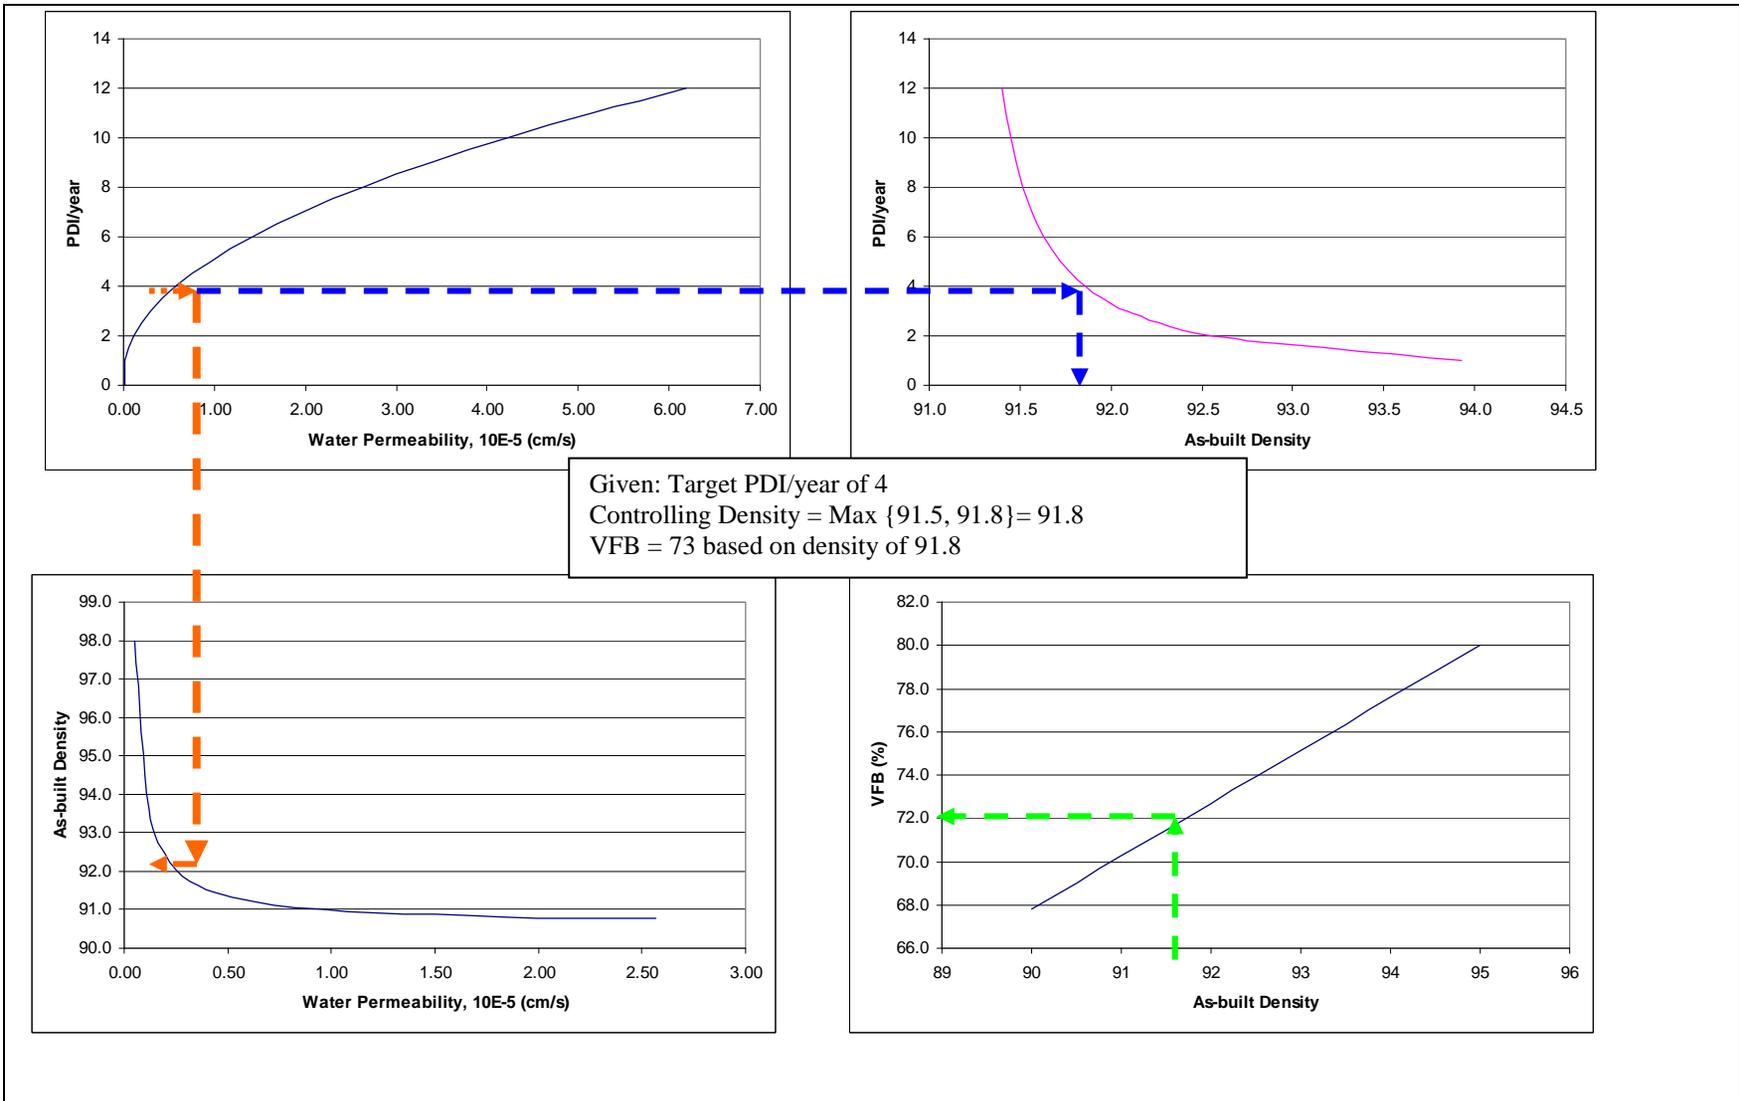
Figure 7.7 Application Model for Relating Permeability and Mix Design Properties to Performance
