Superstructures come in a variety of types and configurations and comprised of concrete, steel, timber, a combination of materials, or another material entirely. Retrofits or repairs may see use of a differing structural material than the existing. This may be due to availability, cost, geometric or installation restrictions. For instance, a fractured timber stringer may be retrofitted with a C-channel bolted to its side or a rolled beam may replace the stringer altogether.

It is necessary for the inspector to understand the components of the superstructure and their function within the load path. The bridge inspector must understand the critical areas of each type of superstructure as well as the defects associated with the structural material the component is comprised of.

This chapter is broken down by construction material (concrete, steel, timber, etc.) and superstructure type (girder, truss, arch, etc.). Each material section lists the elements in numerical order (as they are labeled in the AASHTO Manual for Bridge Element Inspection) and describes the element in detail. Each element segment of the chapter details the element level inspection and safety inspection to furthe

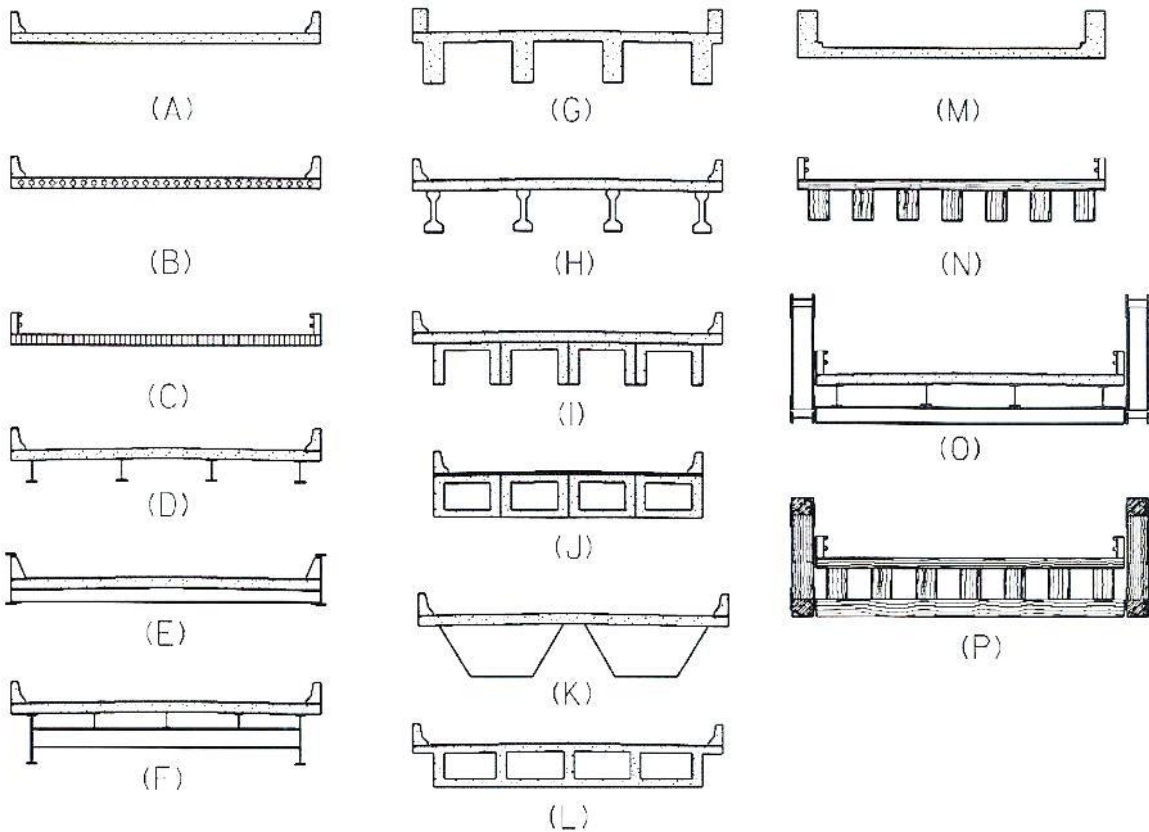
**Figure 2.4.1-1:** Common Superstructure Types – (A) Reinforced Concrete Flat Slab; (B) Reinforced Concrete Voids Slab; (C) Timber Slab; (D) Steel Multi-beam; (E) Steel Through Girder; (F) Steel Girder/Floor Beam/Stringer; (G) Reinforced Concrete Tee Beam; (H) Prestressed Concrete I Beam; (I) Prestressed Concrete Channel; (J) Prestressed Concrete Box Beam; (K) Steel Box Girder; (L) Post-tensioned Concrete Box Girder; (M) Reinforced Concrete Through Girder; (N) Timber Multi-beam; (O) Steel Truss; (P) Timber Truss.

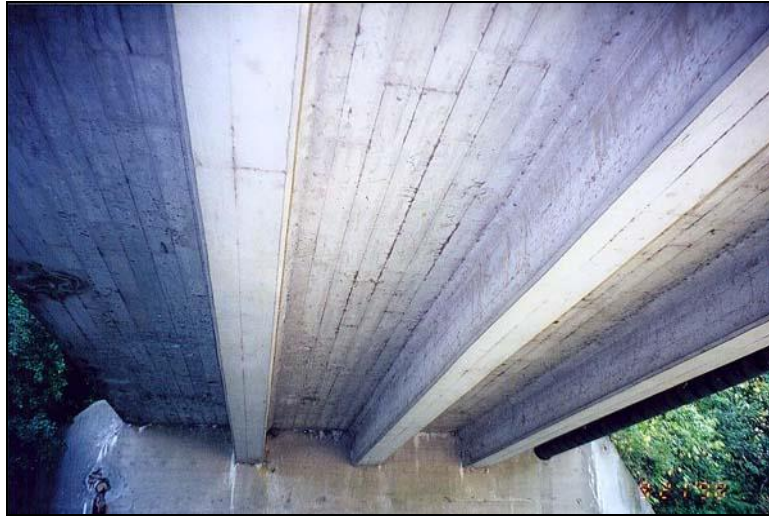
**Figure 2.4.3-2:** Reinforced Concrete Tee Beam Bridge.

negative bending regions. Transverse, vertical stirrups placed along the beams serve as shear reinforcing.

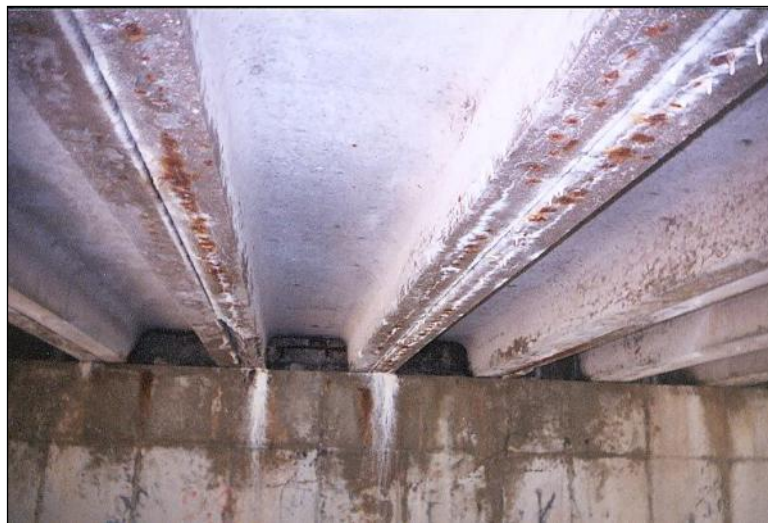
**Figure 2.4.3-4:** Deteriorated Prestressed Channel Beams.

- Channel beams:** Channel beam bridges use precast channel beams as the primary load-carrying members. The channels are placed on the substructure units so that they form an upside down “U”, with the vertical legs forming the beams and the horizontal top slab forming the deck. The channels are placed tight side by side and transversely connected so that the individual beams act as a unit under live loads. Grouted shear keys also help the beams to act together. Channel beam bridges are used for simple spans up to about 50 feet. Widths of the individual beams usually range from 3 to 4 feet. The main reinforcing steel is placed longitudinally towards the bottom of the channel legs, while the main deck reinforcing steel is placed transversely in the top slab. Vertical stirrups may be placed along the channel legs and serve as shear reinforcing.

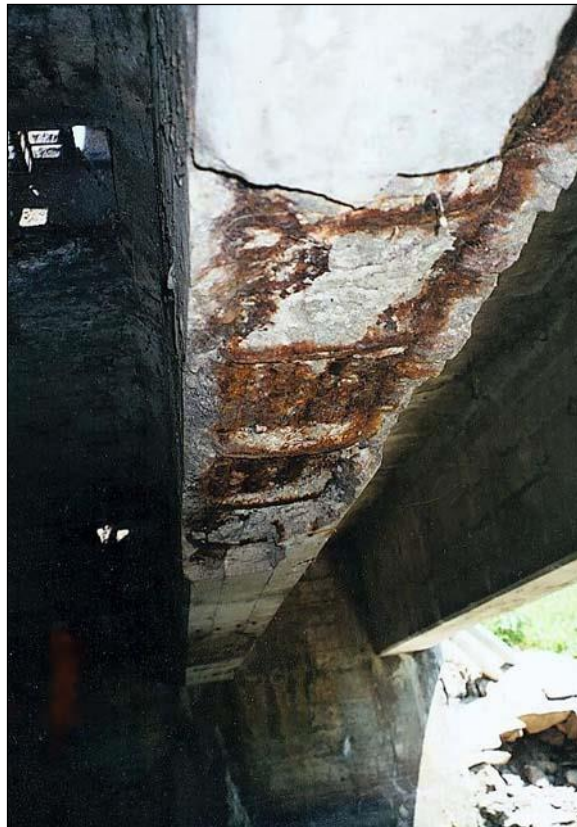
**Figure 2.4.2.2-5:** Reinforced Concrete Tee Beam – Condition State 4.

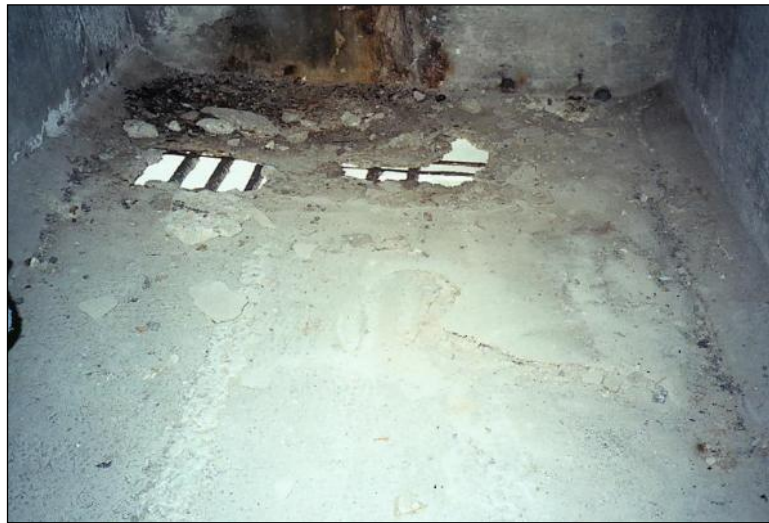
**Figure 2.4.2.2-7:** Reinforced Concrete Box Girder Bottom Flange Through Thickness Section Loss - Condition State 4.

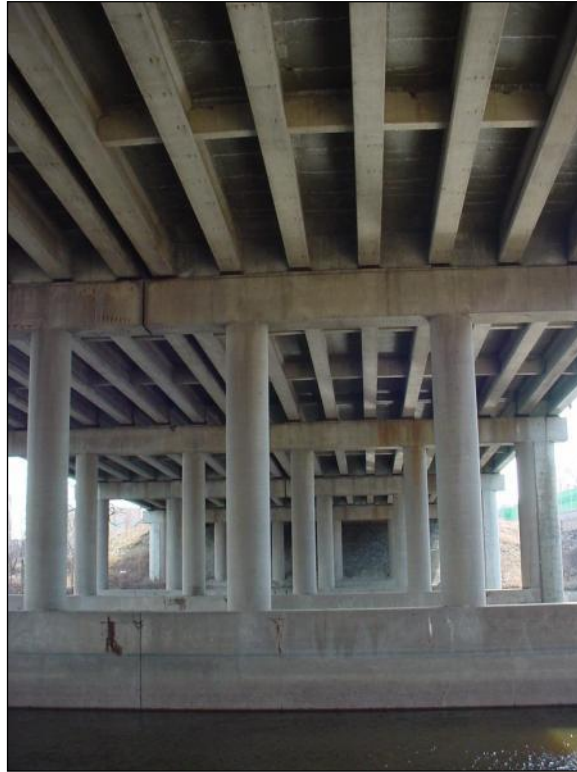
**Figure 2.4.3-1:** Prestressed I-beams.

3. **Prestressed I-beams and Bulb-Tees:** Prestressed I-beams and bulb-tees are commonly precast members without voids. They make for efficient use of material by concentrating the concrete away from the beam's neutral axis where it is needed most for stiffness and strength. Concrete decks are often designed to act compositely with the I-beams. They are used for simple spans up to about 160 feet in length. They may also be made continuous over piers for live loads and secondary dead loads. This is done by placing conventional reinforcing steel longitudinally in the deck over the piers to resist negative bending. The main steel prestressing strands are placed parallel to traffic and located in the bottom flange of the beam. Conventional reinforcing steel ties are placed transversely along the beam for shear reinforcement. Secondary members of prestressed I-beam bridges include concrete diaphragms at the abutments and piers and either steel or concrete diaphragms within the spans.

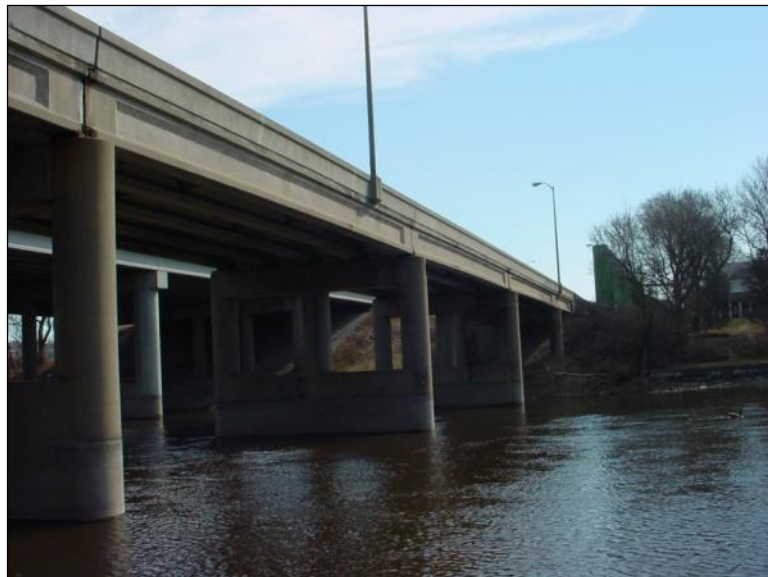
**Figure 2.4.3.1-1:** Prestressed Concrete I-Beam Bridge.

These are primary bending elements that are typically plant-fabricated precast/prestressed open: I-beams, bulb tees, inverted channels, closed boxes, and segmental post-tensioned closed boxes. On closed box shapes and inverted channel sections, the top flange may also function as the bridge deck. Stringers account for all prestressed members that support the deck in a floor system. Floor beams account for all prestressed floor beams that typically support stringers in a floor system.

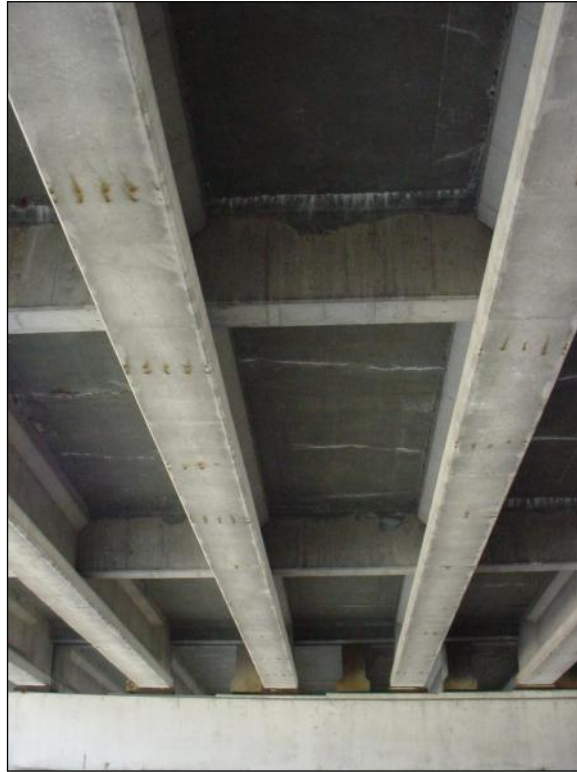
**Figure 2.4.3.1-3:** Prestressed I-Beams – Condition State 1.

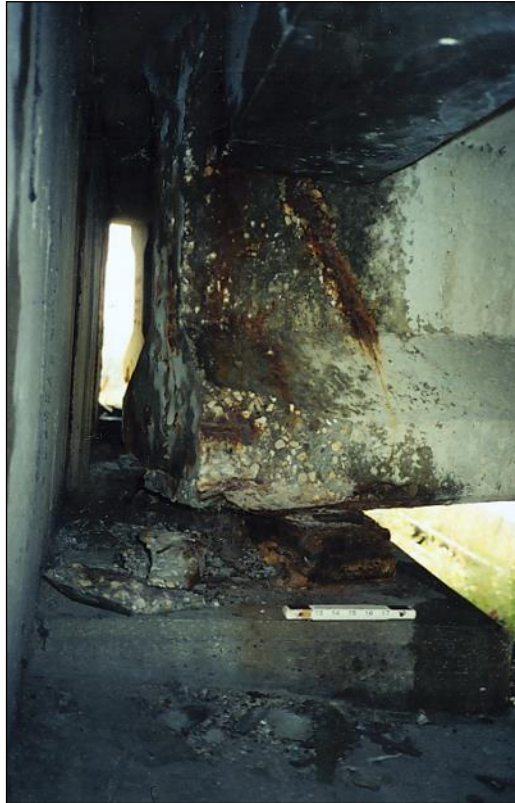
**Figure 2.4.3.1-5:** End of Prestressed I-Beam with Spalls and Exposed Strands and Rebar – Delamination/Spall/Patched Area Condition State 3.

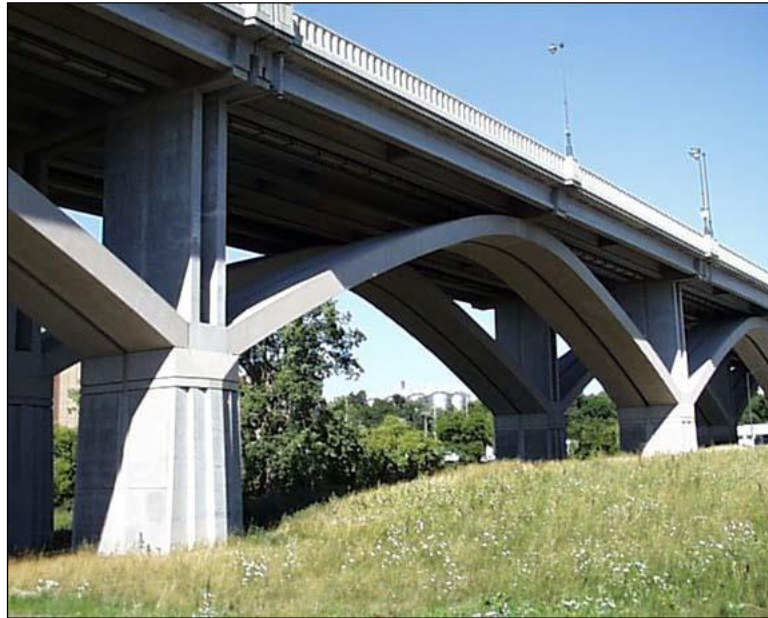
**Figure 2.4.3.2-1:** Open Spandrel Prestressed Arch Bridge with Struts.

Prestressed arches are rare forms of the concrete arch. Arches are primary load-carrying elements that carry axial compressive stresses, as well as bending, tension, and compressive stresses. Normally, the axial loads are great enough on an arch that there are no net tensile stresses due to bending. When bending stresses are large enough to produce net tension, post-tensioning is used to pre-compress the arch cross-section. This keeps the entire cross-section in compression, eliminating any net tensile stress.

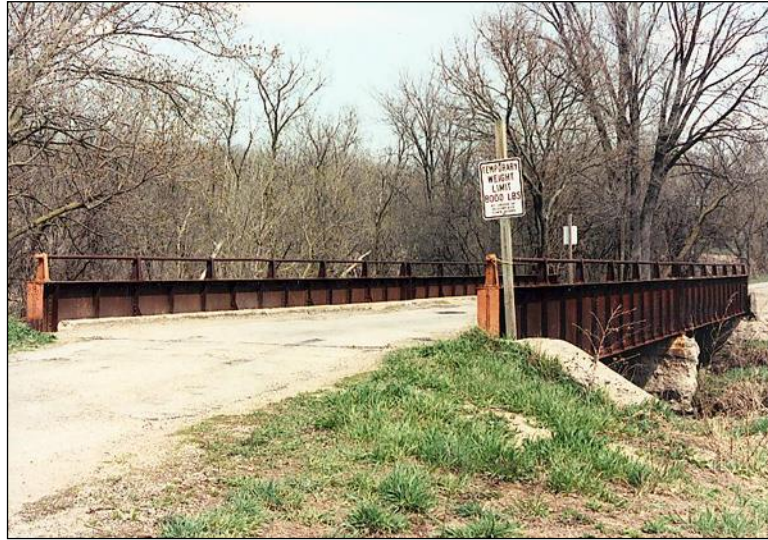
**Figure 2.4.4-4:** Steel Through Girder Bridge.

- Through girders:** Through girder bridges are similar to two-girder bridges but the deck is placed between the girders rather than on top of them. Many older short- to medium-span highway and railroad bridges use this configuration. These types of bridges are two-girder systems and are therefore classified as NSTM bridges.

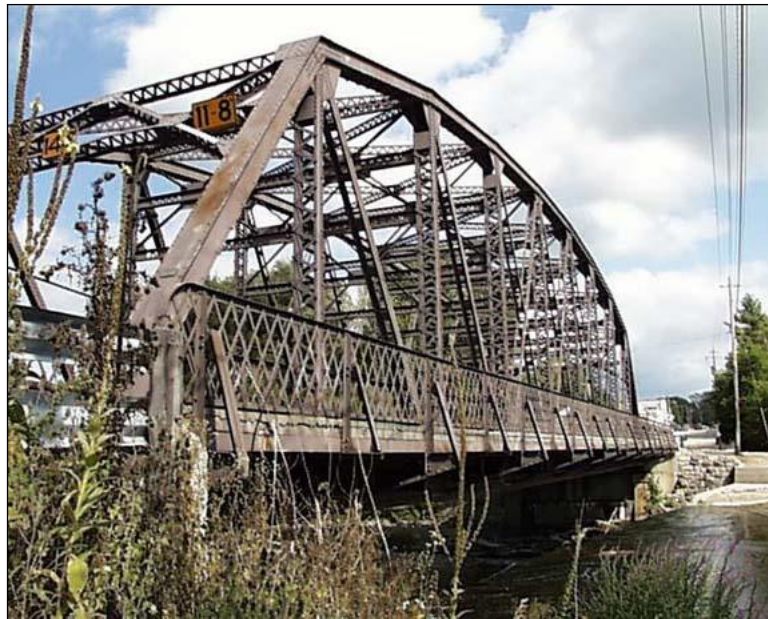
**Figure 2.4.4-6:** Steel Truss Bridge.

6. **Trusses:** Truss bridges are structures with two or more parallel trusses being the main load-carrying members. The deck may be placed on top of the trusses (deck truss) or between the trusses (through truss when there is overhead lateral bracing or a pony truss when there is no overhead lateral bracing). Through or pony trusses are most often constructed using two trusses, and therefore are considered NSTM structures. Deck trusses are constructed with two or more trusses. Only two truss deck trusses are NSTM structures. Truss chord, diagonal, and vertical members may be fabricated from eyebars, rolled shapes, or built-up members. Connections are made with rivets, bolts, welds, and pin connections. All truss bridges have floor systems similar to two-girder systems. To keep the two trusses in line longitudinally, secondary lateral bracing members diagonally connect the bottom chords. For deck and through trusses, the top chords are connected the same way. Sway bracing keeps the two trusses in line laterally. On deck and through trusses, sway bracing transversely frames between the truss verticals. On through trusses, sway bracing may limit vertical clearances. On pony trusses, sway bracing is usually placed as a transverse diagonal on the outside of the trusses. It connects the top chord to transverse “outrigger” floor beam extensions and functions to prevent buckling of the top chord.

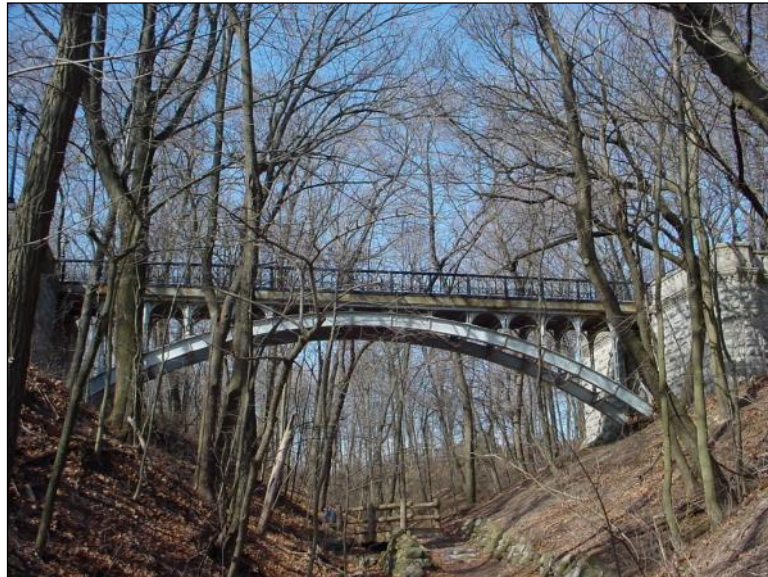
**Figure 2.4.4-7:** Steel Deck Arch Bridge.

ribs. The spandrel columns may be rolled or built-up shapes. Each arch rib may be fabricated into an “I” or box shape (solid rib arch) or into a truss shape (braced rib arch). When diagonal braces connect the spandrel columns above the rib, the bridge is classified as a spandrel braced arch. The floor system will contain floor beams, spandrel girders, and sometimes stringers. Secondary members include the upper and lower lateral bracing which brace the floor system and arch ribs, respectively. Transverse sway bracing keeps the ribs and spandrels in line laterally. Although many deck arch bridges have only two arch ribs, the bridges are not considered NSTM since arches resist a combination of compression loads and bending moments, not tension.

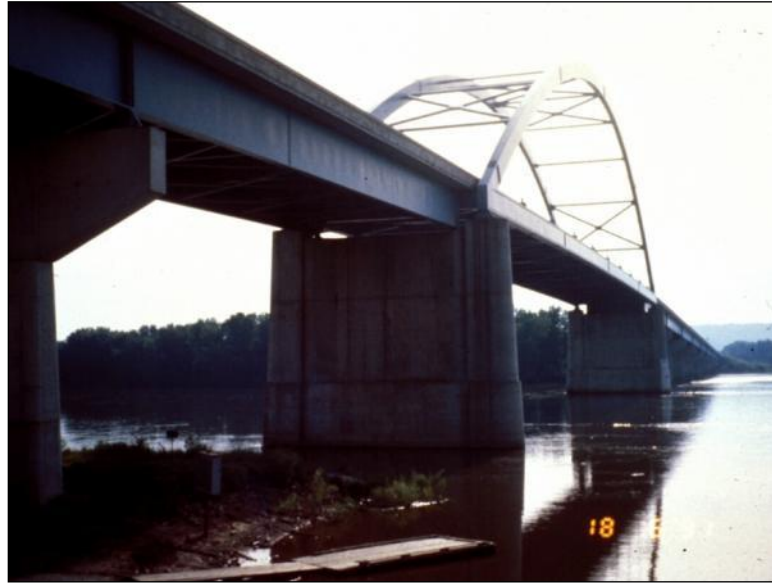
**Figure 2.4.4-8:** Steel Tied Arch Bridge.

girder will directly lead to a failure of its associated arch. The tie girder may also behave as a bending member, in conjunction with the ribs, to deliver dead and live gravity loads to the pier. Primary and secondary members of tied arches are similar to those of through arches, although the arch ribs are typically solid box shaped elements. Floor beams frame directly into the webs of the tie girders, and cables or hangers (solid or hollow) directly support the tie girder. The hangers may be oriented vertically or diagonally.

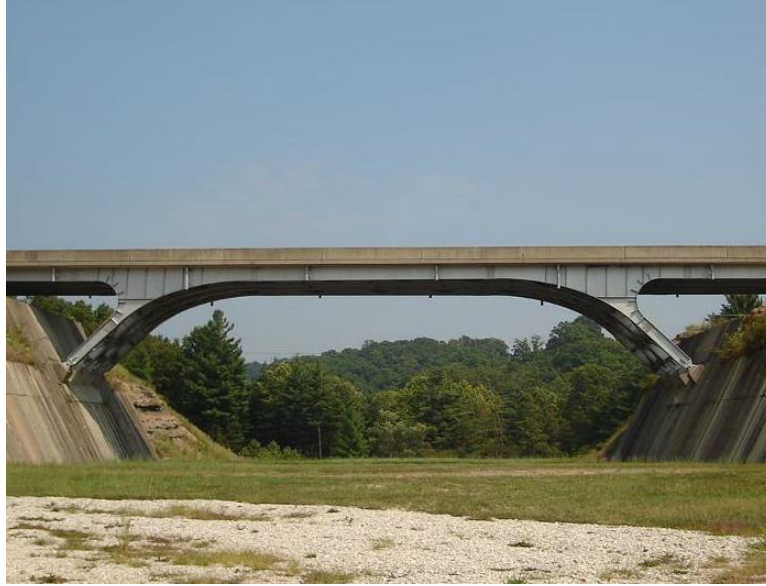
**Figure 2.4.4-9:** Steel Rigid Frame Bridge.

- 10. Rigid frames:** Rigid frame bridges are structures in which the structure's inclined supporting "legs" are integrated with the girders to form a rigid frame. Rigid frames are usually constructed using welded plate girders and legs to form a "K" shape or, in some instances, an inverted triangular delta shape. Though the legs are used as bridge piers, the legs are actually part of the superstructure because of their rigid connection to the girders. This rigid intersection of the leg and girder is referred to as the knee and allows both the girders and legs to resist bending moments. Large moments and shear forces are resisted by the knee, resulting in a complex arrangement of stiffeners in this area. The legs are pinned at grade, and the girder ends supported by conventional abutments. Rigid frame bridges may use two or more frames to support the deck. The girders, legs, and bearings are all primary members on multi-rigid frame. Secondary members are the diaphragms, cross-frames, longitudinal stiffeners, transverse stiffeners, and radial stiffeners. Spans 50 to 200 feet are attainable using rigid frames.

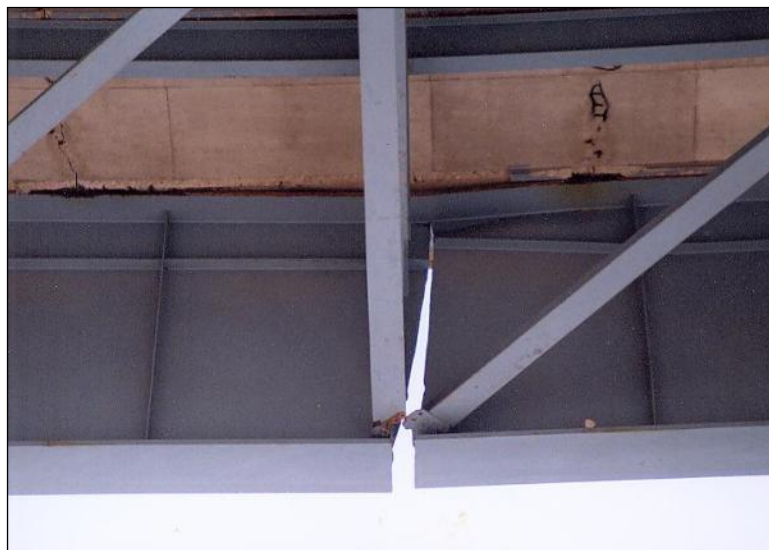
**Figure 2.4.4.1-3:** Girder Failure Due to Brittle Cracking – Condition State 4.

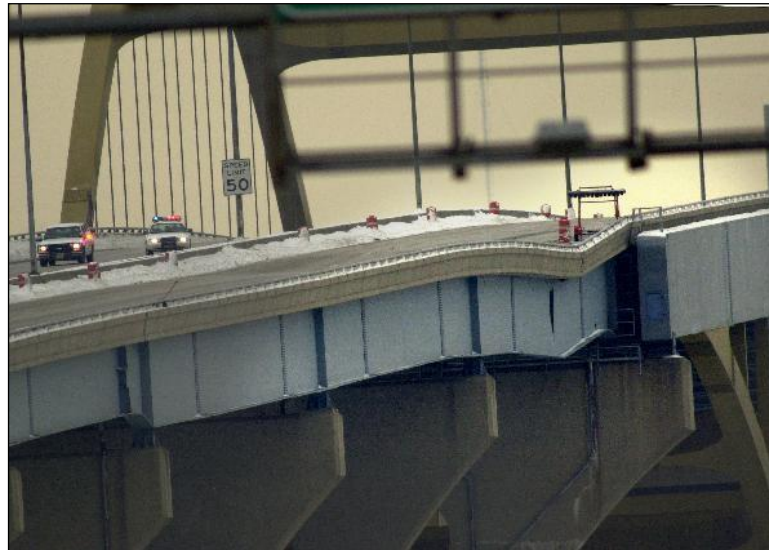
**Figure 2.4.4.1-4:** Girder Failure Due to Brittle Cracking – Condition State 4.

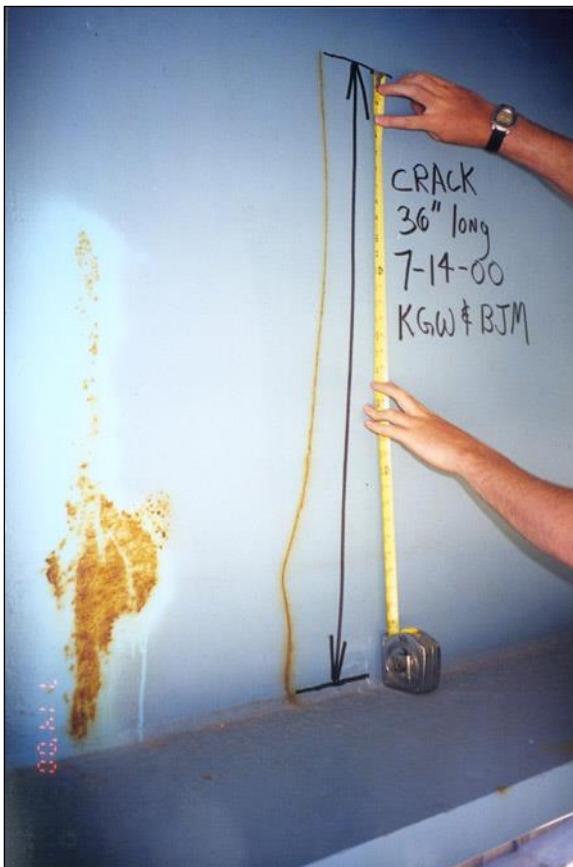
**Figure 2.4.4.1-5:** Brittle Crack 3 Feet Long in a Girder Web 10 Feet Deep, Opposite of Lower Lateral Shelf Plate - Condition State 4.

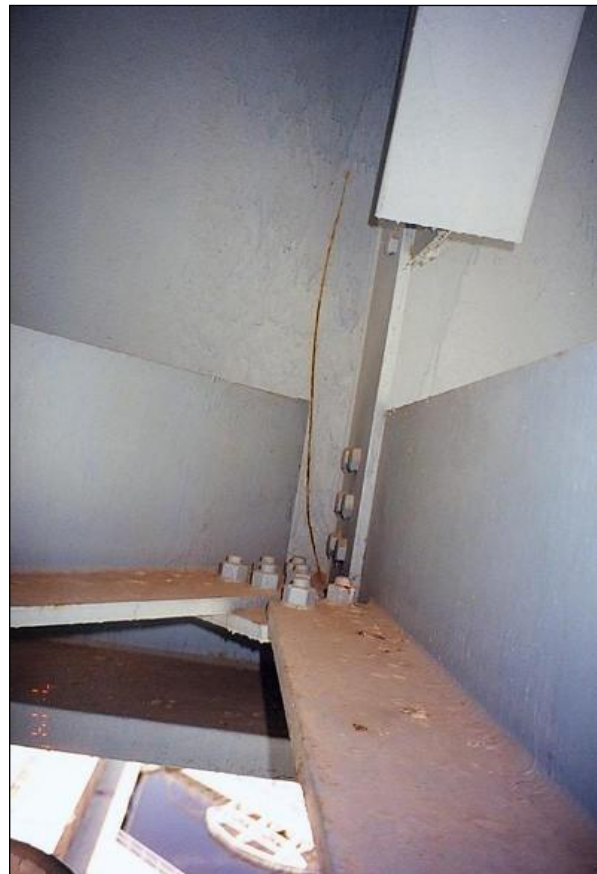
**Figure 2.4.4.1-6:** Same Crack as shown in Figure 4.75, Inside Face of Girder at Lower Lateral Shelf Plate - Condition State 4.

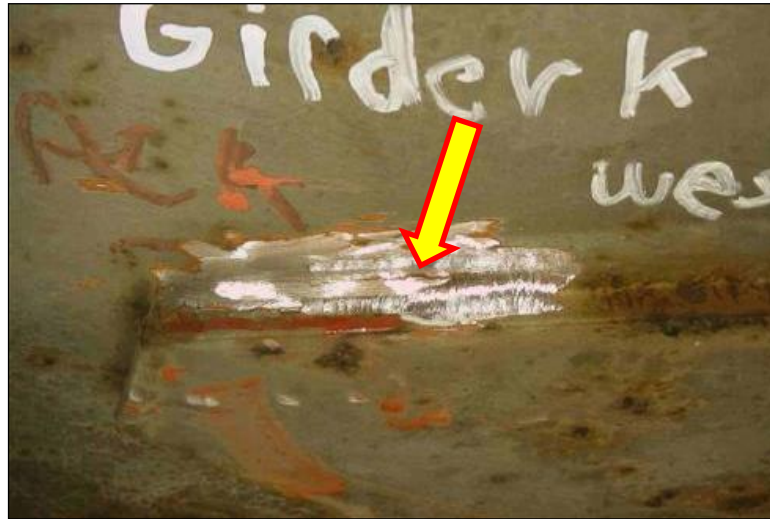
**Figure 2.4.4.1-7:** Fatigue Crack at a Welded Cover Plate End (Rust Line within the Ground Area).

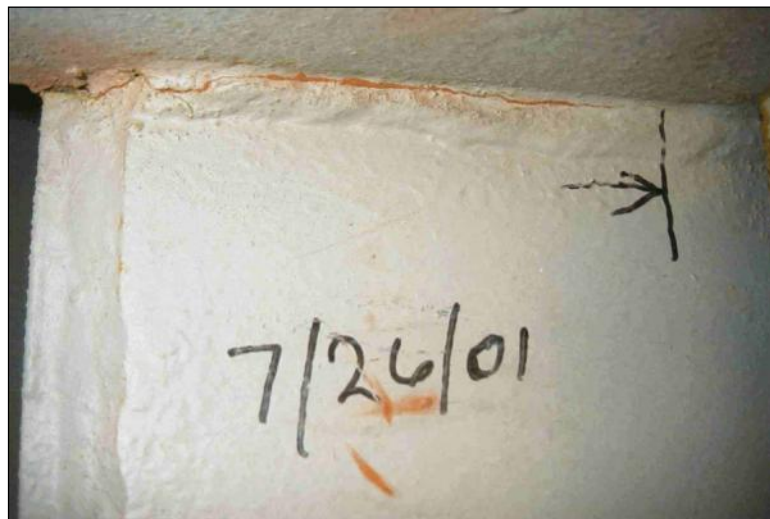
**Figure 2.4.4.1-8:** Rust Line at Weld Toe Indicating a Fatigue Crack.

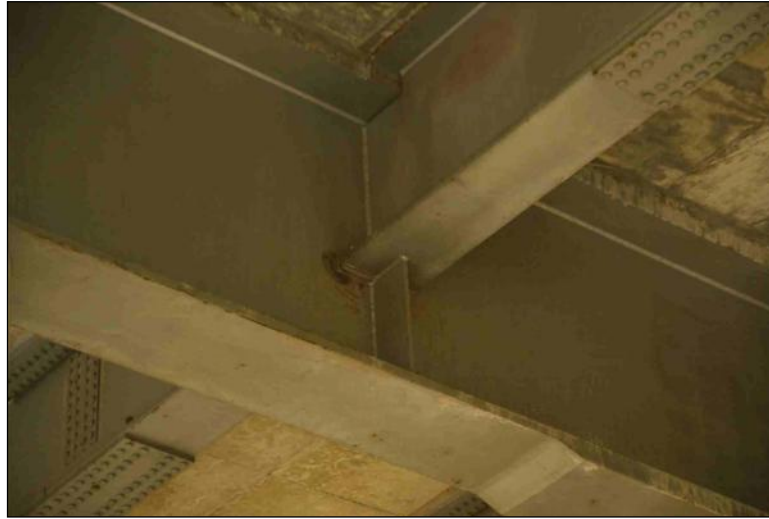
Figure 2.4.4.1-9: Welded Girder to Cross Girder Connection Detail.

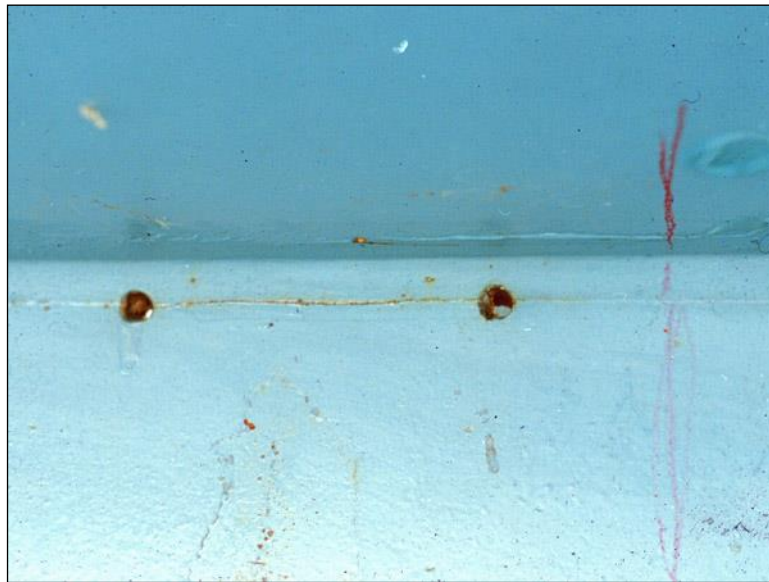
**Figure 2.4.4.1-12:** Fatigue Crack at Flange/Web Intersection Arrested with Drilled Holes - Condition State 2.

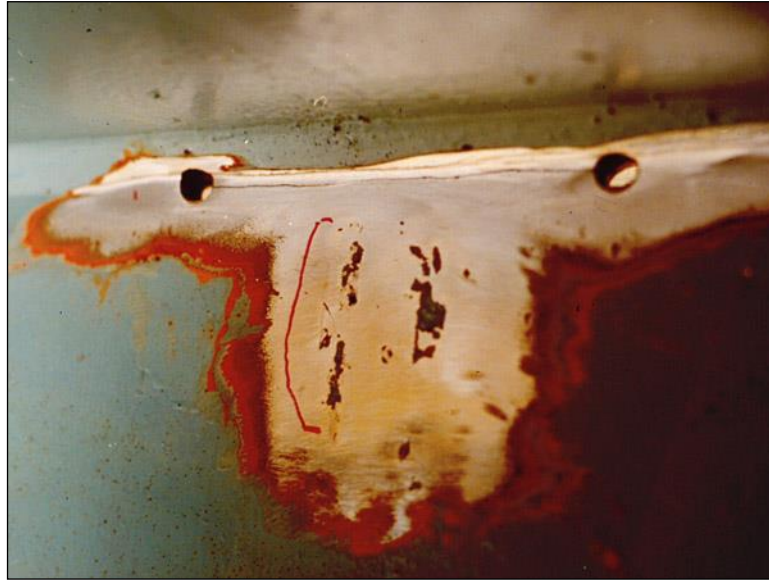
**Figure 2.4.4.1-13:** Fatigue Crack at Flange/Web Intersection After Cleaning – Condition State 2.

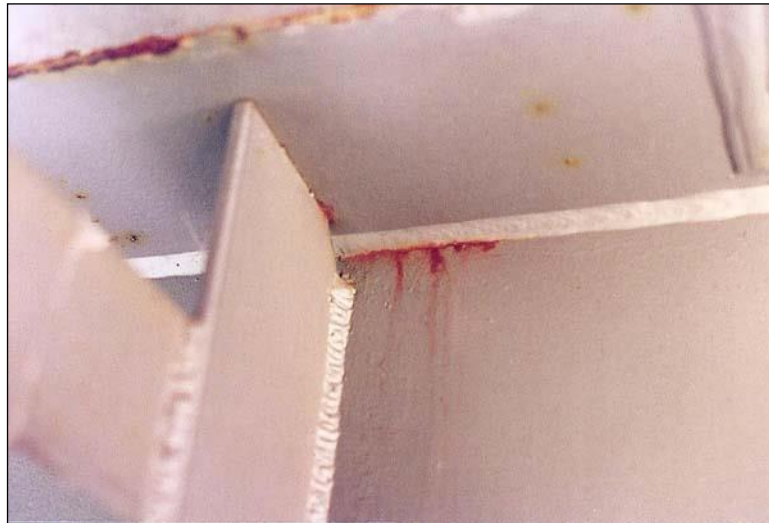
**Figure 2.4.4.1-14:** Fatigue Crack Indicated by "Fretting Corrosion" Rust Stains Along a Longitudinal Fillet Weld - Condition State 3.

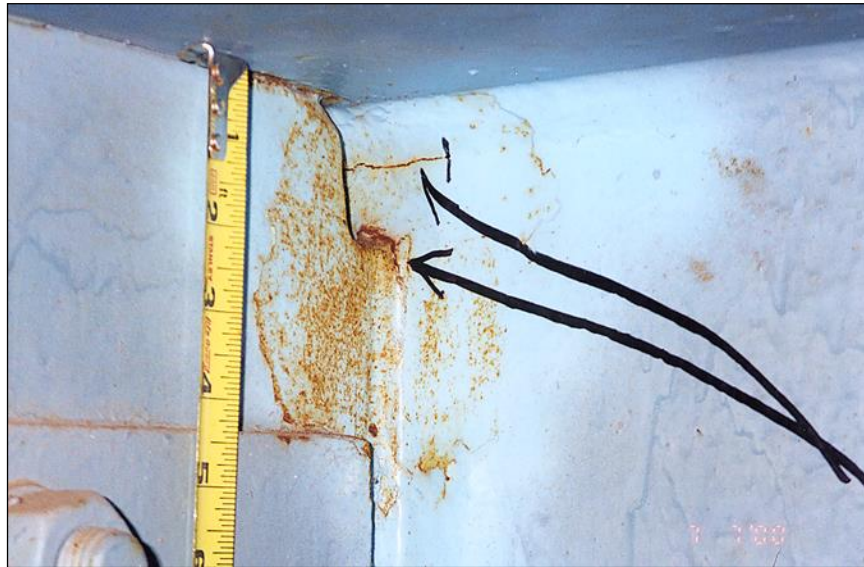
**Figure 2.4.4.1-15:** Double Fatigue Cracks in Girder Web, Top of Connection Plate – Condition State 3.

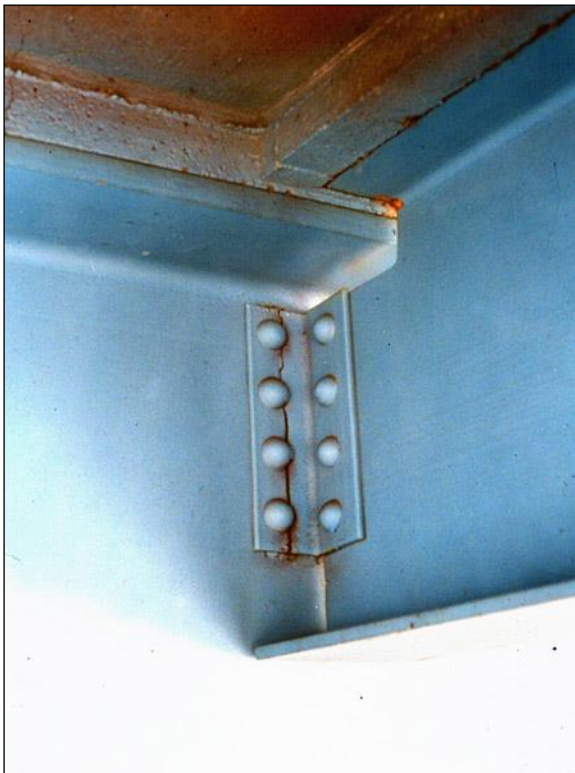
**Figure 2.4.4.1-16:** Fatigue Crack Through the Rivet Line of a Connection Angle - Condition State 3.

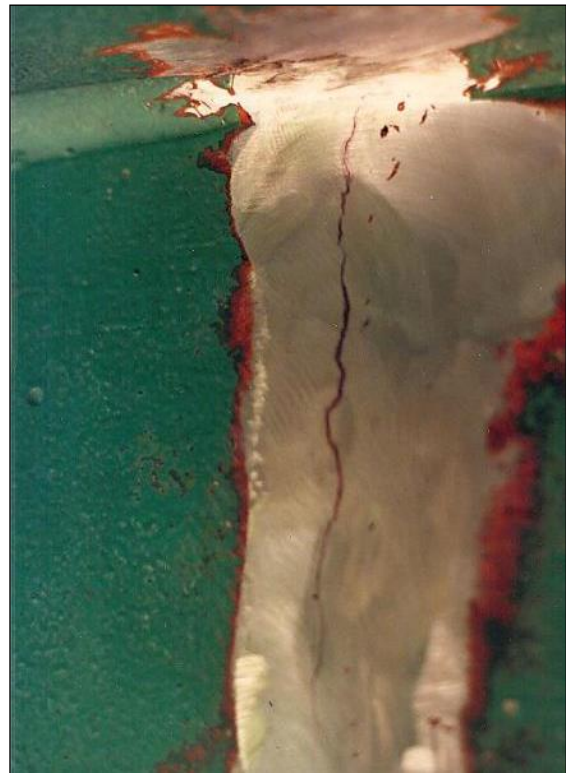
**Figure 2.4.4.1-17:** Unarrested Fatigue Crack - Condition State 3.

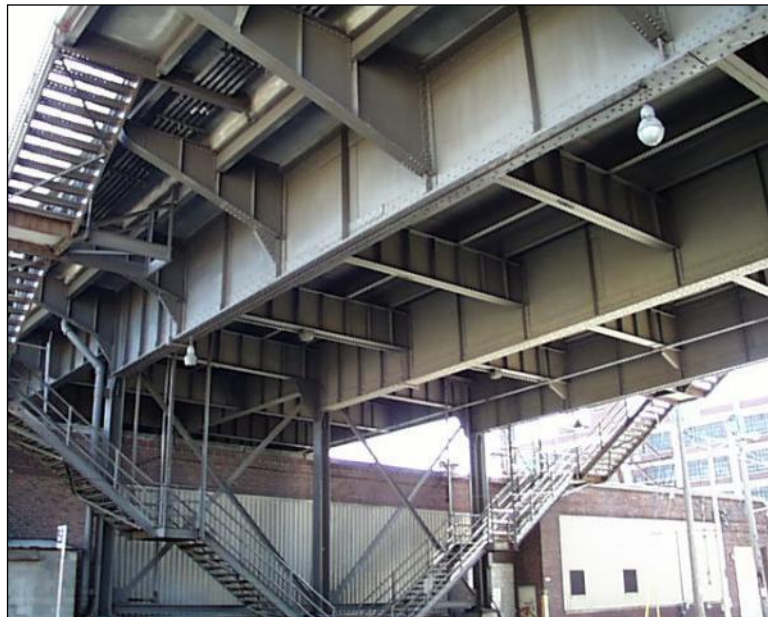
**Figure 2.4.4.1-19:** Fabricated Steel Girders and Floor Beams, and Rolled Stringers.

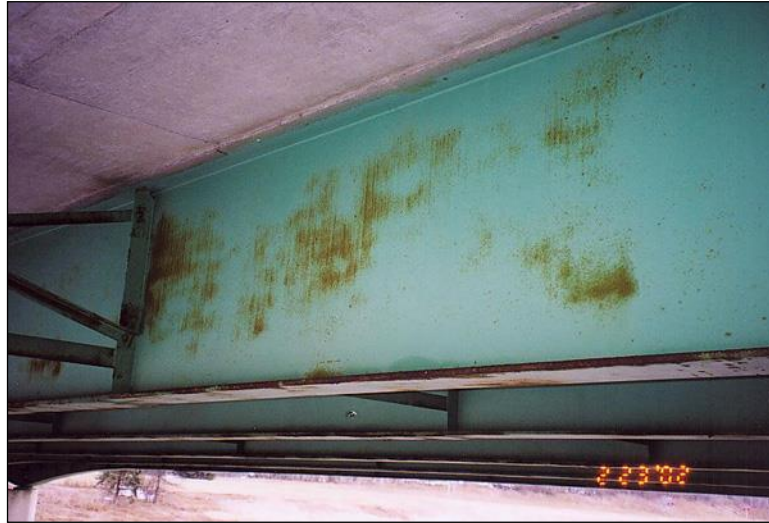
**Figure 2.4.4.1-23:** Girder – Corrosion Condition State 2.

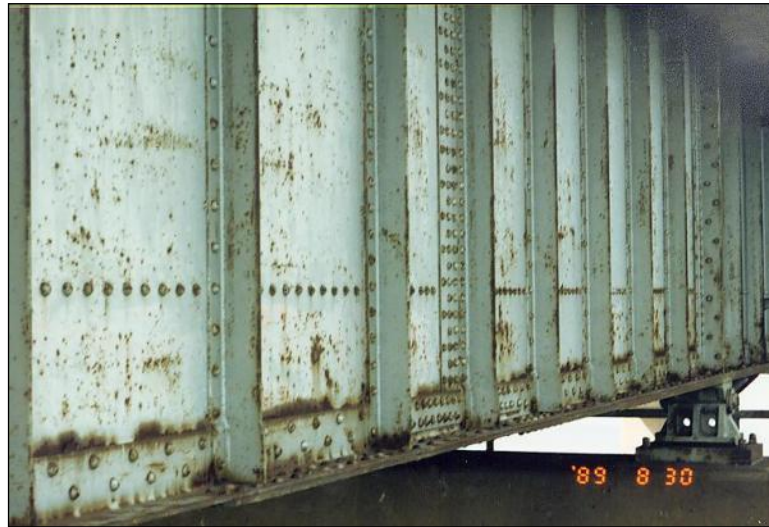
**Figure 2.4.4.1-25:** Steel Girder – Corrosion Condition State 2.

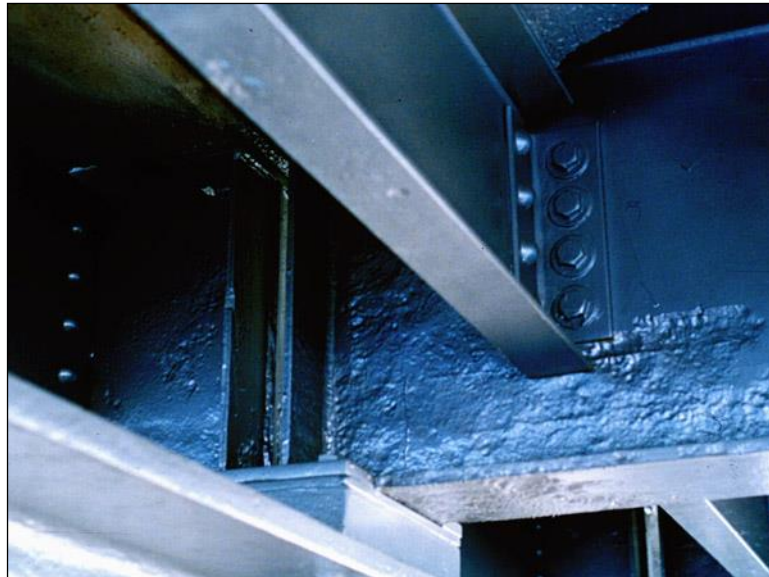
**Figure 2.4.4.1-32:** Section Loss on Girder Web Painted Over – Corrosion Condition State 3.

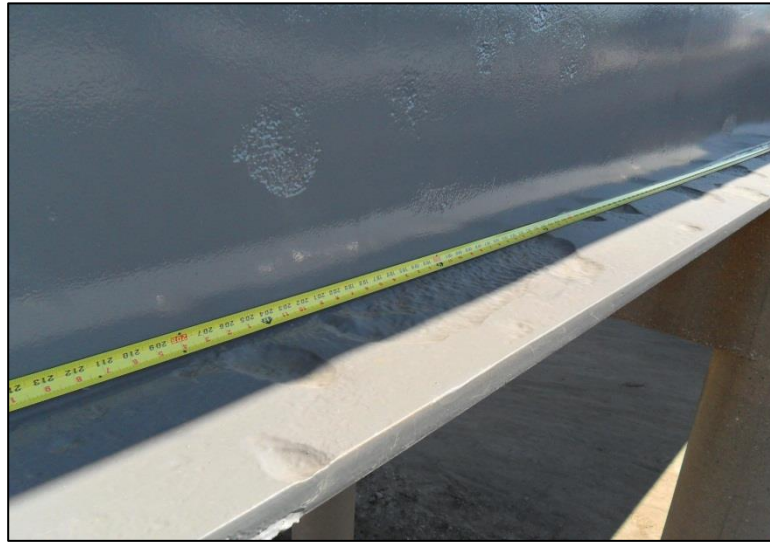
**Figure 2.4.4.1-33:** Severe Pitting Along Bottom Flange Painted Over – Corrosion Condition State 4.

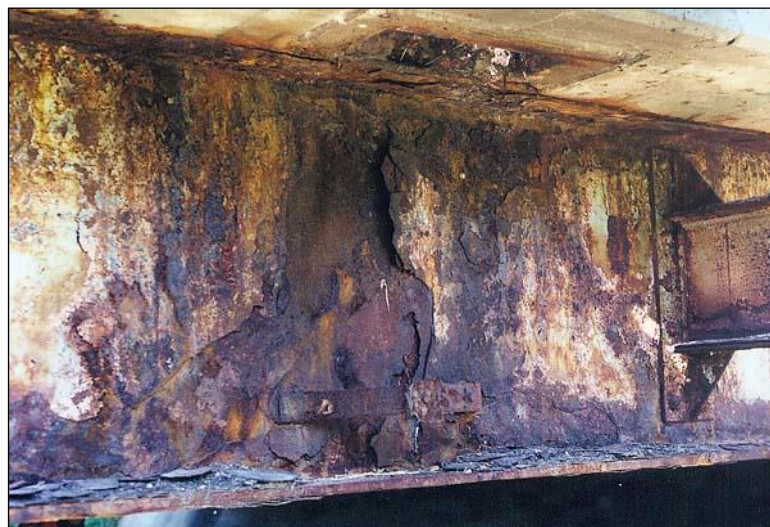
**Figure 2.4.4.1-34:** Laminate Section Loss of Web – Corrosion Condition State 4.

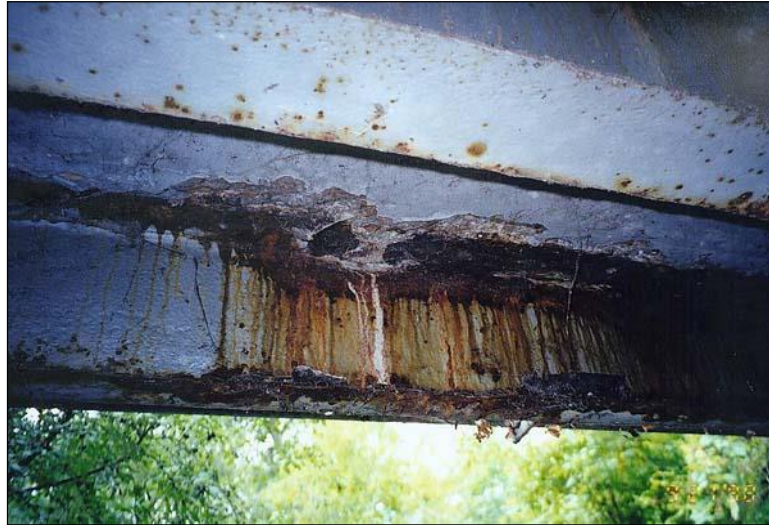
**Figure 2.4.4.1-35:** Steel Rolled Beams – Corrosion Condition State 4.

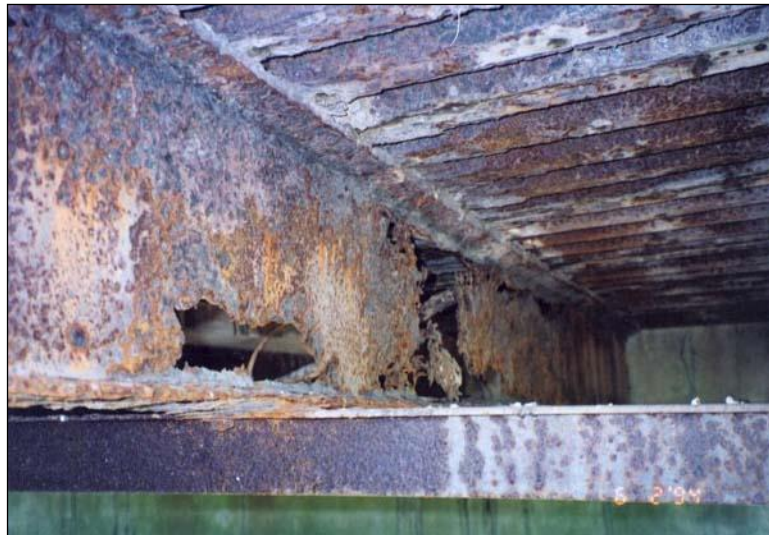
**Figure 2.4.4.1-36:** Steel Beam – Corrosion Condition State 4.

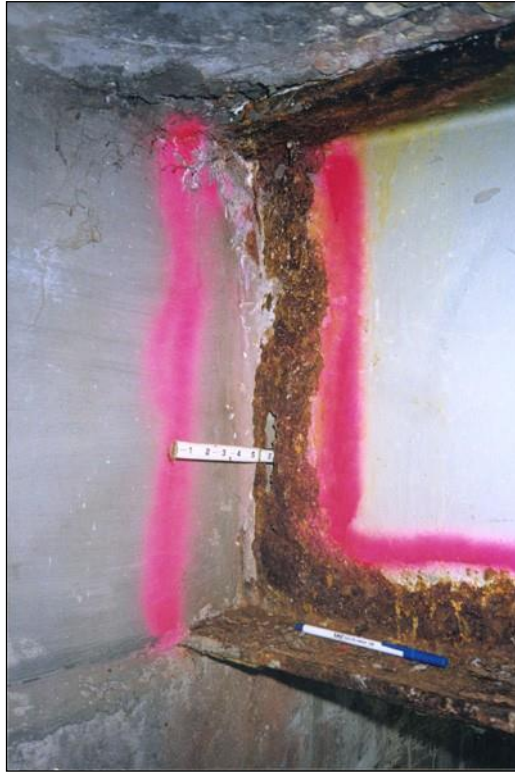
**Figure 2.4.4.1-37:** Through Thickness Section Loss of a Rolled Beam Web - Condition State 4.

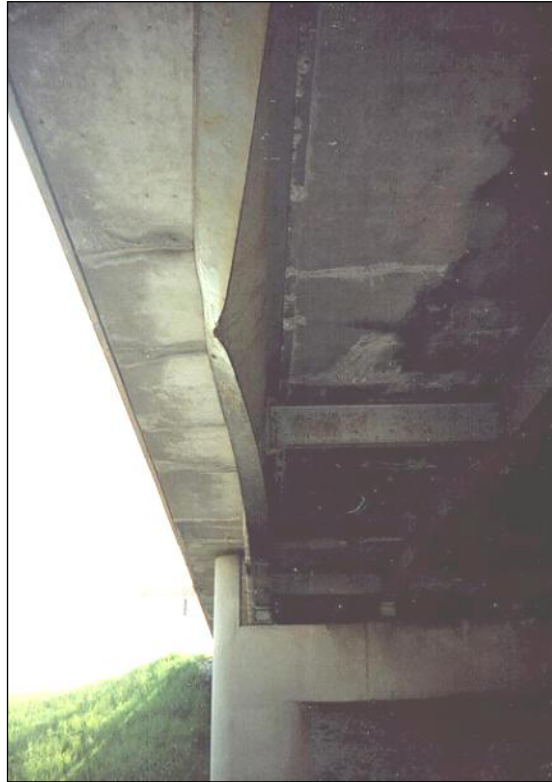
**Figure 2.4.4.1-39:** Impact Damage to Exterior Girder – Distortion Condition State 4.

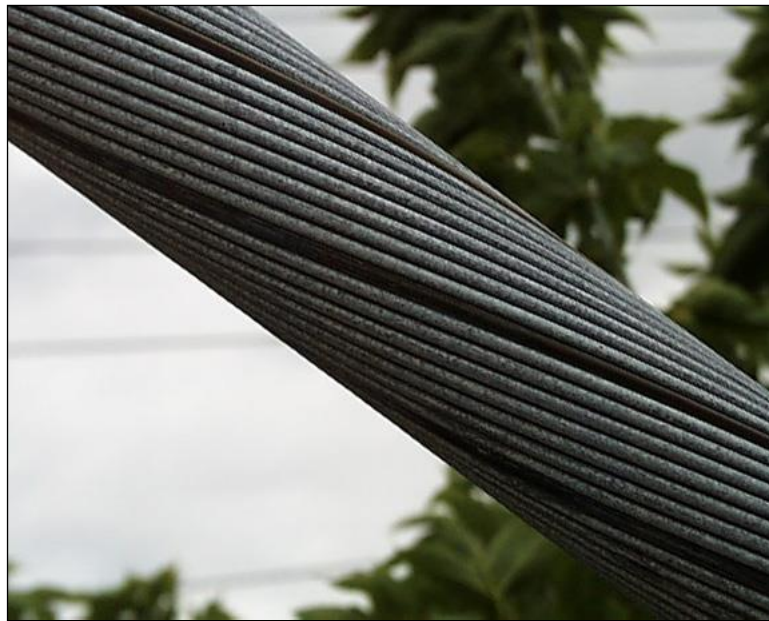
**Figure 2.4.4.2-2:** Galvanized Steel Cable – Condition State 1.

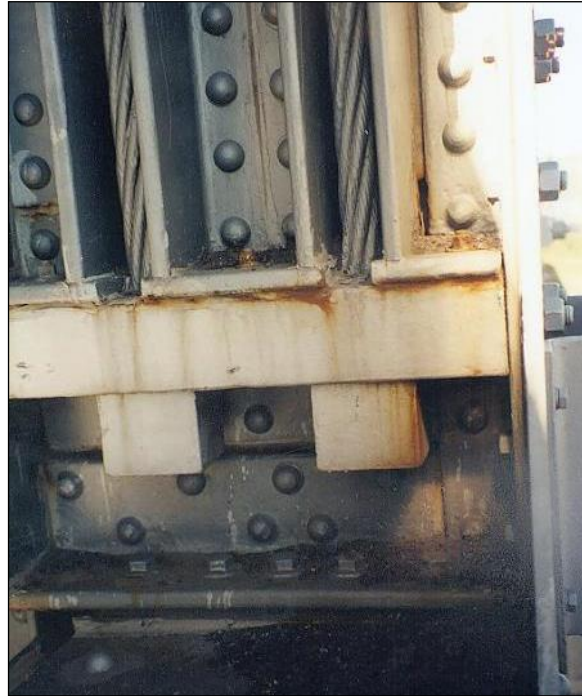
**Figure 2.4.4.2-3:** Cable Anchorage for a Tied Arch Bridge – Condition State 1.

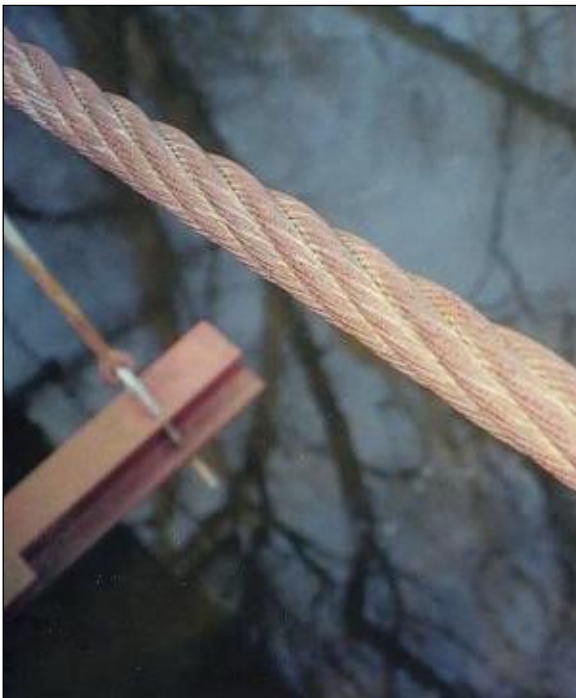
**Figure 2.4.4.2-4:** Galvanized Steel Cable Exhibiting Freckled Rust – Corrosion Condition State 2.

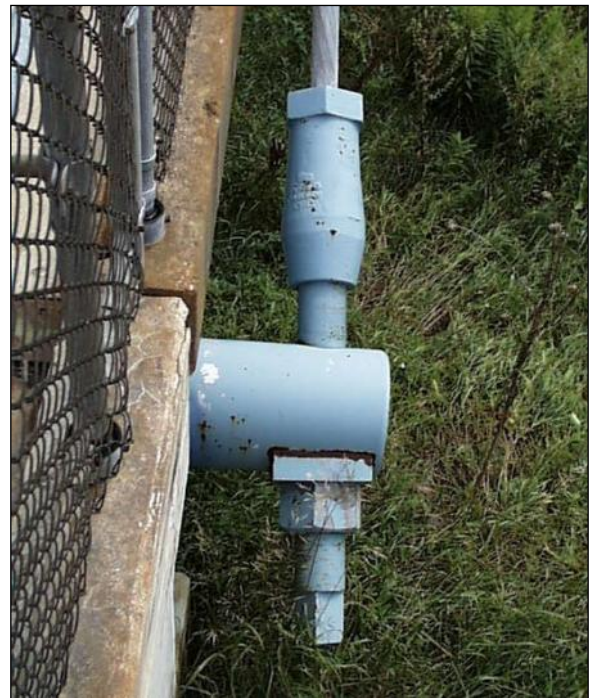
**Figure 2.4.4.2-5:** Cable Anchorage for a Cable Stayed Bridge – Connection Condition State 2.

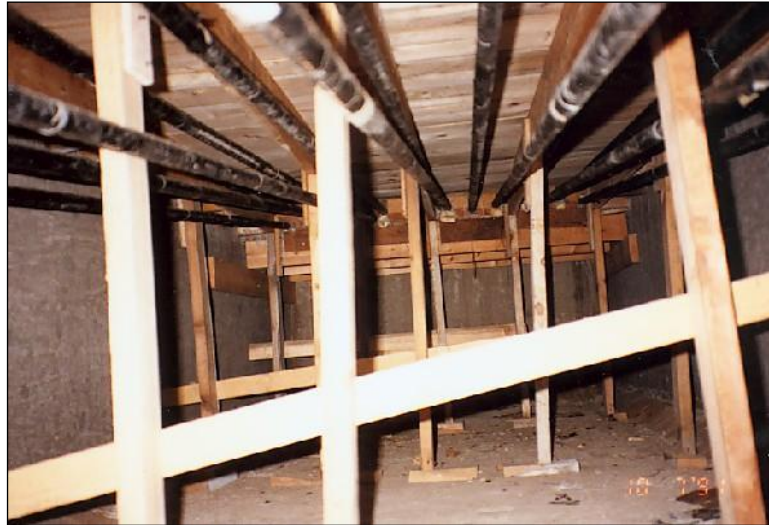
**Figure 2.4.4.3-1:** Exposed Post Tensioning Rods Inside of a Concrete Box Girder - Condition State 1.

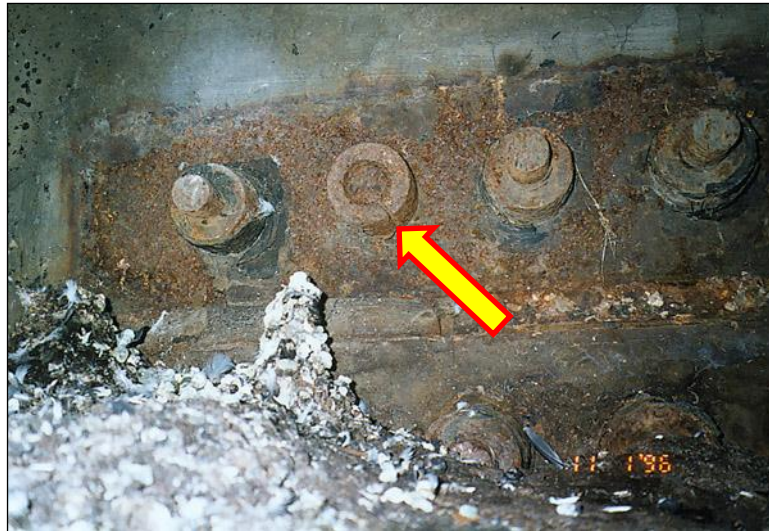
**Figure 2.4.4.3-4:** End of Post-Tensioning Rod with Cracked Nut – Connection Condition State 3.
