Superstructures come in a variety of types and configurations and comprised of concrete, steel, timber, a combination of materials, or another material entirely. Retrofits or repairs may see use of a differing structural material than the existing. This may be due to availability, cost, geometric or installation restrictions. For instance, a fractured timber stringer may be retrofitted with a C-channel bolted to its side or a rolled beam may replace the stringer altogether.

It is necessary for the inspector to understand the components of the superstructure and their function within the load path. The bridge inspector must understand the critical areas of each type of superstructure as well as the defects associated with the structural material the component is comprised of.

This chapter is broken down by construction material (concrete, steel, timber, etc.) and superstructure type (girder, truss, arch, etc.). Each material section lists the elements in numerical order (as they are labeled in the AASHTO Manual for Bridge Element Inspection) and describes the element in detail. Each element segment of the chapter details the element level inspection and safety inspection to furthe

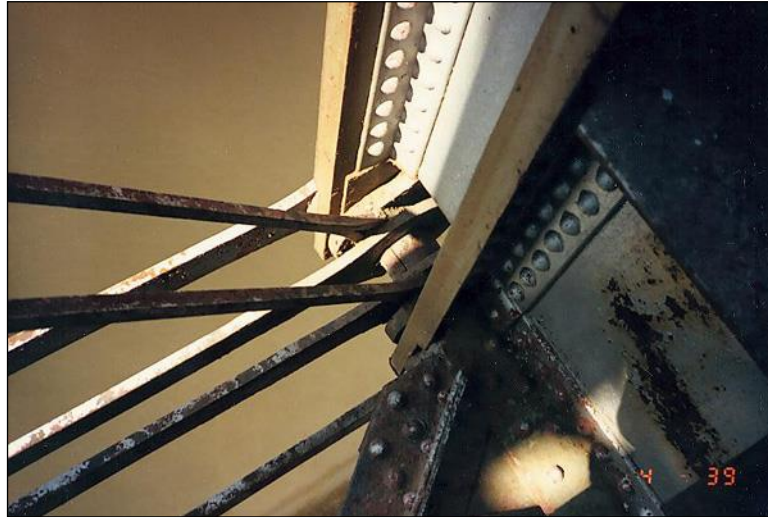
**Figure 2.4.4.4-2:** Multiple Eyebars Connected with a Pin.

**Eyebars and Loop Rods:** These are pin-connected members. Many old eyebars were fabricated by forging cast eyebar heads to a rolled bar which formed the eyebar body. Loop rods are a very old style of tension member. The loops were formed by heating and bending the rod ends, then forging the free end back onto the body.

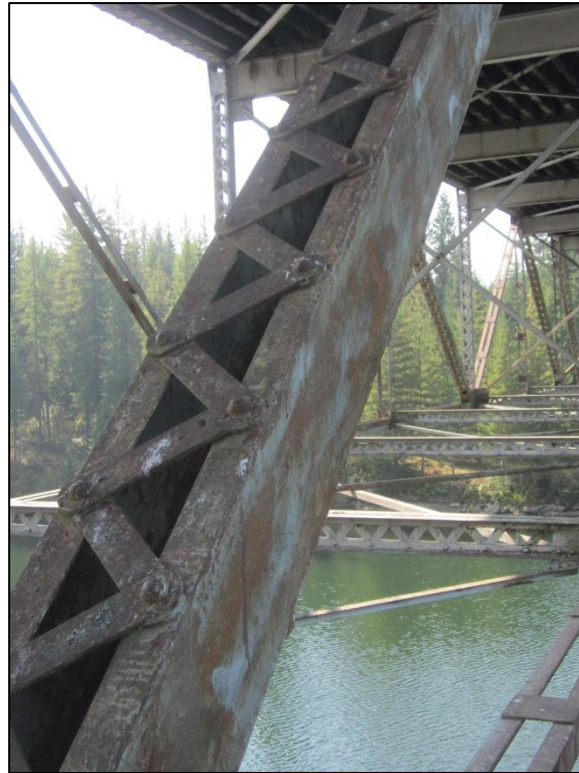
**Figure 2.4.4.4-3:** Diagonal Truss Member Exhibiting Rust with No Loss of Section – Corrosion Condition State 2.

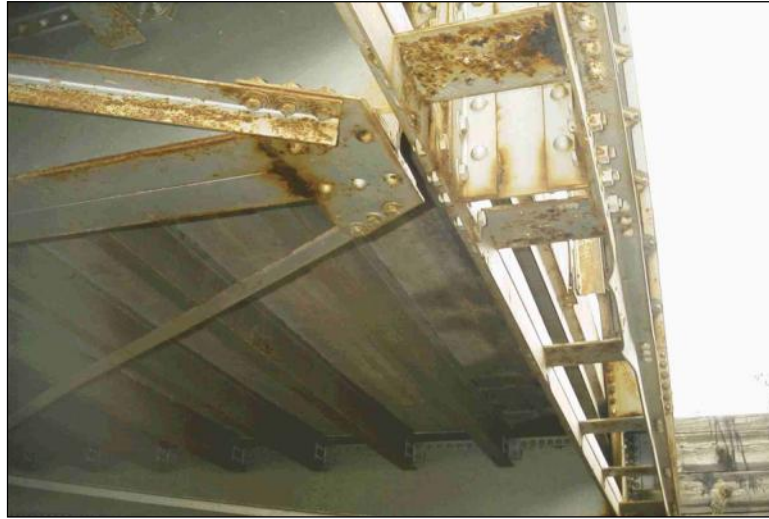
**Figure 2.4.4.4-5:** Truss Bottom Chord (Note Impact Damage) – Distortion Condition State 2.

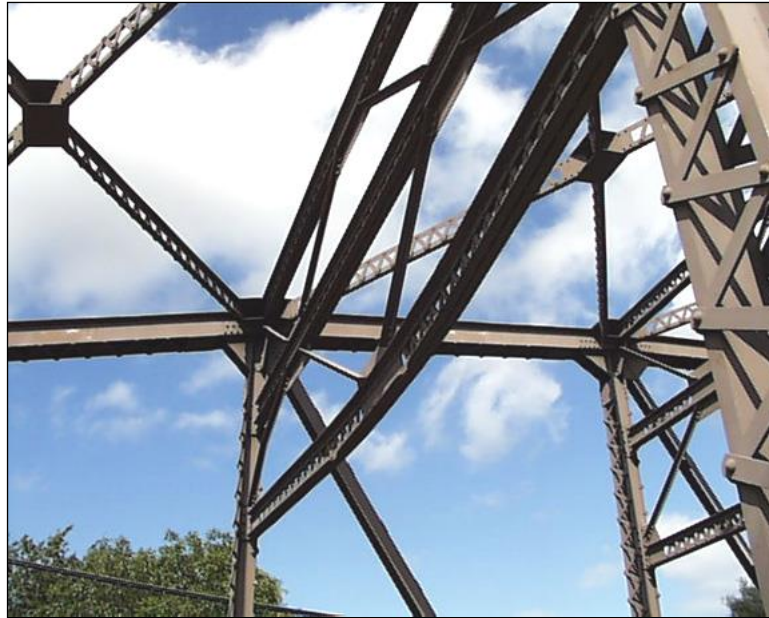
**Figure 2.4.4.4-6:** Impact Damage to a Truss Sway Strut – Distortion - Condition State 2.

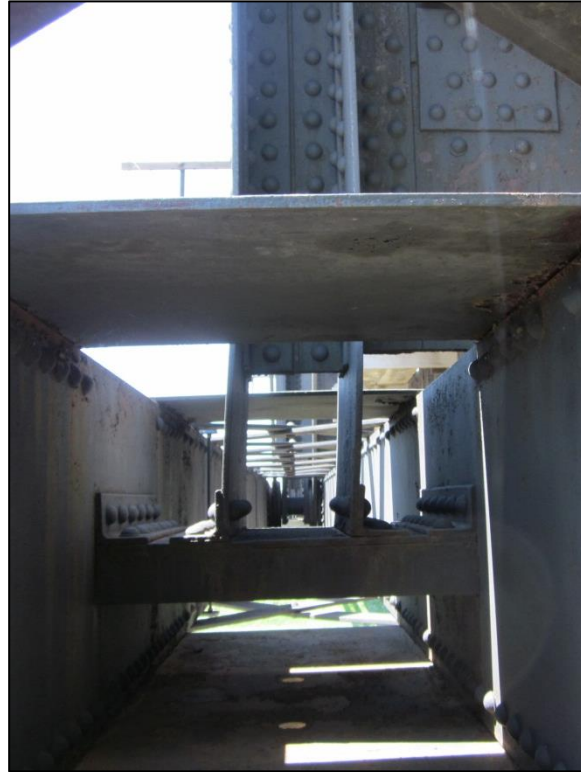
**Figure 2.4.4.5-1:** Vertical to Bottom Chord Gusset Plate Deformed Out-of-Plane – Distortion Condition State 2.

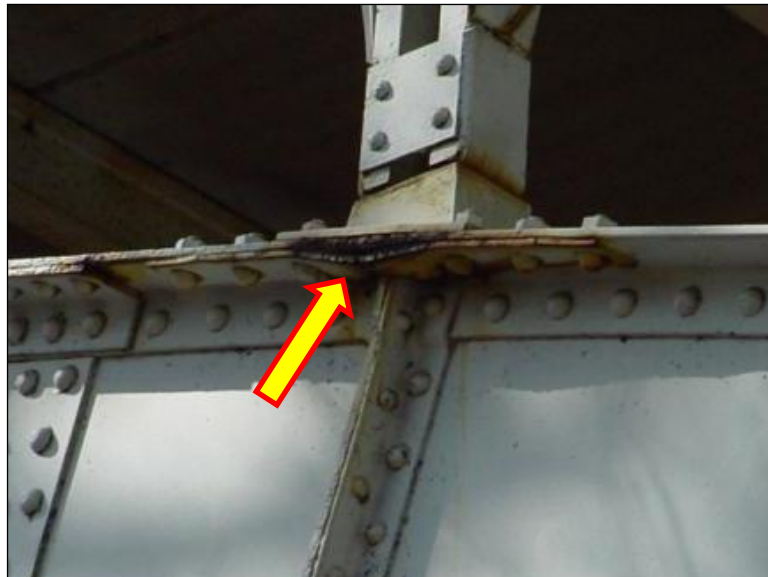
**Figure 2.4.4.6-2:** Pack Rust at Riveted Steel Arch Flange Plates – Connection Condition State 3.

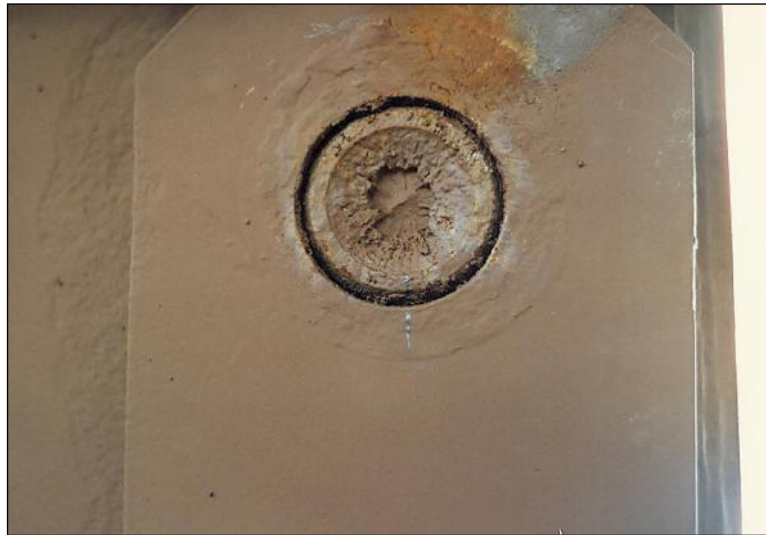
**Figure 2.4.4.7-3:** Pin Shear Failure.

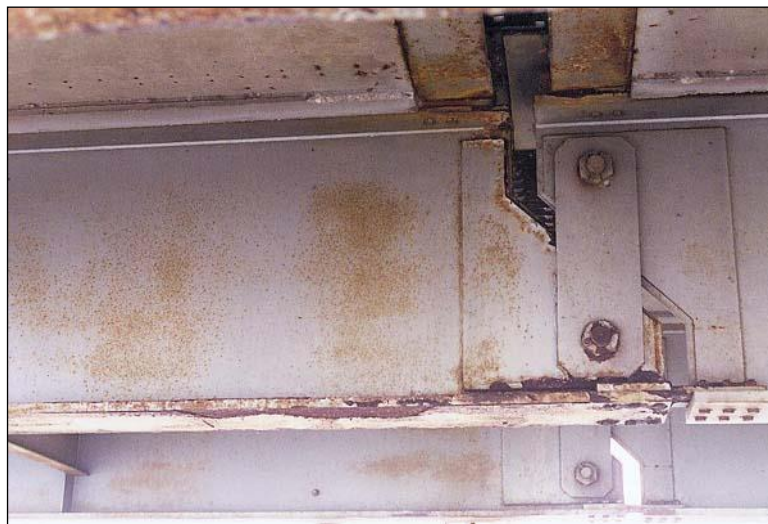
**Figure 2.4.4.7-5:** Girder, Pin, and Hanger – Corrosion Condition State 2.

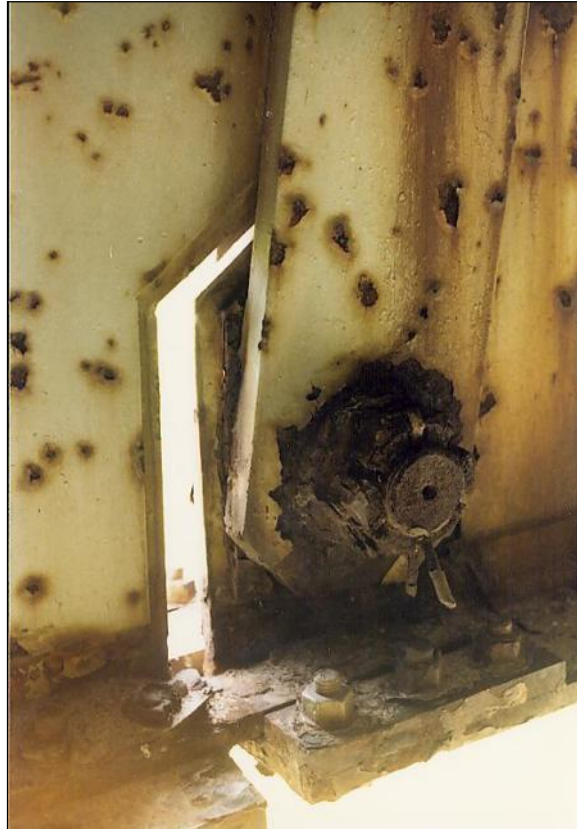
**Figure 2.4.4.7-6:** Pin and Hanger – Corrosion Condition State 4.

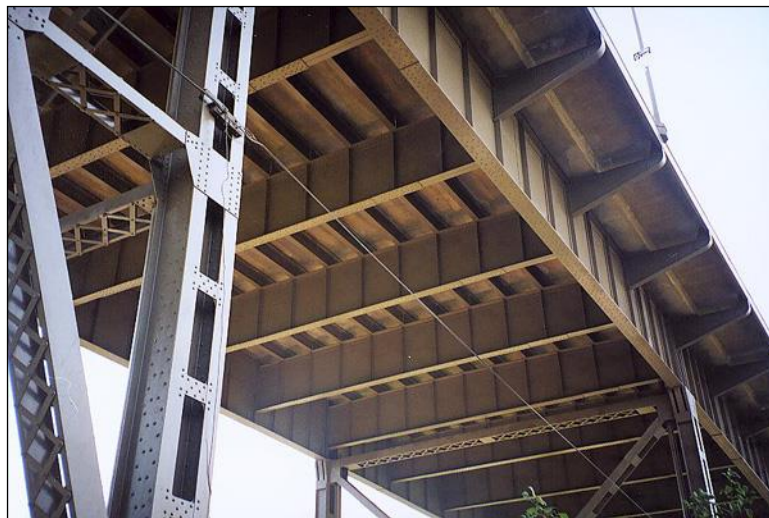
**Figure 2.4.4.8-1:** NSTM Two-Girder Bridge.

Members are classified as being either nonredundant steel tension member (NSTM) or non-NSTM. Per CFR 23 Subpart C 650.305, a nonredundant steel tension member is, “A primary steel member fully or partially in tension, and without load path redundancy, system redundancy or internal redundancy, whose failure may cause a portion of or the entire bridge to collapse.” Superstructures that have one or two primary load-carrying members spanning between supports that are in tension or have a tension component are not load path redundant. This means that failure of one of these primary members will likely cause a collapse of the entire structure. Superstructures that have three or more primary load-carrying members spanning between supports are non-NSTM. These members are load path redundant, which means that if one of the primary members fails, the loads it carries can be redistributed to the remaining primary members, thereby preventing a total collapse.

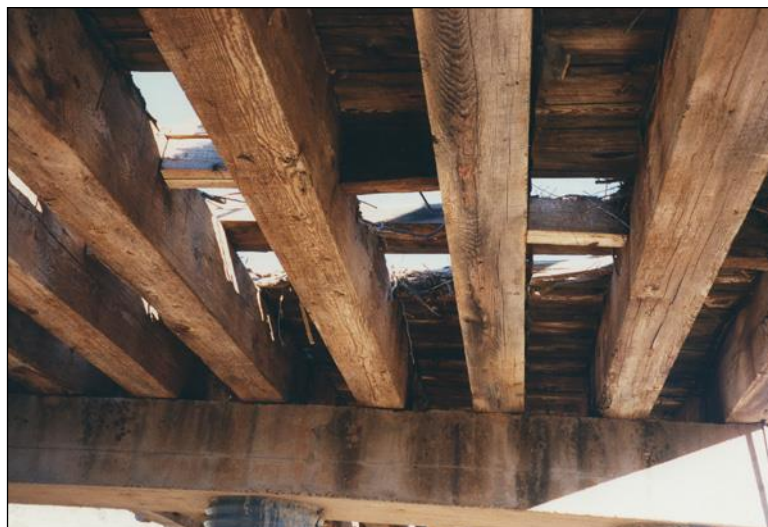
**Figure 2.4.5.1-2:** Timber Beams – Decay/Section Loss Condition State 1.

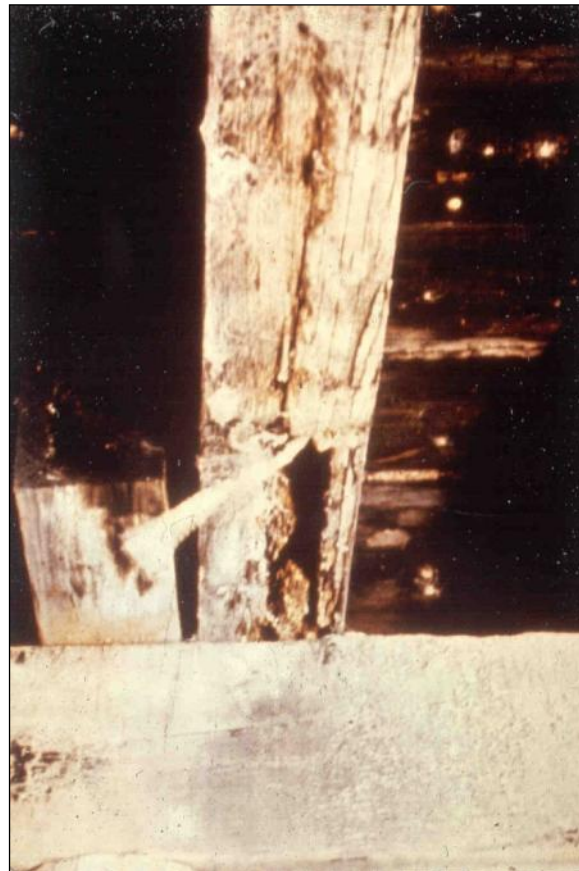
**Figure 2.4.5.1-4:** Timber Beam – Decay/Section Loss Condition State 4.

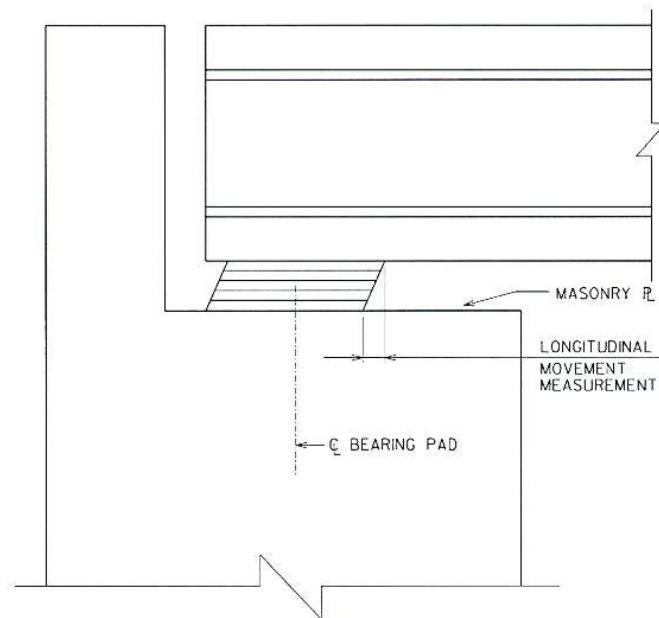
**Figure 2.4.8.1-1:** Elastomeric Bearing Movement Measurement.

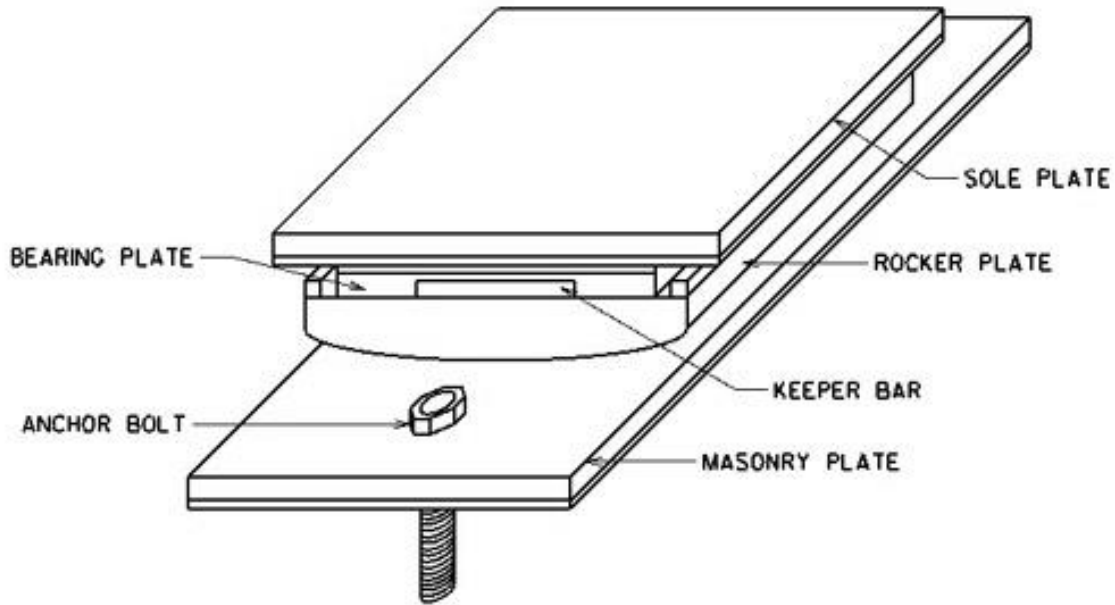
Figure 2.4.8.2-1: Sliding Plate Bearing.

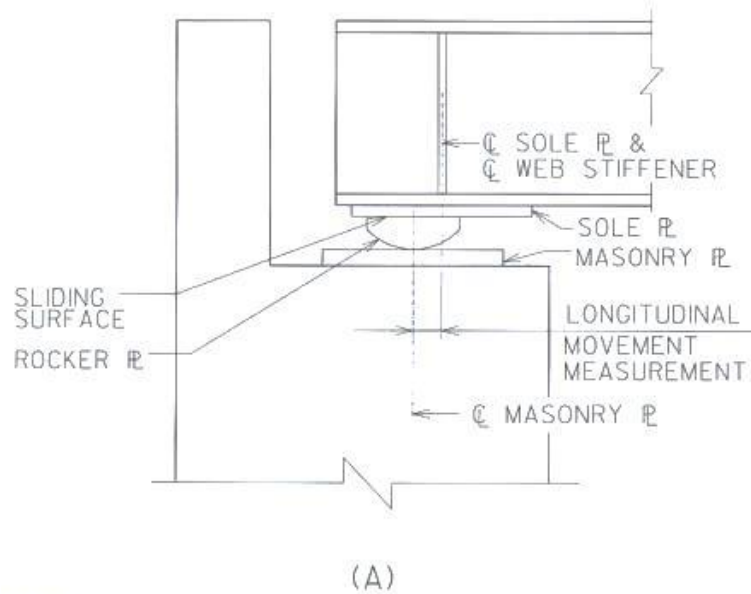
Figure 2.4.8.2-3: Expansion Bearing Movement Measurements.

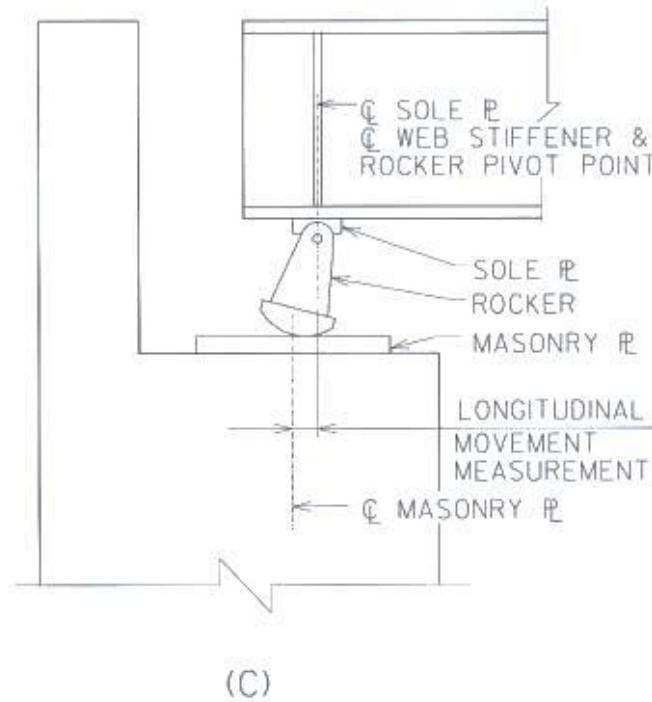
Figure 2.4.8.2-5: Expansion Bearing Movement Measurements.

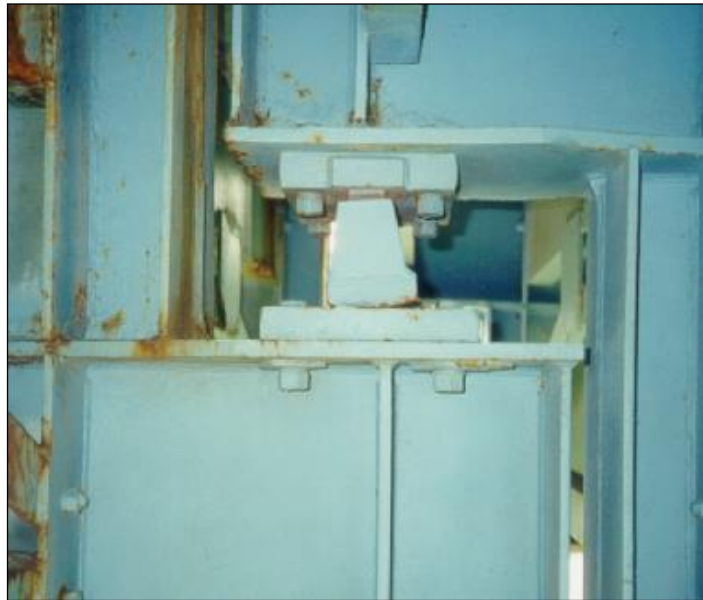
**Figure 2.4.8.2-6:** Rocker Bearing – Condition State 1.

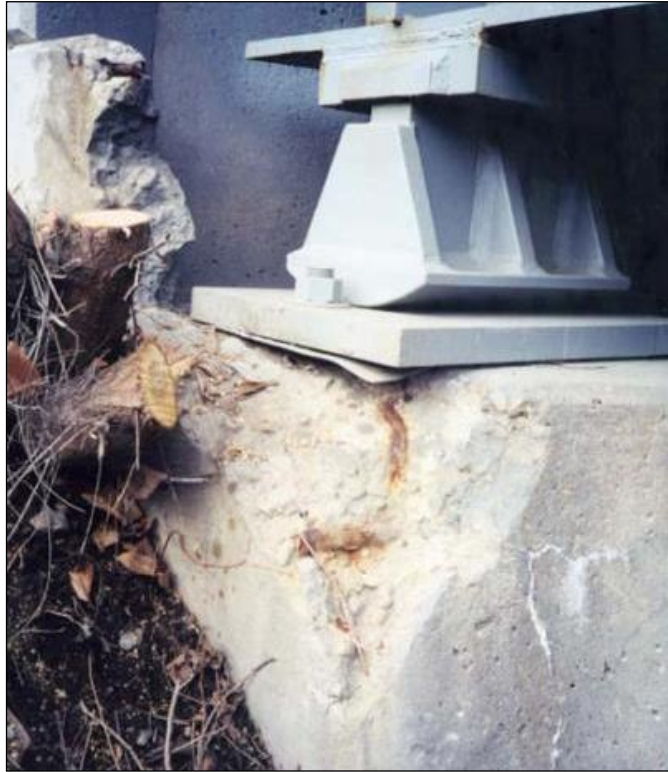
**Figure 2.4.8.2-7:** Rocker – Loss of Bearing Area Condition State 2

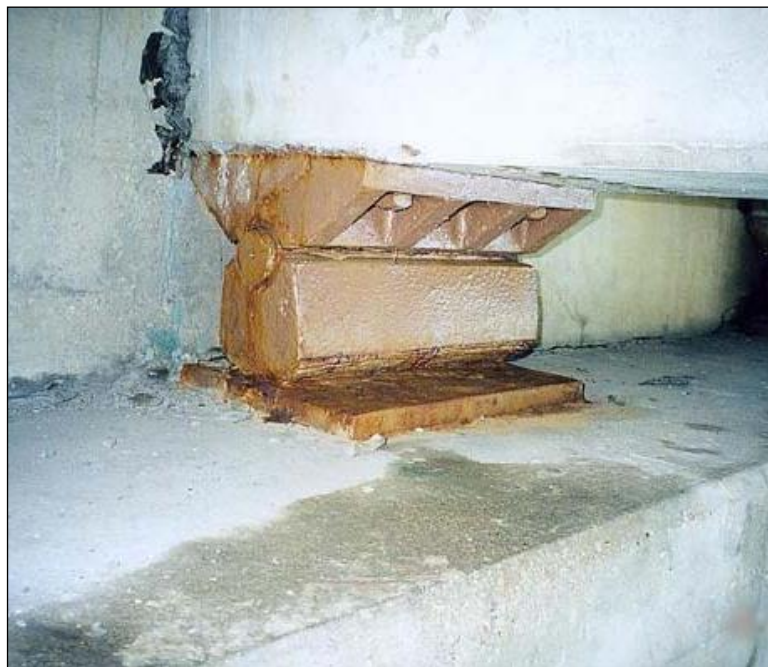
**Figure 2.4.8.2-8:** Rocker Bearing – Corrosion Condition State 2.

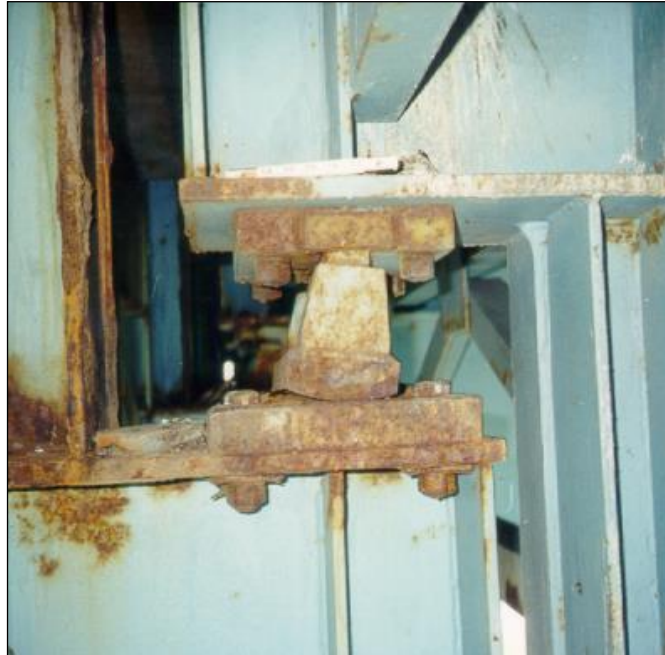
**Figure 2.4.8.2-9:** Rocker Bearing – Condition State 2.

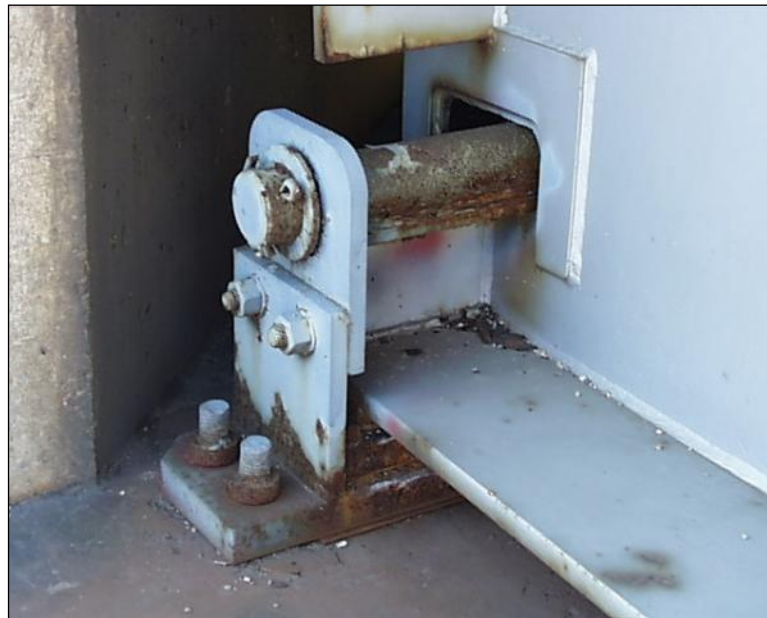
**Figure 2.4.8.2-10:** Hold-Down (Restraining) Bearing - Corrosion Condition State 2.

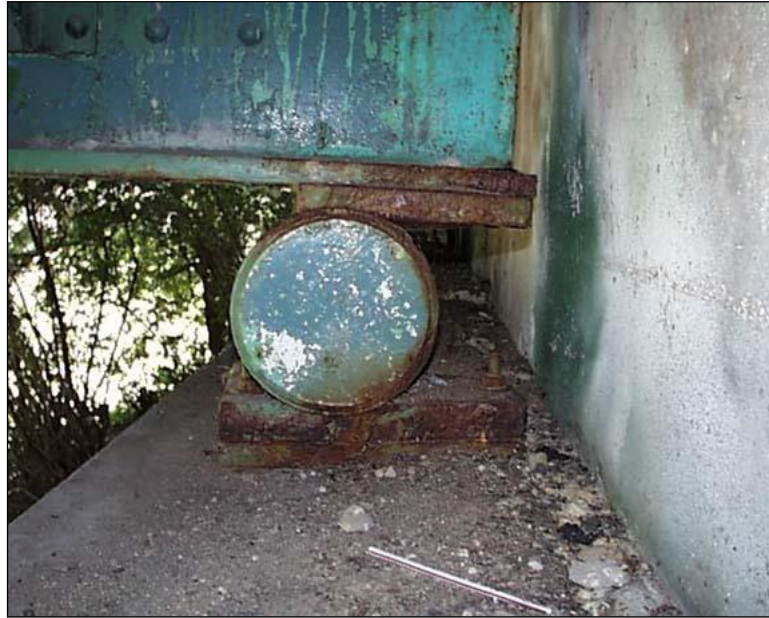
**Figure 2.4.8.2-11:** Critically Misaligned Roller Bearing – Alignment Condition State 3.

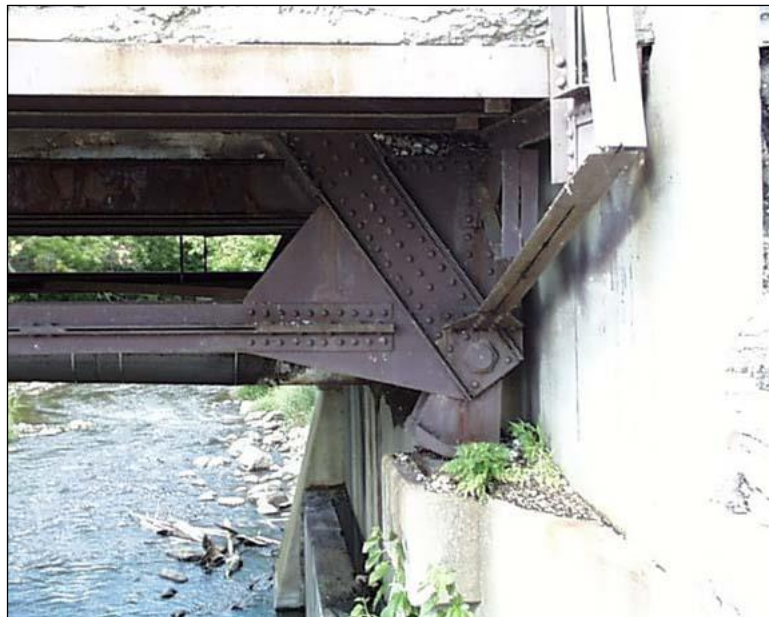
**Figure 2.4.8.2-12:** Rocker Bearing – Movement Condition State 3.

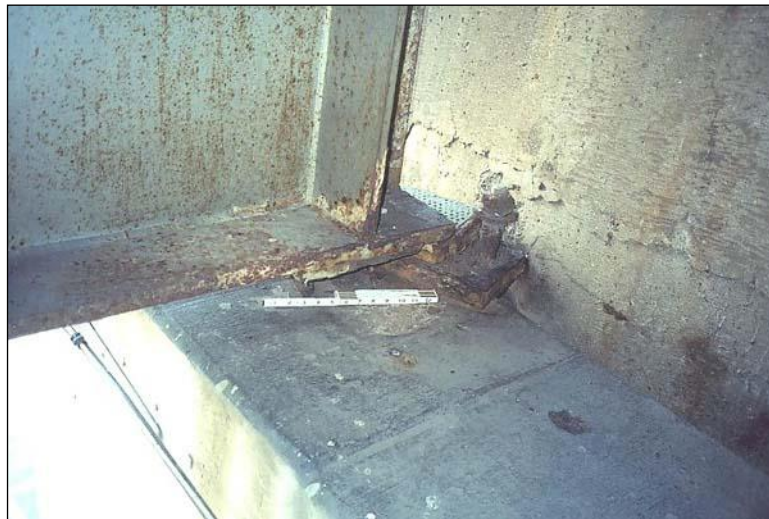
**Figure 2.4.8.2-14:** Masonry Plate Walkout Due to Failed Anchor Bolt – Connection Condition State 3.

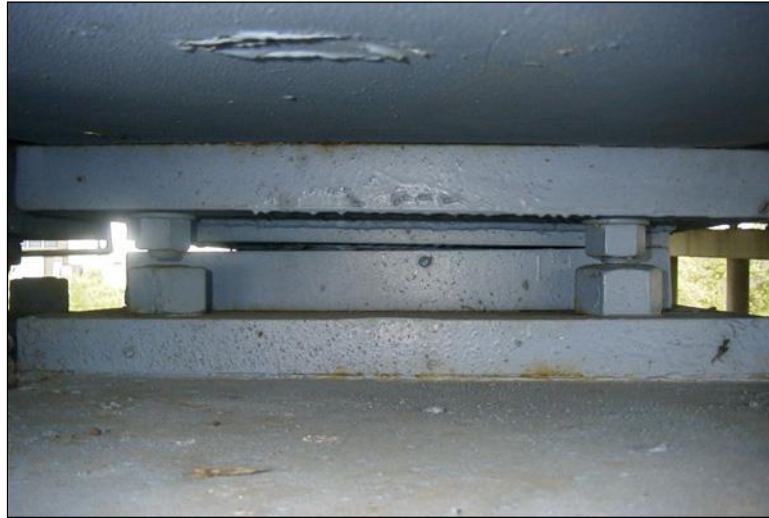
**Figure 2.4.8.4-2:** Tipped Pot Bearing – Movement Condition State 2.
