Non-Cementitious Repair Materials Study

Final Report

WisDOT Project No. 0092-18-02
June 2019

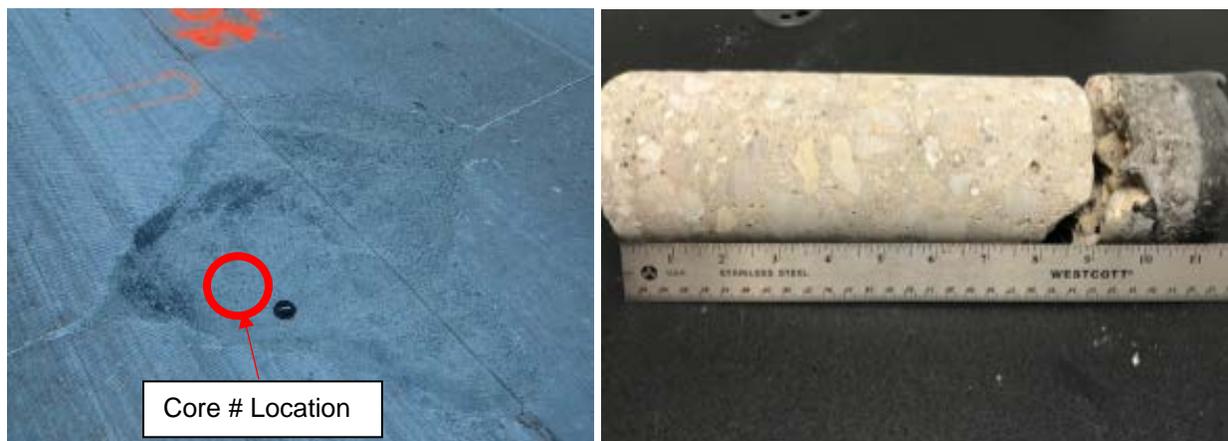
Prior to the replacement of the RM-1 PDRs, the project team had the opportunity to conduct a field visit to document the condition of the PDRs and extract three cores in July 2018. The first core was extracted from an apparently sound PDR on the left most lane, close to a transverse joint. The thickness of the underlying pavement in this location was approximately 8.5 inches and the thickness of the PDR was around 2.5 inches (see figure 3-3).

Figure 3-3. RM-1 core location #1 (left) and extracted core #1 (right).

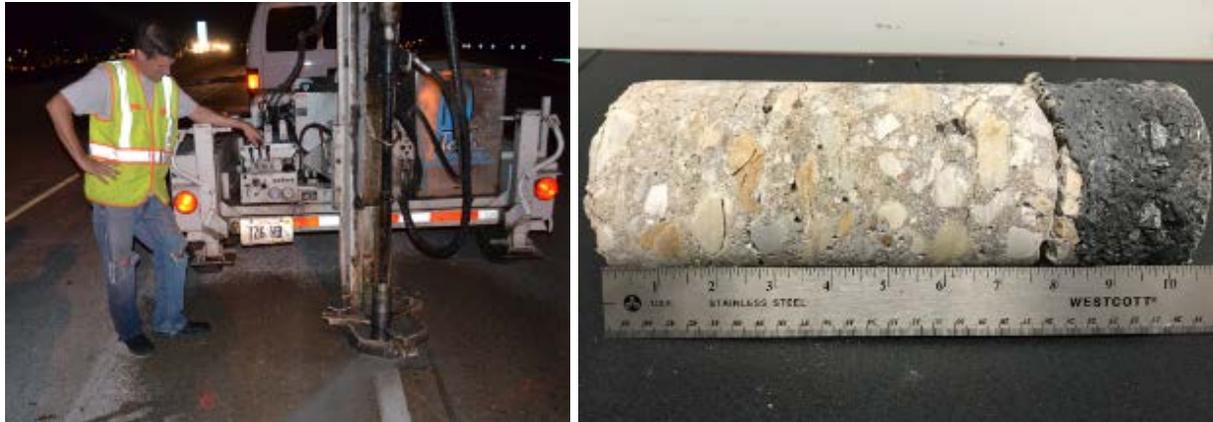
The second core location was also in the left most lane, close to the longitudinal joint. The PDR showed no signs of distress on the surface. The thickness of the RM-1 PDR at this location was around 2.25 inches and the concrete pavement was approximately 7.75 inches thick (see figure 3-5). The RM-1 PDR was debonded from the substrate concrete. Similar to core #1, the debonded core had significant amounts of substrate concrete still bonded to it (see figure 3-6).

Figure 3-5. Coring operation in progress for core #2 (left) and the extracted core #2 (right).

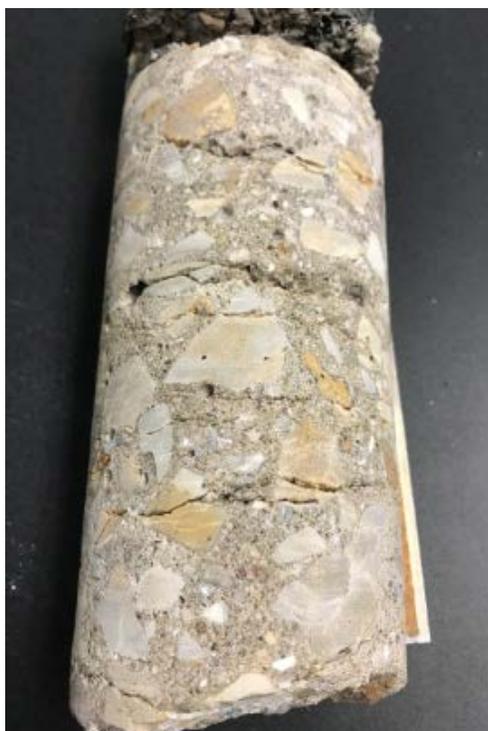
A closer examination of the substrate concrete revealed multiple parallel horizontal cracks through the entire depth of the core (see figure 3-7) and these cracks extend through the coarse aggregates. This potentially suggests freeze-thaw-related damage, however, since petrographic analysis was not performed on the extracted cores, this speculation cannot be confirmed.

Figure 3-7. Multiple parallel horizontal cracks extending through the entire depth of core #2.

It is worth noting the very low UPV value for the substrate concrete core specimen extracted from Site #1 (Core #2). This measurement was on the concrete core that exhibited parallel cracking throughout the entire depth (see figure 3-7.) Interestingly, this core specimen could not withstand the -23 °C temperature and disintegrated before the UPV measurement could be made. This observation further supports the findings from the field investigations that the PDRs are often performed in areas where the substrate concrete is already weak and freeze-thaw cycling during the winter season likely contributes to further deterioration of the substrate concrete and eventually result in the failure of the PDR. Figure 4-22 compares the UPV values measured on the laboratory and core specimens.

One of the core specimens extracted (see figure 3-7; Site #1, Core #2, Madison Beltline) exhibited multiple parallel horizontal cracks through the entire depth of the sample. When this specimen was conditioned at -23 °C for UPV testing, it completely disintegrated. Extremely cold temperatures during the winter seasons could potentially result in deterioration of the substrate concrete in areas where it is already in poor condition. This situation will surely compromise the bond between the repair material and the underlying concrete and can cause the material to pop out of the repair area.

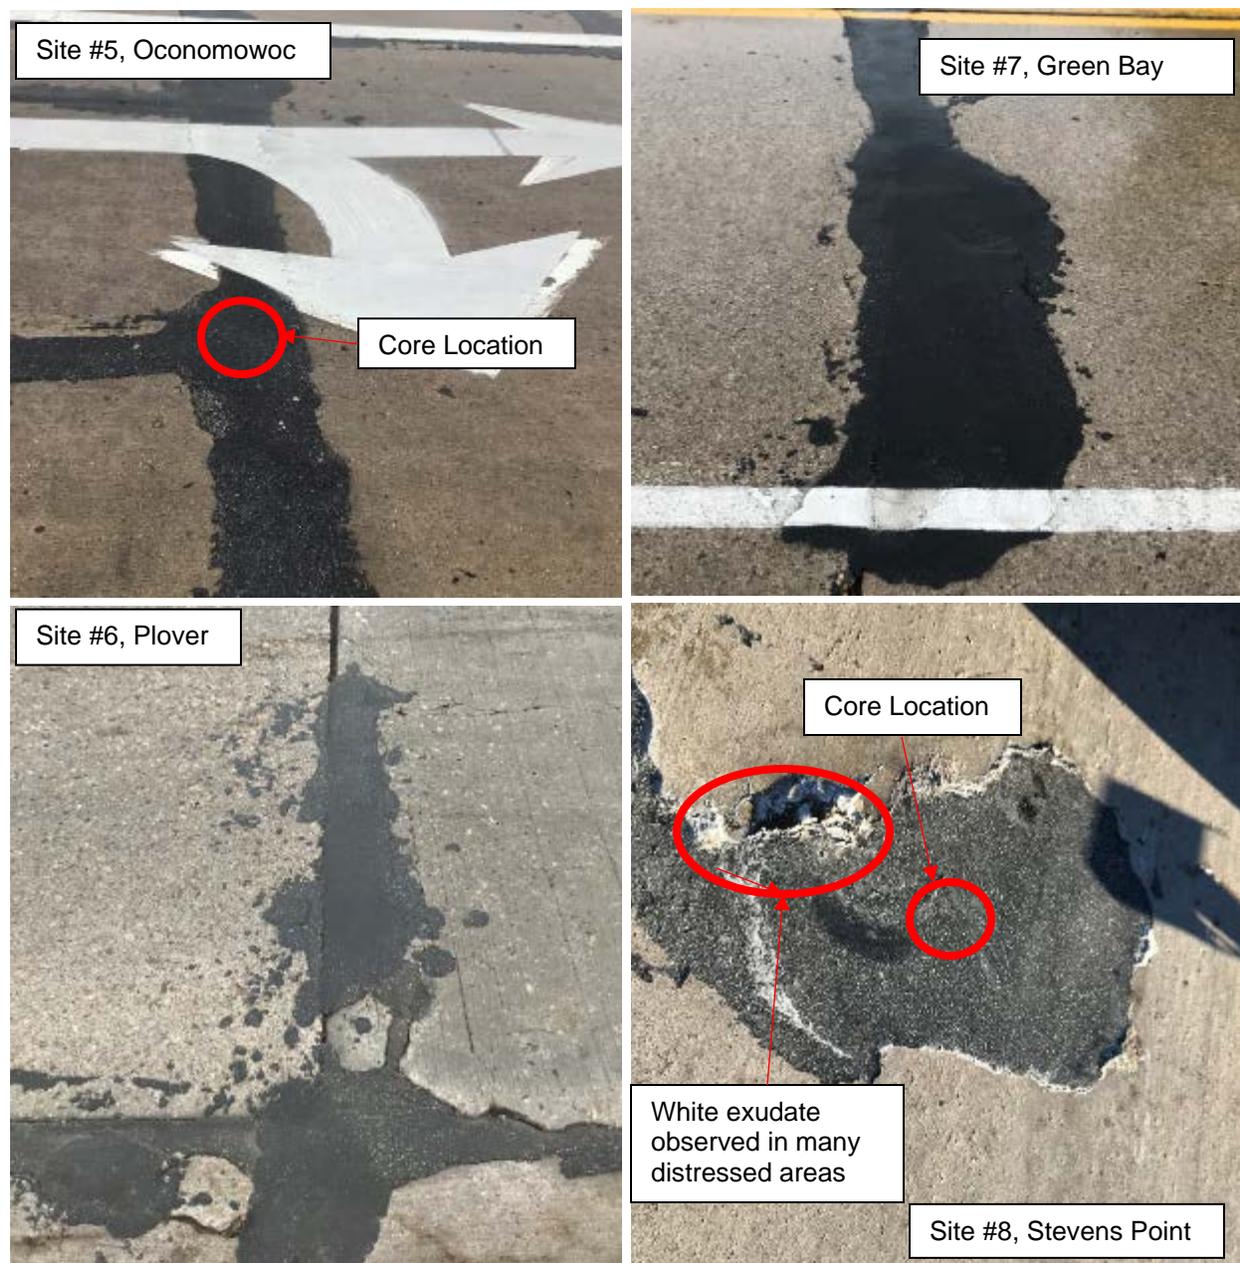
Figure 3-13. RM-3 used in concrete pavement PDR applications.

The field condition of the repaired areas was observed to be Fair to Excellent. The existing concrete pavement at Site #8 was heavily distressed. Severe joint spalling and scaling was widespread on this pavement. Also, many of the spalls and cracks noted on the pavement exhibited white exudate, which could be signs of other types of materials-related distresses. Considering the poor condition of the areas that have been chosen as the candidates for RM-3 applications (particularly on Site #8), the material has exhibited reasonably good performance.

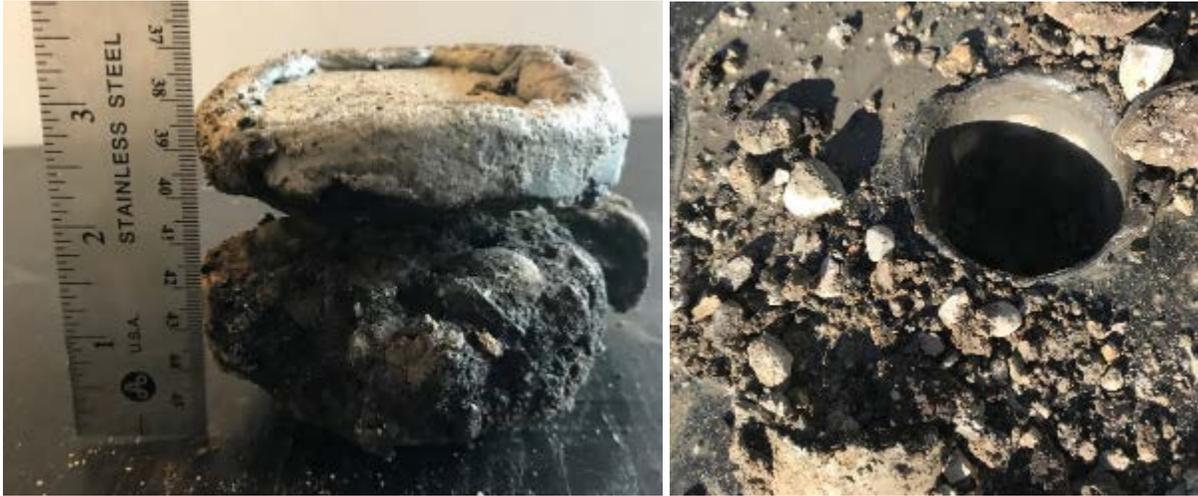
In areas where the cores were extracted (Sites #5 and #8), the underlying concrete pavement was deteriorated to such an extent that only loose material was found beneath the repair material. At Site #5, the extracted repair material deteriorated into multiple pieces even through the repaired

Figure 3-14. RM-3 core from Site #5 (left) and remains of underlying concrete pavement extracted from the core hole (right).

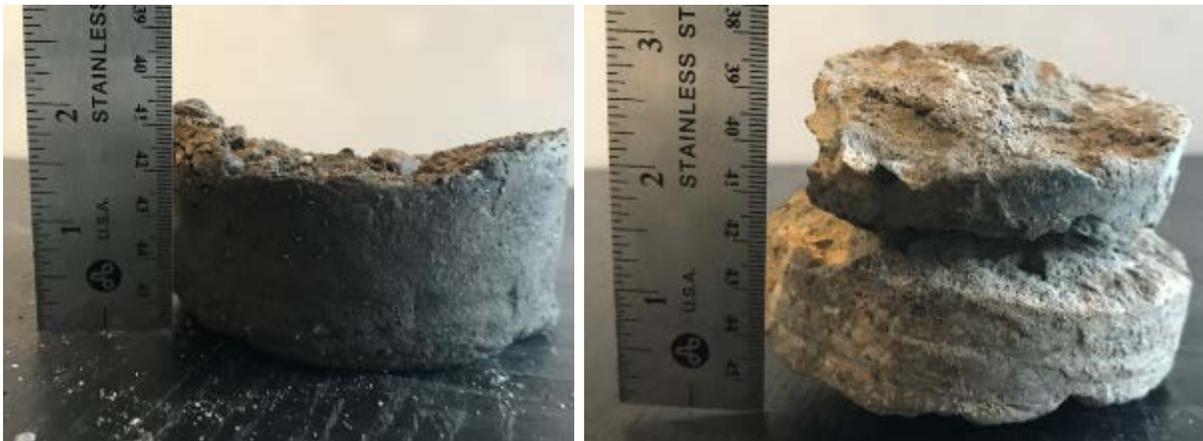
Figure 3-15. RM-3 core from Site #8 (left) and pieces of underlying concrete pavement extracted from the core hole (right).

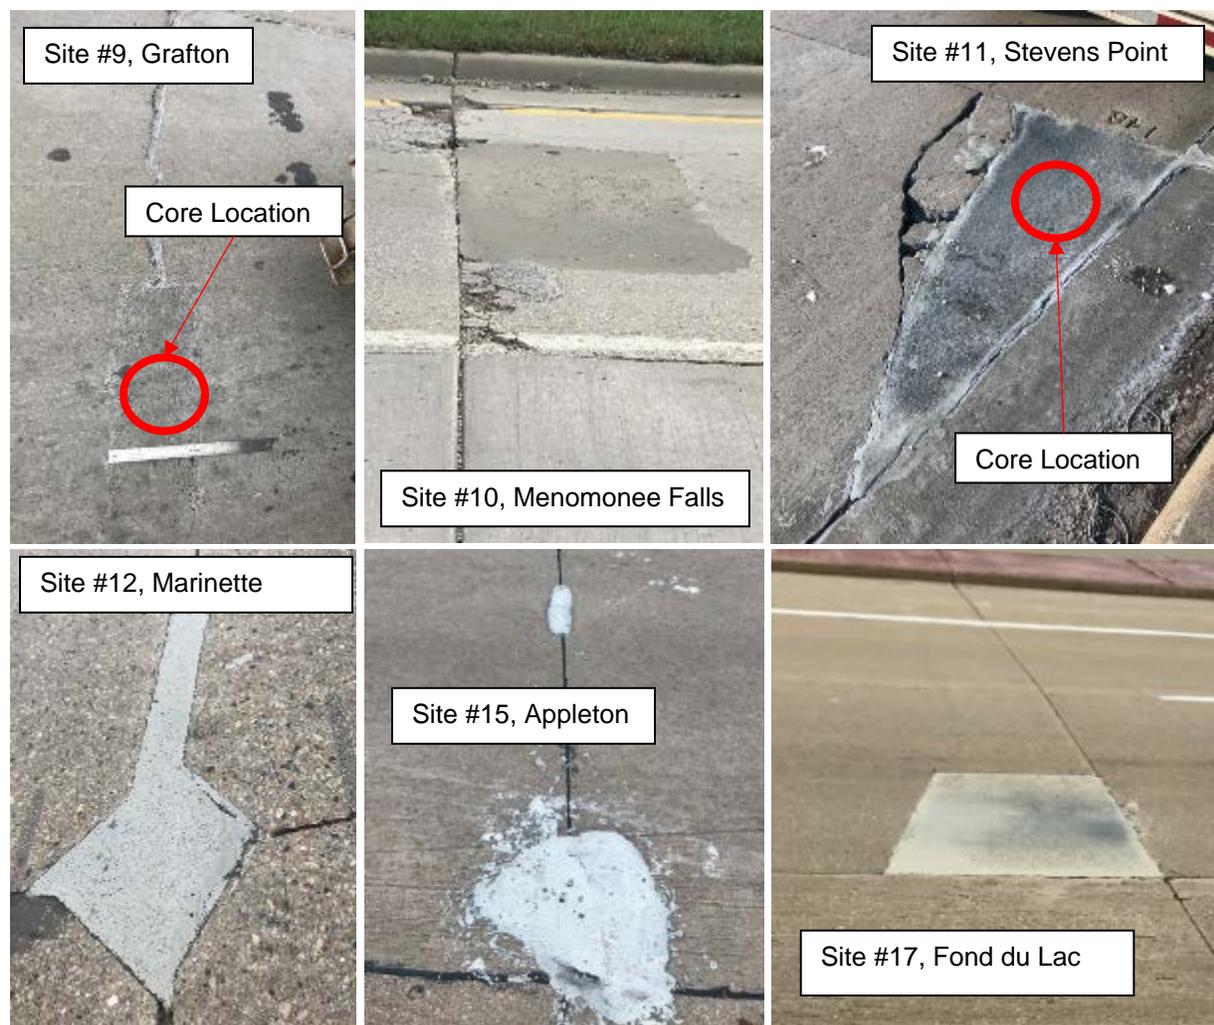
Figure 3-16. RM-4 used in concrete pavement PDR applications.

Two cores were extracted, one each from Sites #9 and #11 (core locations are shown in figure 3-16). RM-4 was used to repair a wide transverse crack at Site #9 and a corner break at Site #11.

The existing concrete around the repaired area at Site #11 has continued to deteriorate (see figure 3-16, top right). Figures 3-17 and 3-18 show photographs of the extracted cores.

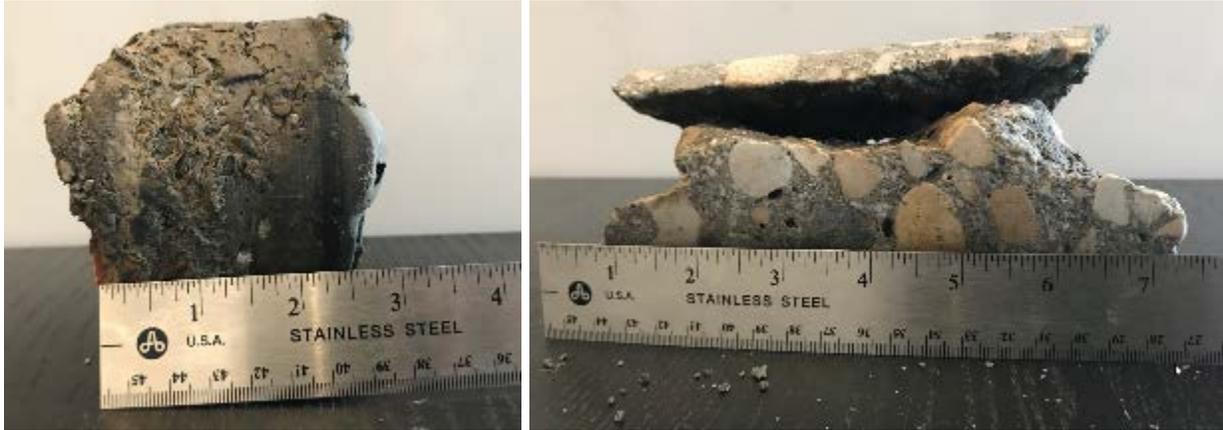
Figure 3-17. RM-4 core from Site #9 (left) and pieces of underlying concrete pavement extracted from the core hole (right).

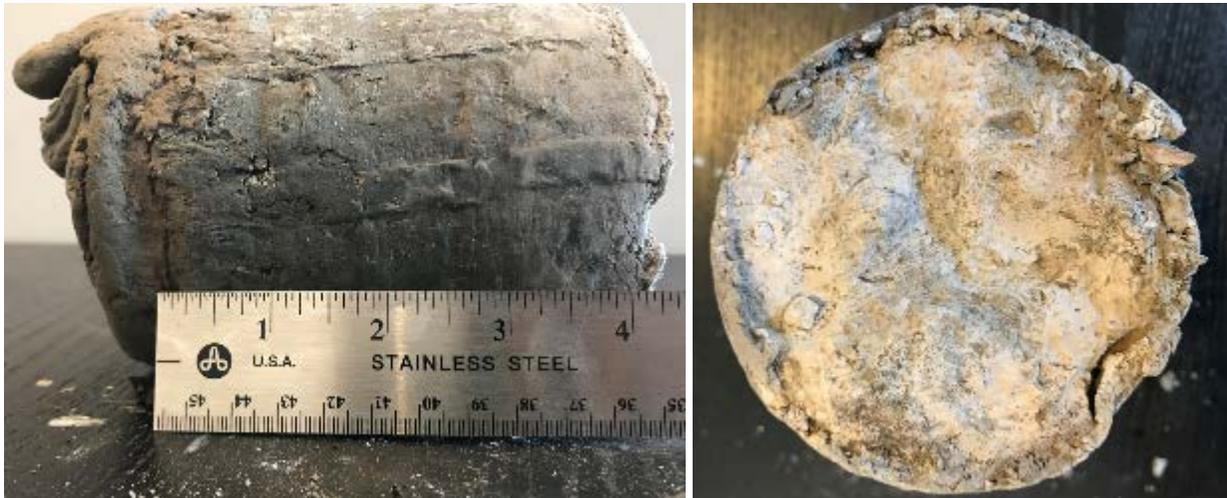
Figure 3-18. RM-4 core from Site #11 (left) and bottom of the core showing substrate concrete material bonded to the repair material (right).

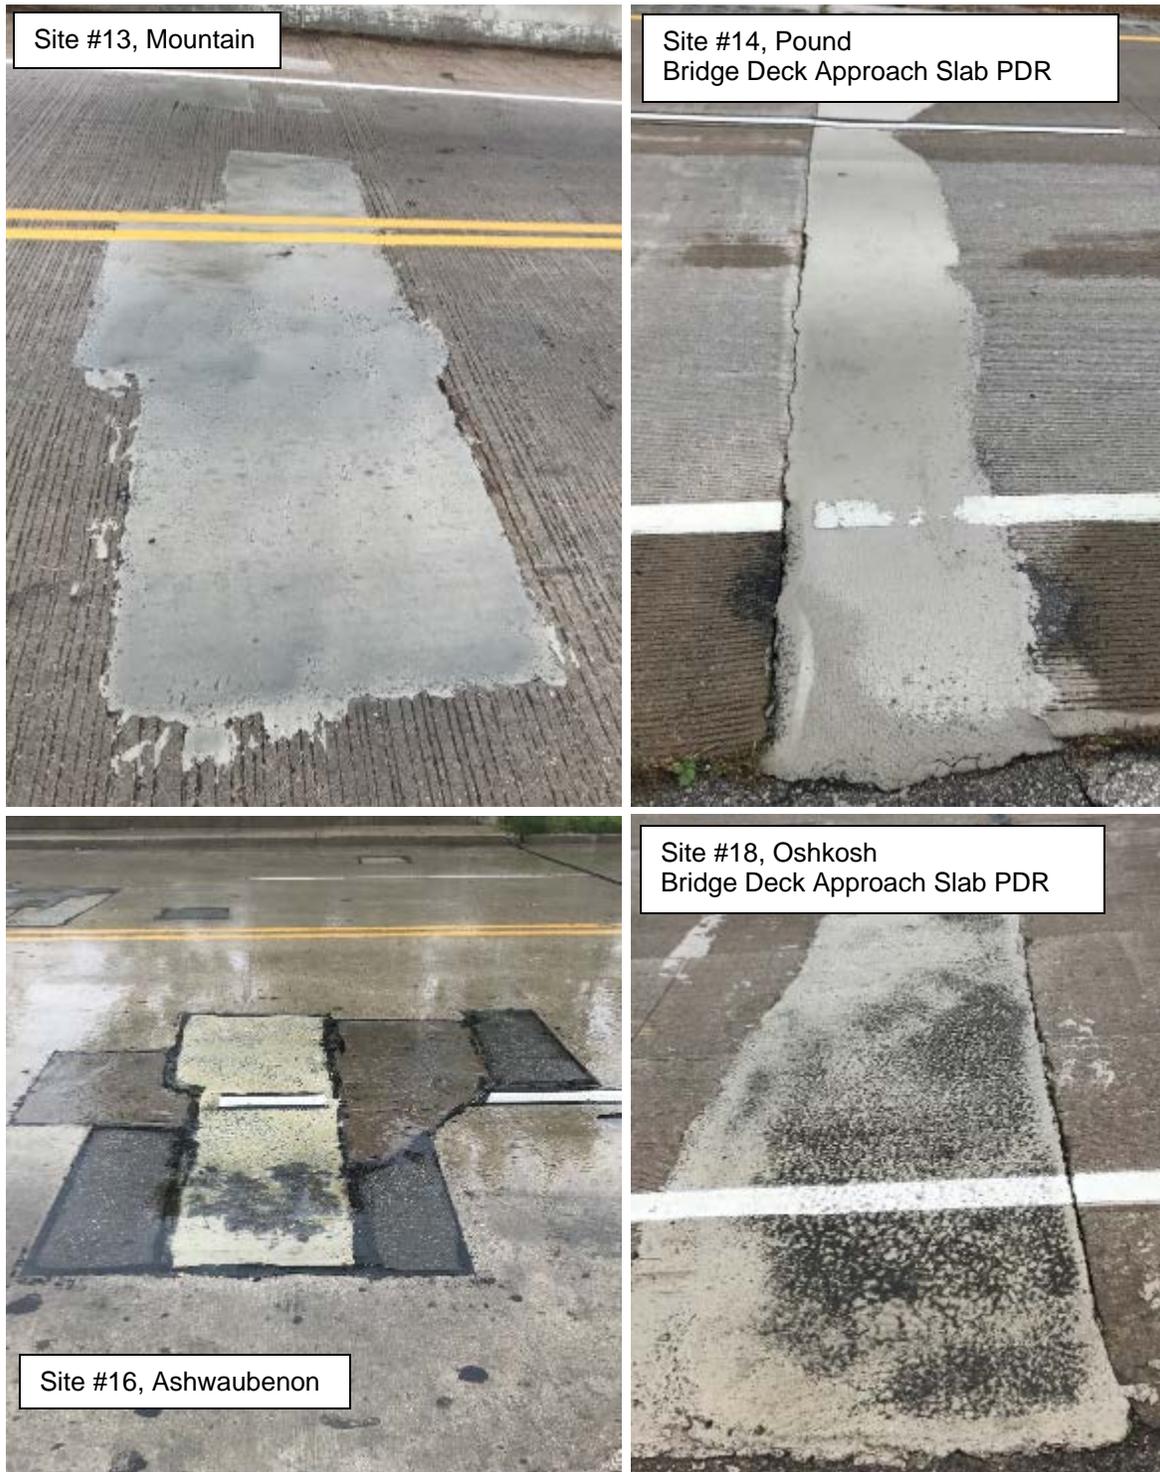
Figure 3-19. RM-4 used in bridge applications.

The RM-4 repairs on bridge decks appear to be performing satisfactorily. In fact, some of the bridge deck PDRs have been in service for over 5 years without any failures. The surface of the PDRs on Site #16 (see figure 3-19, bottom left) have very different tints and appear to have been

performed at different times and the repair boundaries have been sealed with a flexible sealant material. The material manufacturer claims that all the repairs on Site #16 were performed using RM-4 and attributed the difference in color to contaminants from the mixing equipment. The same mixing equipment (see figure 3-20) is used for both RM-3 and RM-4. The material manufacturer noted that if the equipment is not cleaned properly after using it to mix RM-3, the RM-4 mix produced using the same equipment is expected to have a darker shade.

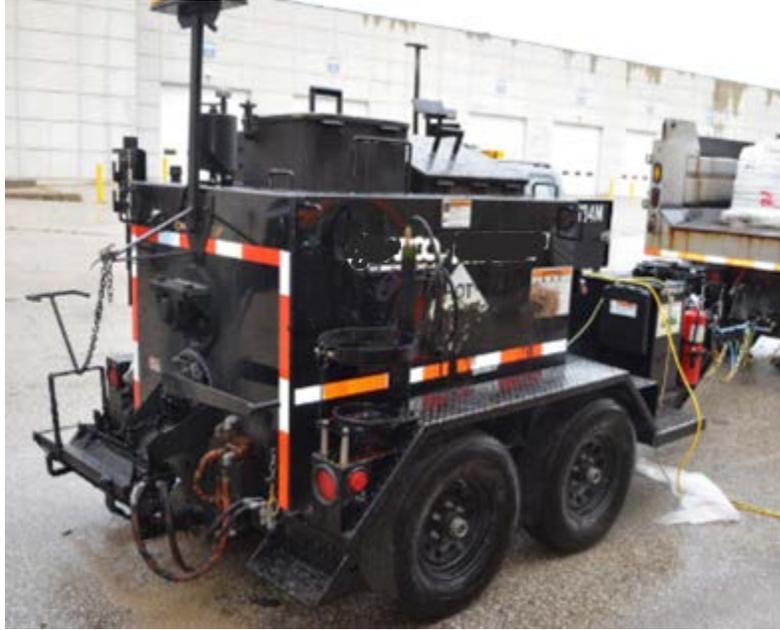
Figure 3-20. Mixing equipment used for RM-3 and RM-4.

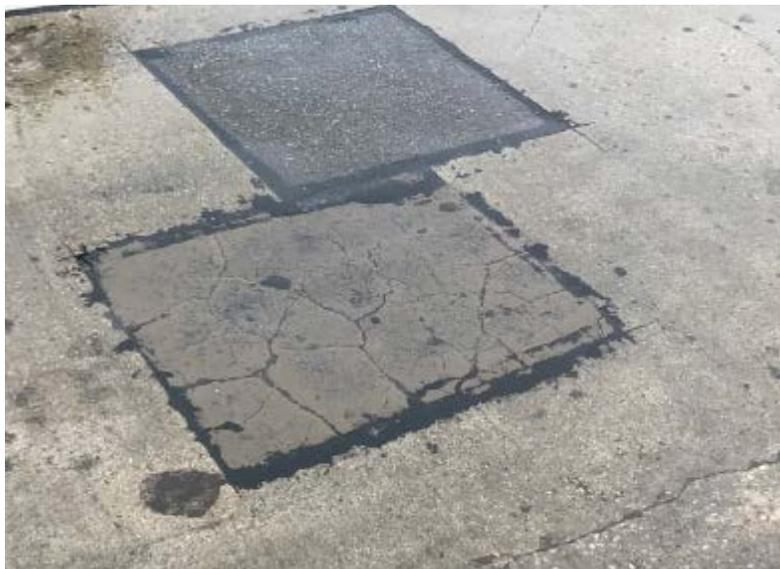
Figure 3-21. Surface map cracking pattern observed on some RM-4 PDRs on Site #16.

The material with the greyish tint has developed a map cracking pattern on the surface (see figure 3-21). The cracks are tight (no loose pieces found in the PDR) and resemble a shrinkage cracking pattern often seen on newly placed concrete.

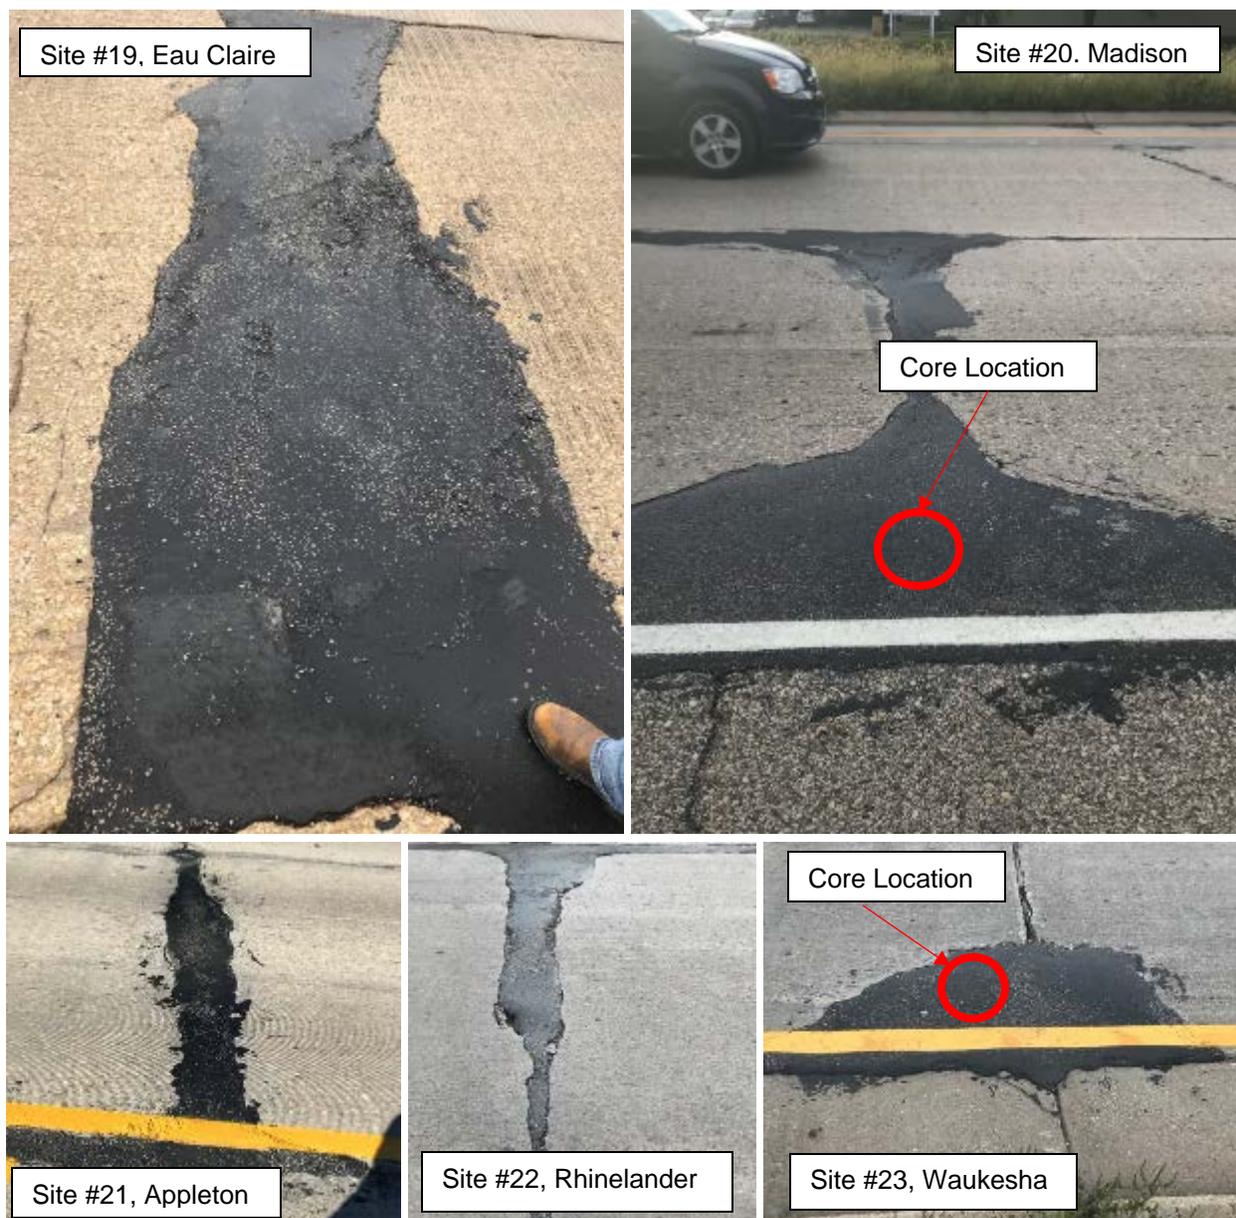
Figure 3-22. RM-5 used in concrete pavement PDR applications.

The repaired areas were observed to be in generally Good condition. While the PDRs exhibited some surface wear from traffic, none of them developed cracking. In a few locations, a small amount of material was missing along the edge of the repaired areas, primarily due to the deterioration of the surrounding concrete pavement.

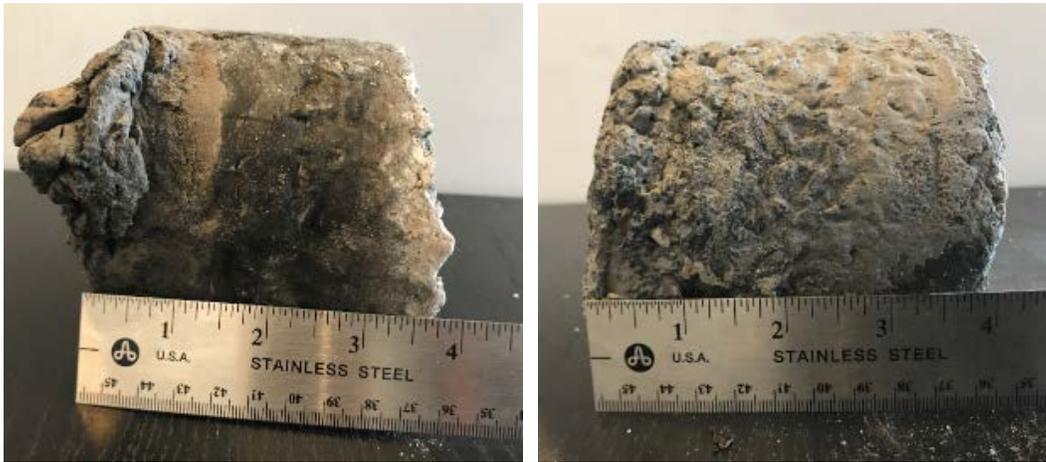
Figure 3-24. RM-5 cores from Site #20 (left) and Site #23 (right).

Figures 3-24 show photographs of the extracted cores. At both the sites, the underlying concrete pavement was completely deteriorated and only loose material was found beneath the RM-5 material.

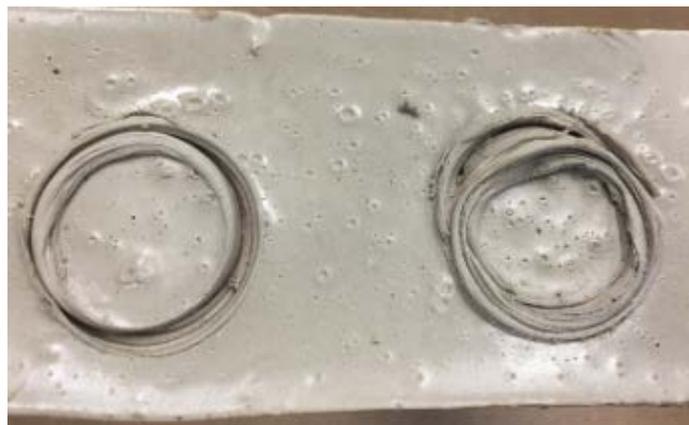
Figure 4-8. Unsuccessful specimen preparation effort for bond testing.

- At $-23\text{ }^{\circ}\text{C}$, the glue used to stick the steel disc to the surface of the repair material failed to hold up during the bond-testing process and the bond between the steel disc and the material failed. Three different cold-temperature resistant glues were tried without any success. After several unsuccessful attempts (on 10 different specimens), eventually one successful test was performed.
- For RM-4 and RM-5, it was not possible to drill the 2-inch core hole successfully. As discussed in the previous chapter, the repair material melted during the coring process. When the core drill was removed from the specimen, the melted material filled up the hole and it was not possible to achieve smooth, uniform top surface which is essential for bond testing process (see figure 4-8).

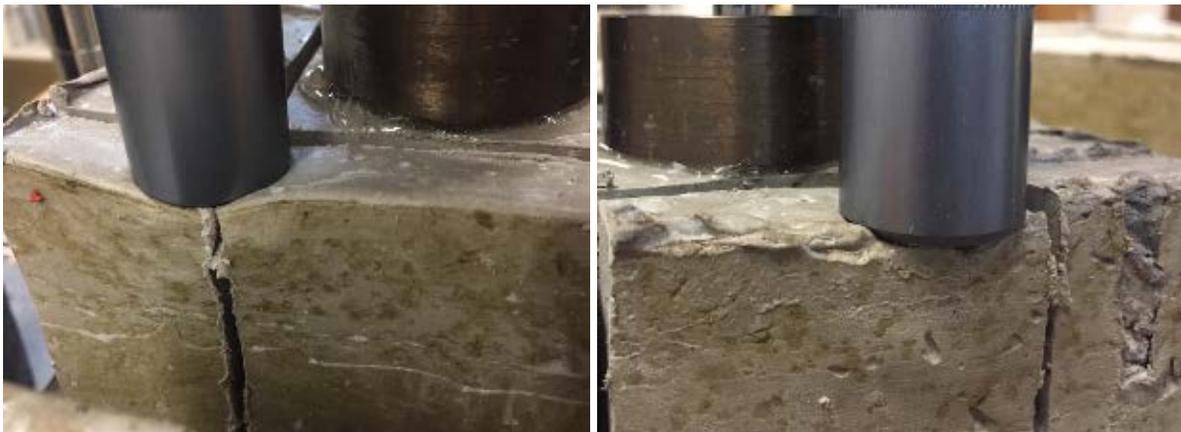
Figure 4-10. RM-4 specimens being crushed by the bond testing equipment at $23\text{ }^{\circ}\text{C}$.

- The bond testing on the RM-4 and the RM-5 specimens using the modified approach described had a number of other issues:
 - At a testing temperature of $23\text{ }^{\circ}\text{C}$, the material was just too soft and was unable to support the reaction forces during pull-out test (see figure 4-10).

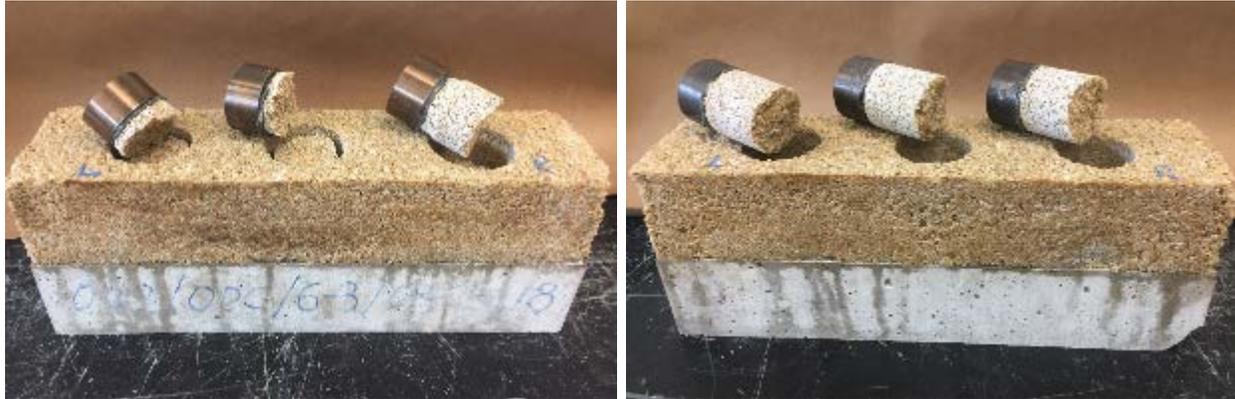
Figure 4-12. Failures observed after pull-off testing at 23 °C (left, shallow failures) and -10 °C (right, deep failures).

For RM-2, the failure was observed within the repair material and not at the bonding interface for the testing temperatures of 23 °C and -10 °C (see figure 4-12). The bond between RM-2 and the substrate concrete appears to be stronger than the tensile strength of the material at these temperatures. While the failure plane was very close to the surface at a testing temperature of 23 °C, a comparatively deeper failure was observed at -10 °C. At -23 °C, only one successful test could be performed.

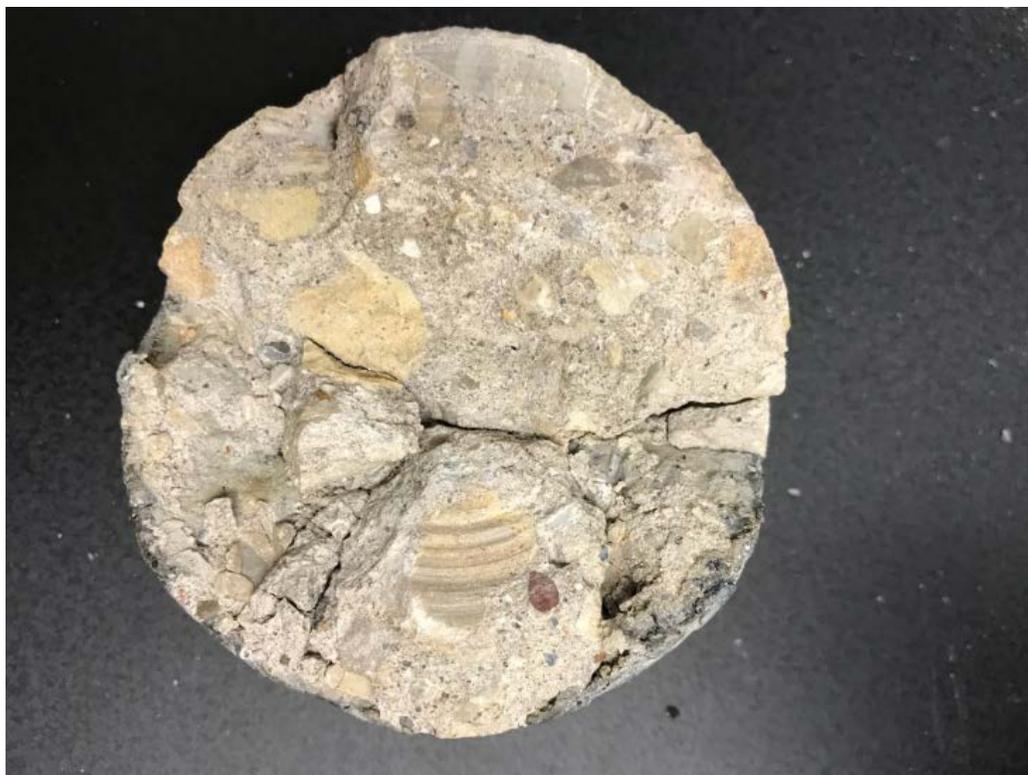
- **Failure to remove all the unsound concrete from the repair area.** In many cores extracted, a significant amount of substrate concrete material still appeared to be well-bonded to the bottom of the RM-1 cores. This may be an indication that the underlying deterioration or delamination in the existing concrete pavement was not adequately or completely removed prior to repair material placement.

Figure A-4. Site #1, RM-1 Core #1—Bottom view of RM-1 portion
(US 12/18, Madison Beltline).

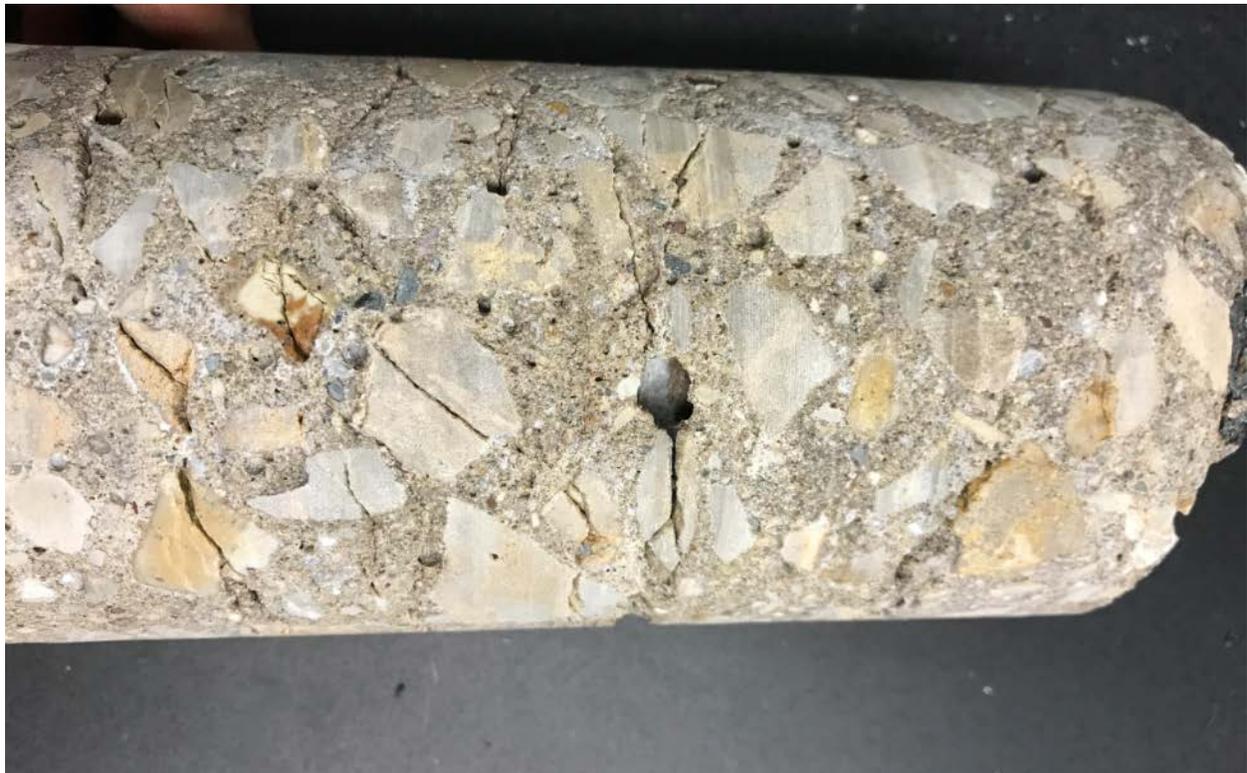
Figure A-6. Site #1, RM-1 Core #2—Closeup of PCC core
(US 12/18, Madison Beltline).

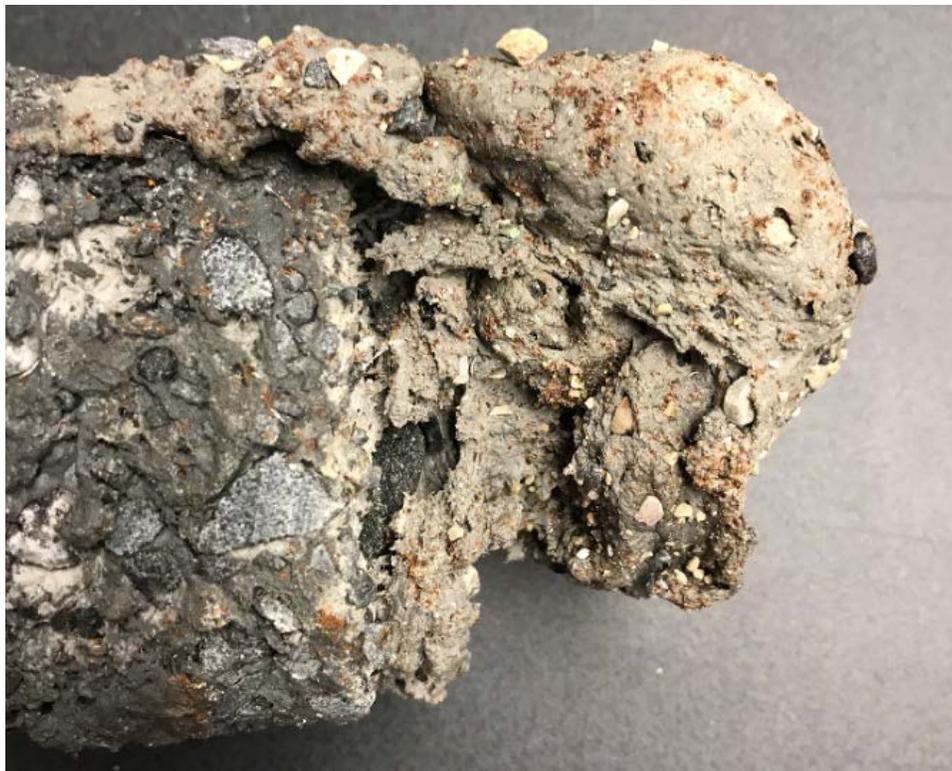
- All the repair materials investigated were relatively flexible even at low temperatures (<20 °F). Coring of these materials was found to be more challenging since the binder in these materials melts under the heat generated in the coring process. The melted binder gums up the coring drill and as a result the whole operation required more water and time than a coring operation on typical asphalt or concrete materials. The “material melting” issue could be a potential concern when performing diamond grinding operations on pavements with these types of repairs where the melted binder can “gum-up” the diamond-head blades.

Figure A-10. Site #1, RM-1 Core #3—Closeup of melted material (US 12/18, Madison Beltline).

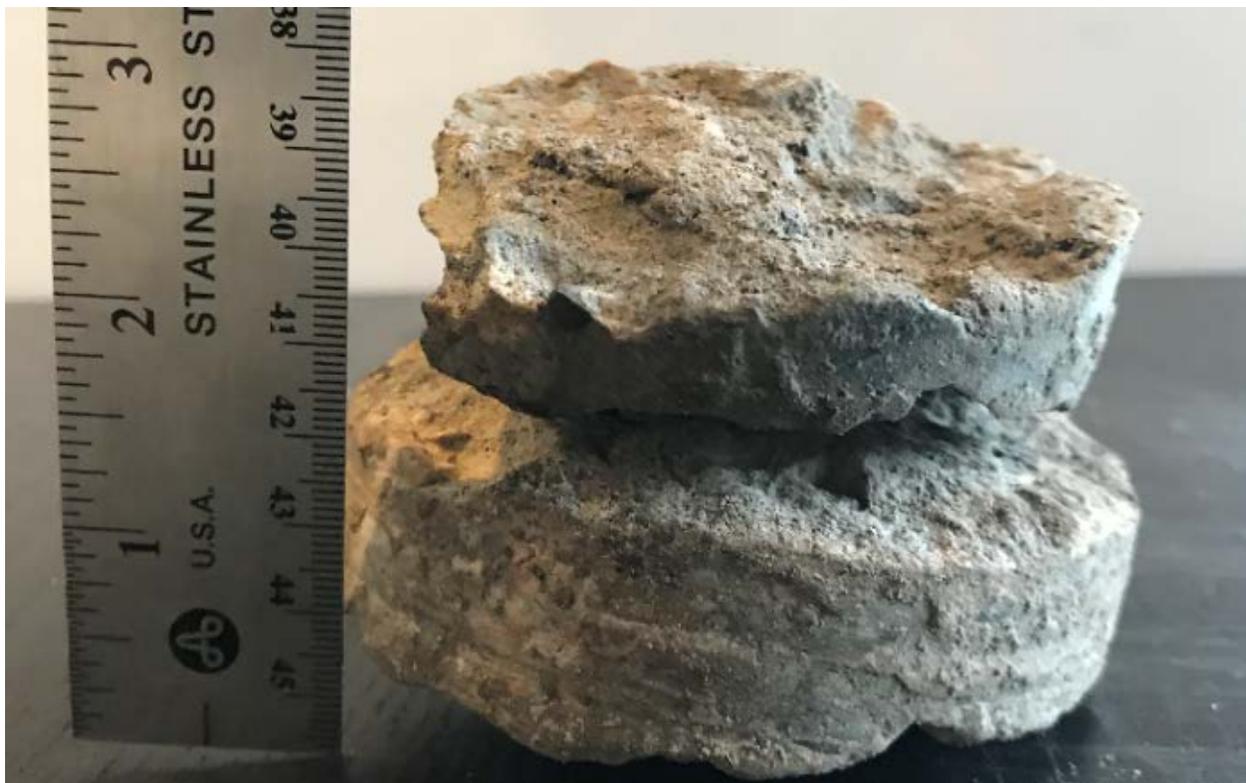
Figure A-14. Site #8, RM-3 Core #1—concrete pavement core pieces
(State Route 66 SB, Stevens Point).

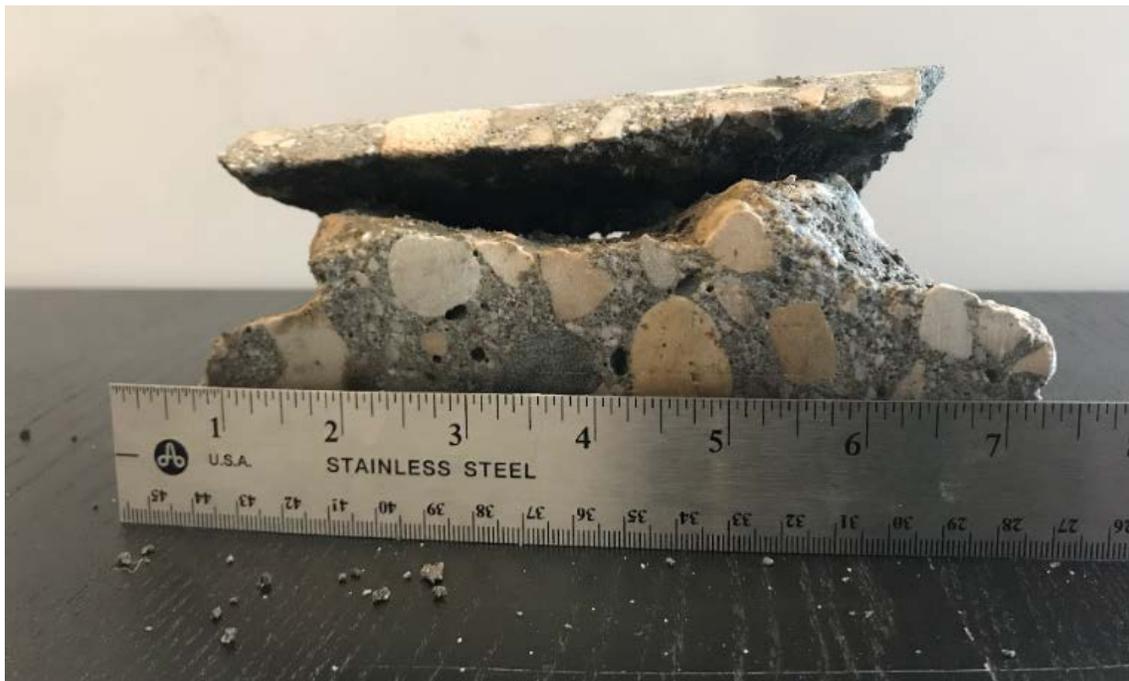
Figure A-16. Site #9, RM-4 Core #1—concrete portion
(Washington St., Grafton).

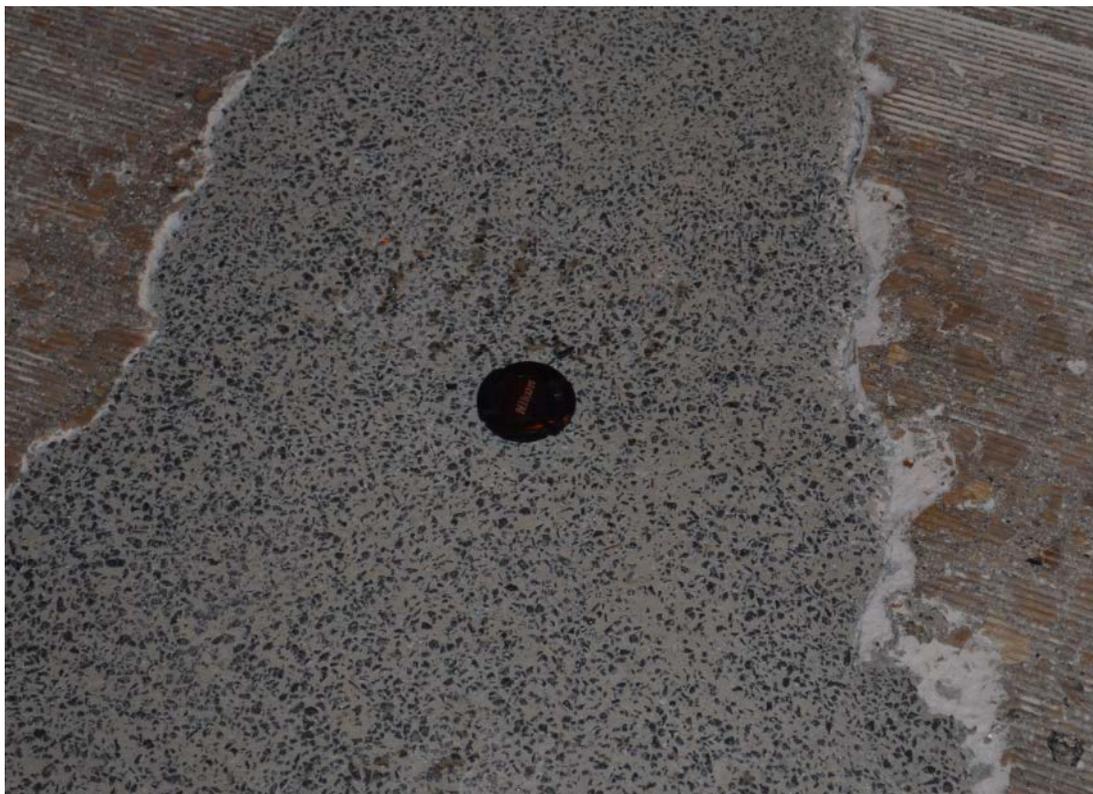
Figure B-8. RM-1 PDR (7)—close-up of repair surface (Site #1, US 12/18, Madison Beltline).

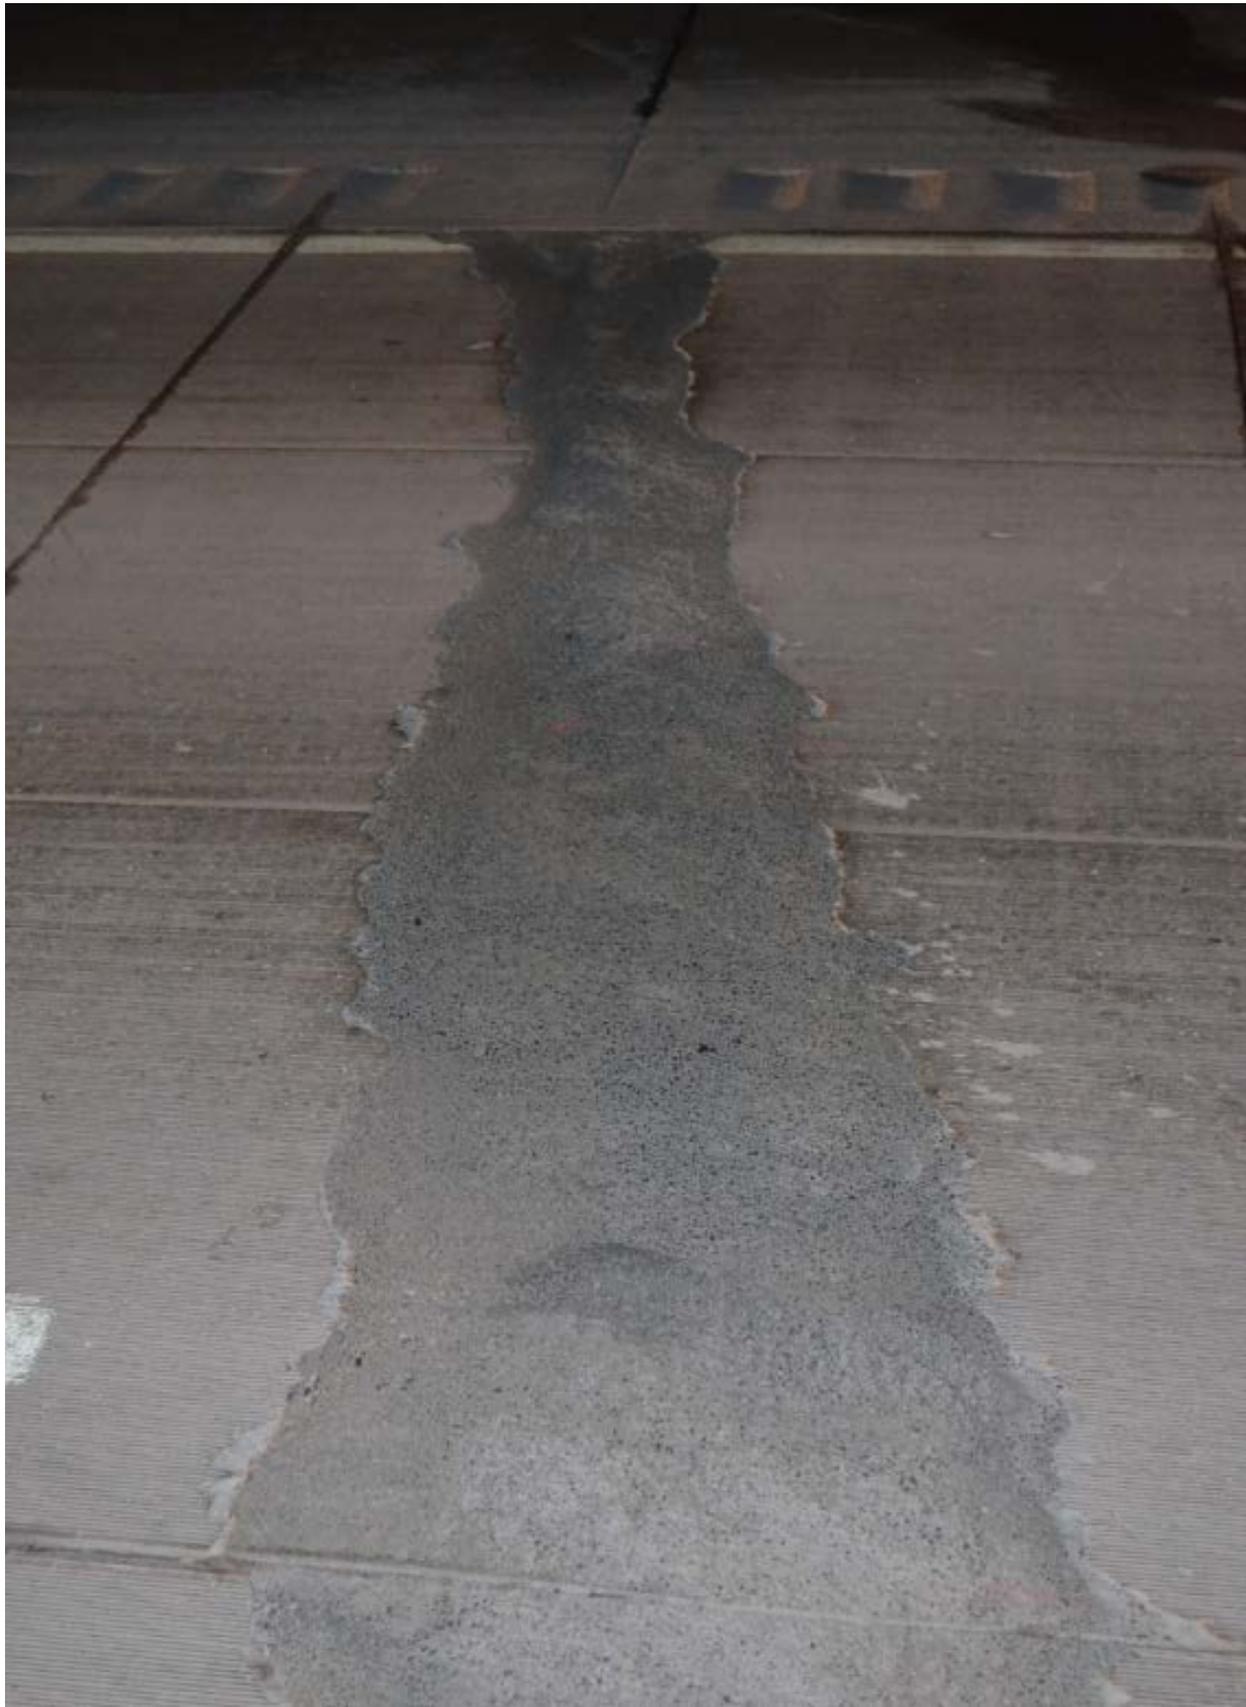
Figure B-9. RM-1 PDR (8)—large, full lane-width patch
(Site #1, US 12/18, Madison Beltline).
