Non-Cementitious Repair Materials Study

Final Report

WisDOT Project No. 0092-18-02
June 2019

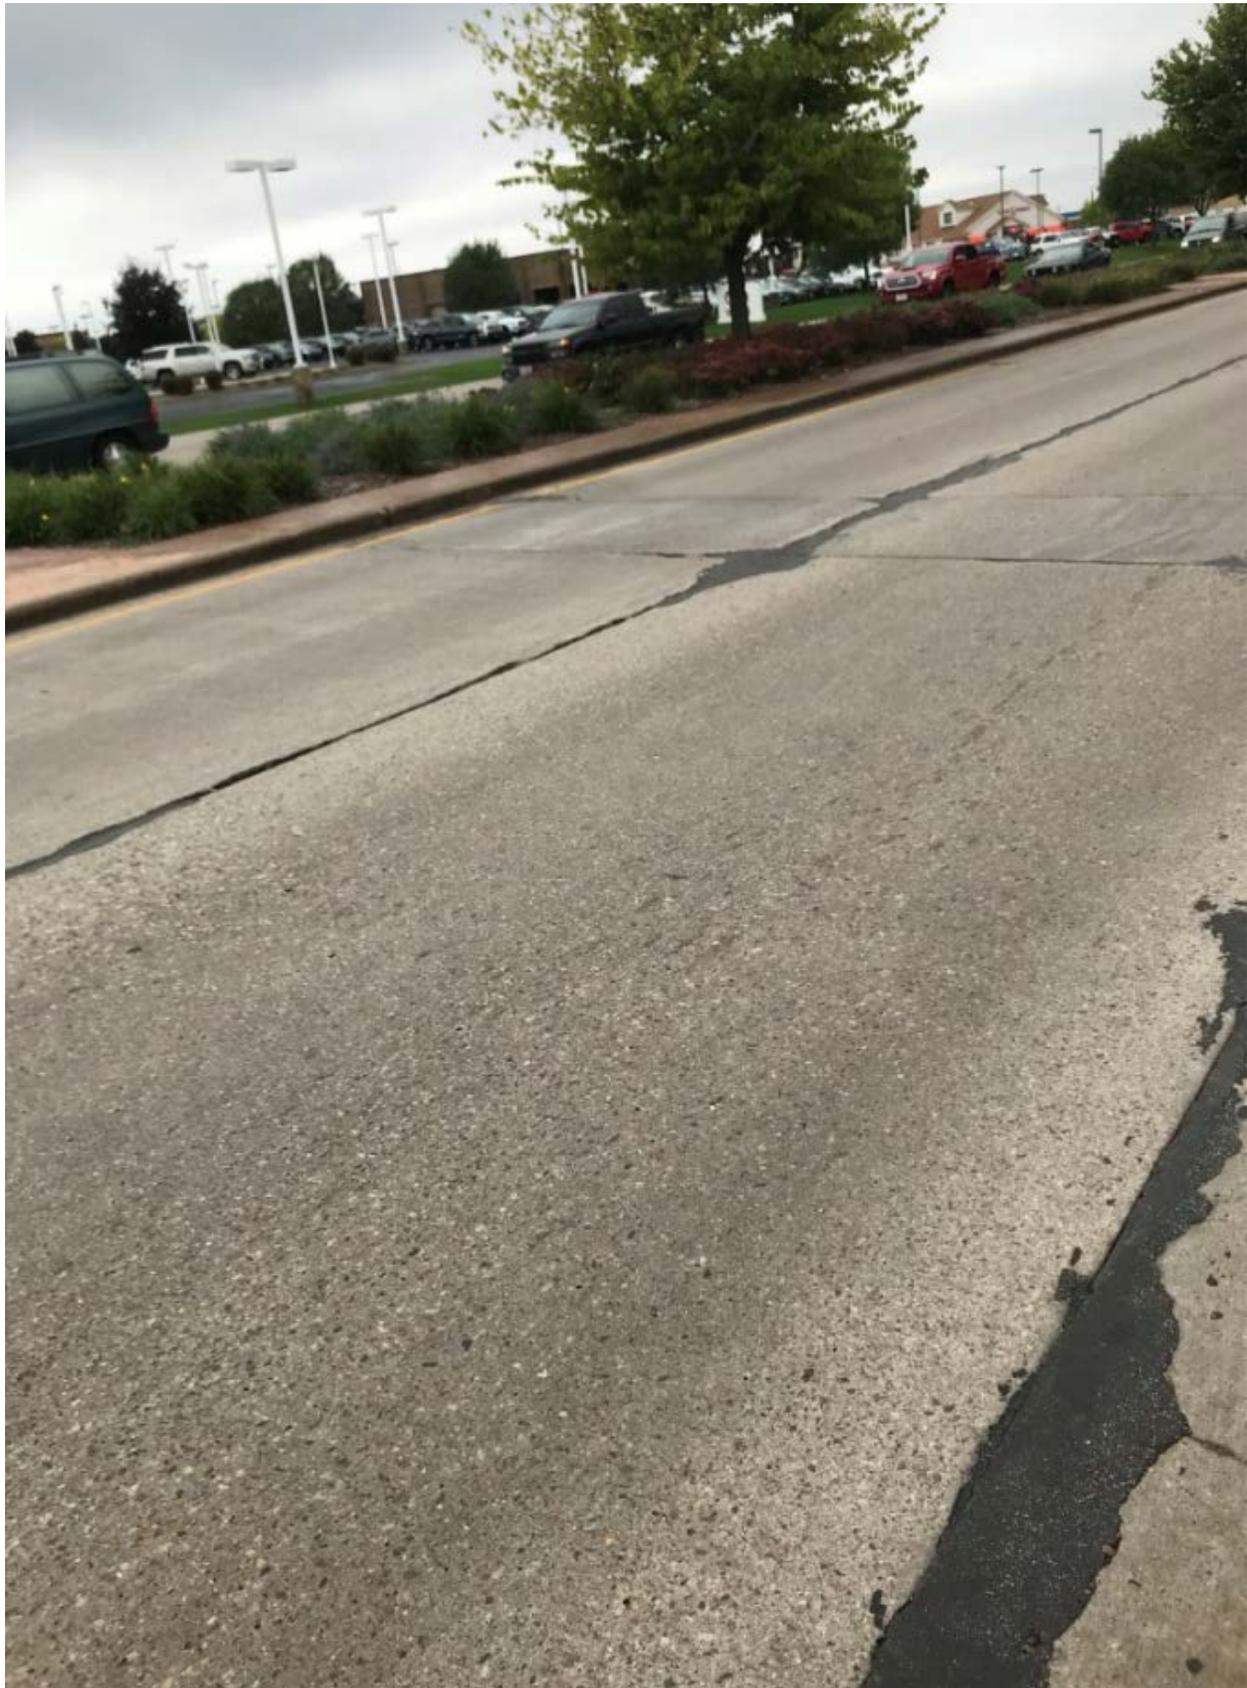
Figure D-4. Overview of existing concrete pavement (Site #6, Plover Rd., Plover).

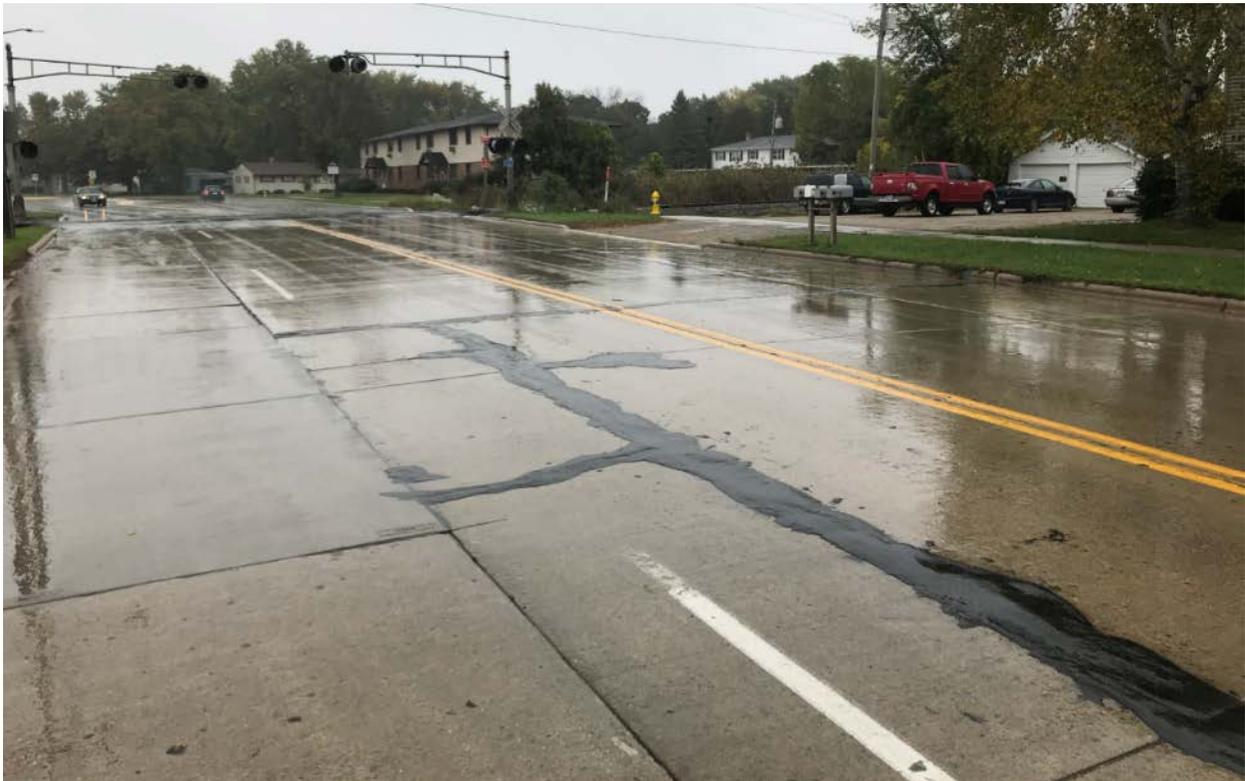
Figure D-5. Overview of RM-3 repairs
(Site #7, S. Taylor St., Green Bay).

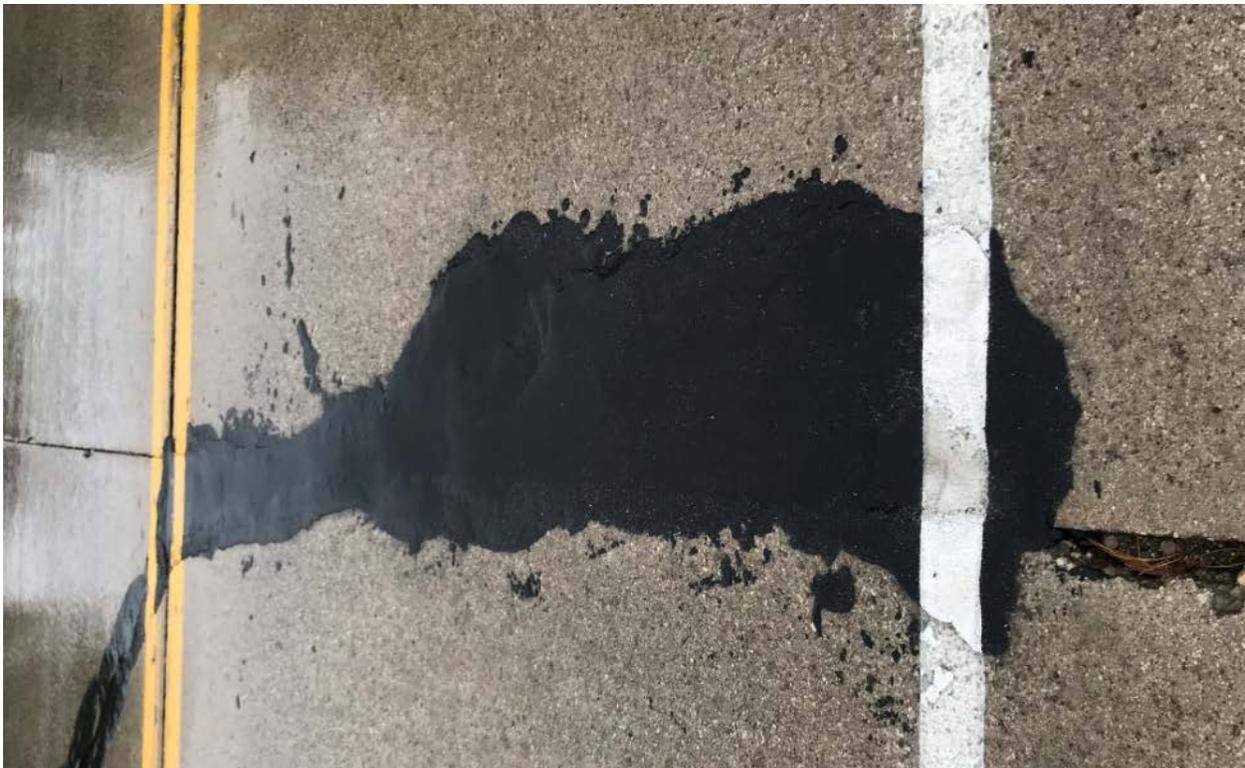
Figure D-6. PDRs along transverse joint
(Site #7 S. Taylor St., Green Bay).

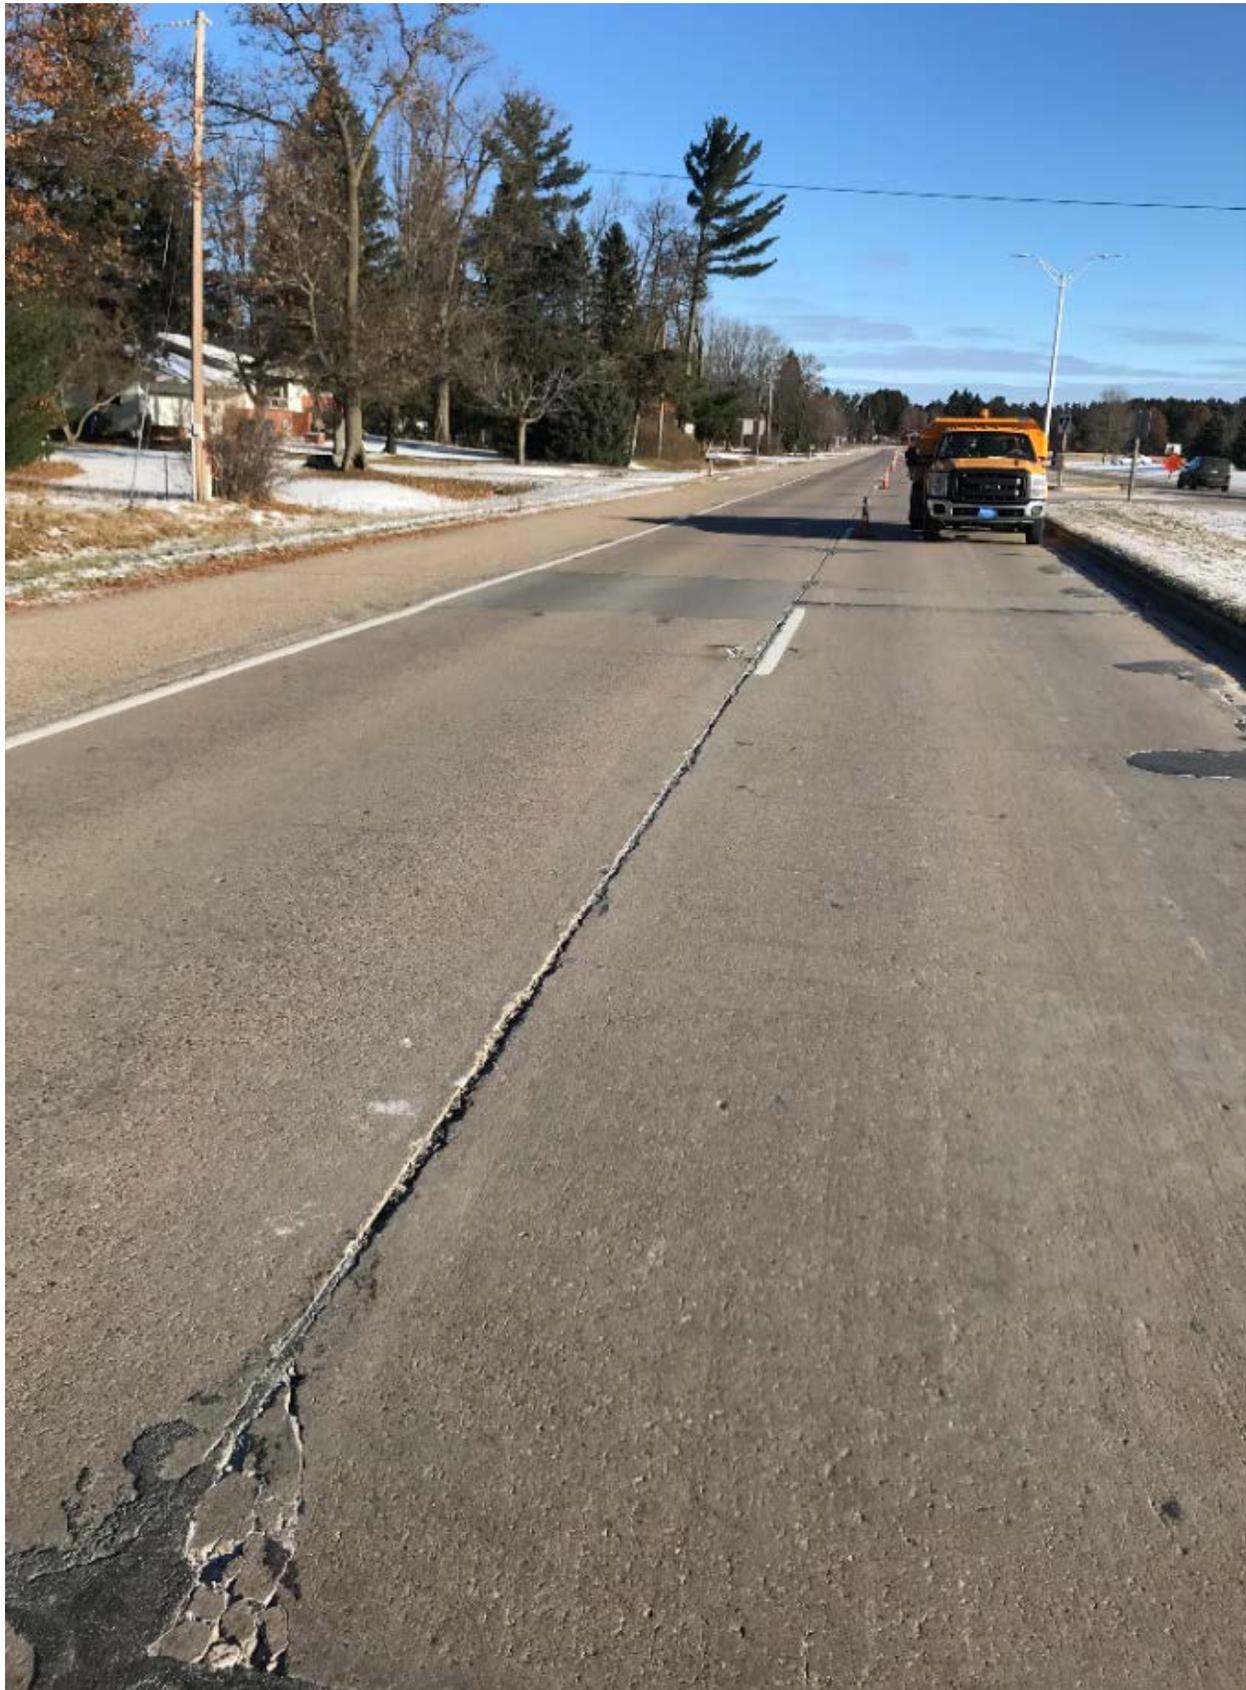
Figure D-7. Overview of existing concrete pavement (Site #8, State Road 66, Stevens Point).

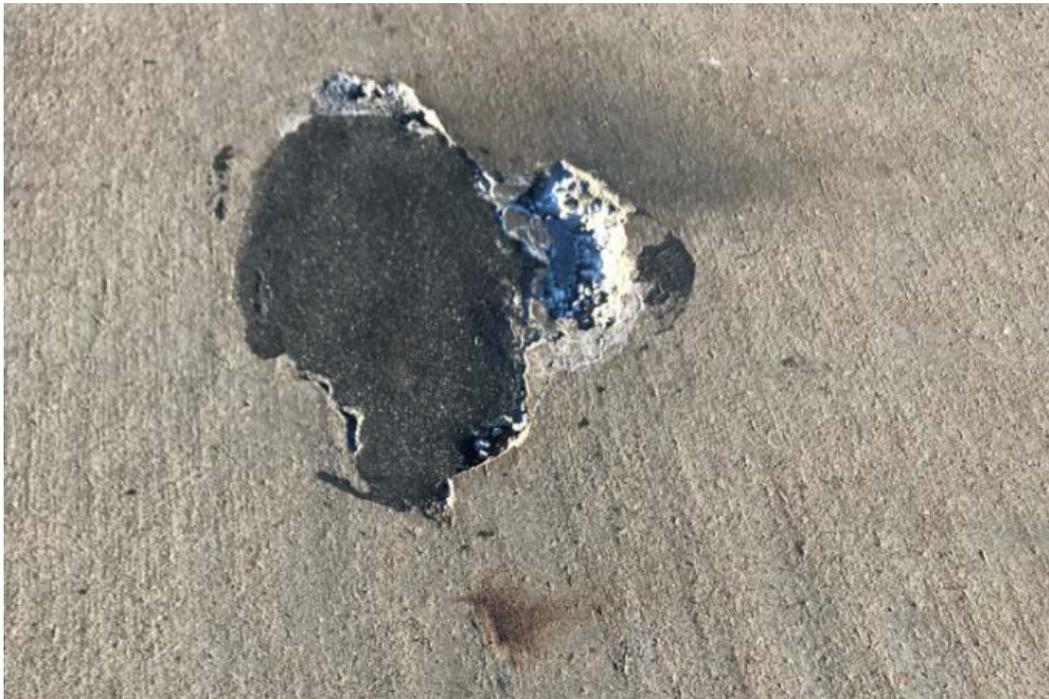
Figure D-9. Small spot repairs in slab interior
(Site #8, State Road 66, Stevens Point).

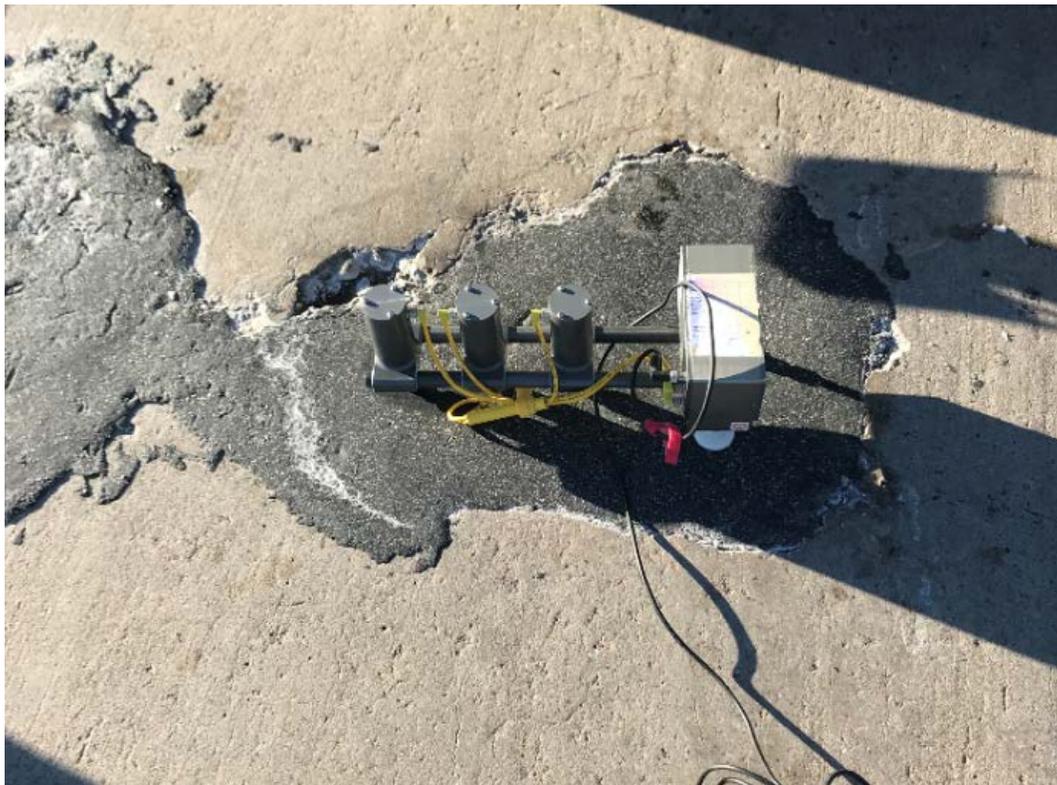
Figure D-10. PSPA testing in progress on PDR in slab interior
(Site #8, State Road 66, Stevens Point).

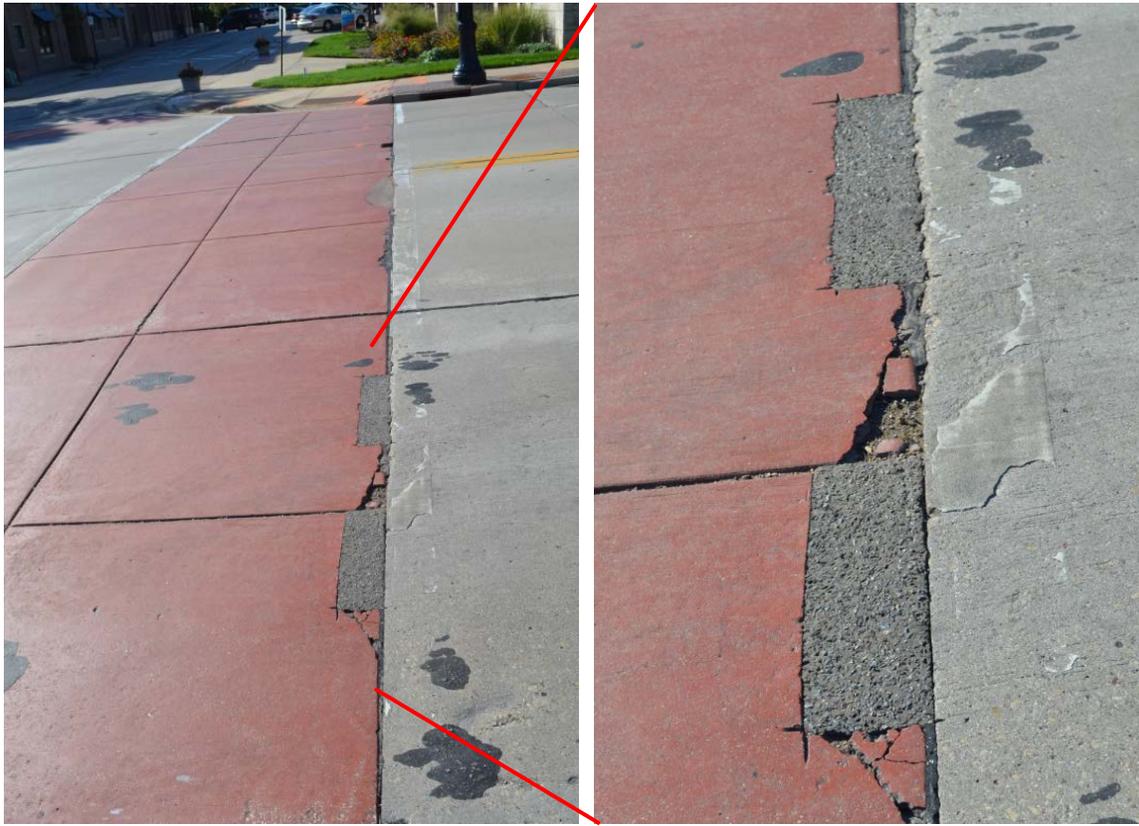
Figure E-1. PDRs along transverse joint
(Site #9, Washington St., Grafton).

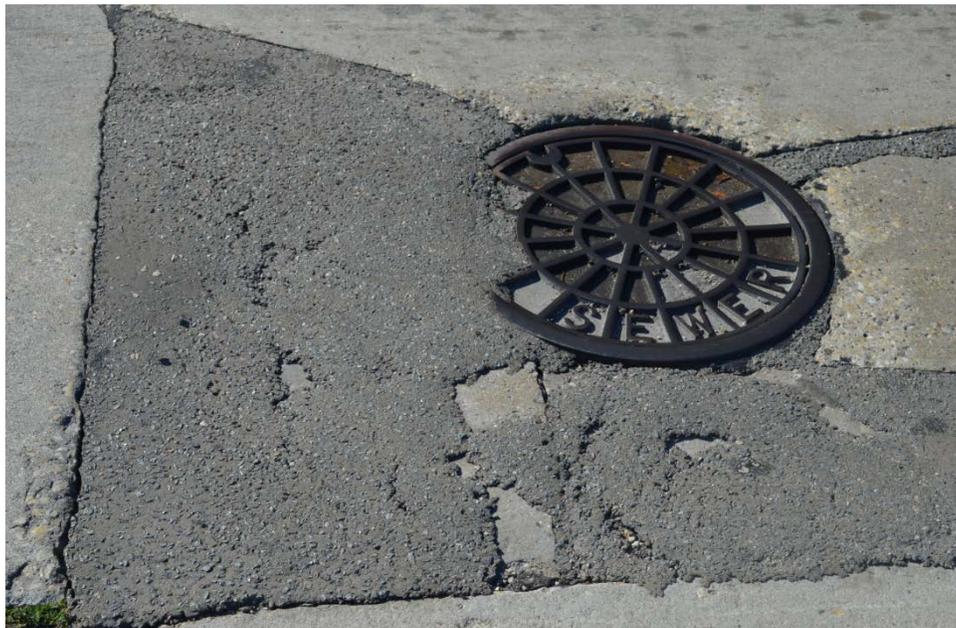
Figure E-2. PDRs to address deteriorated areas around utility hole
(Site #9, State Road 66, Stevens Point).

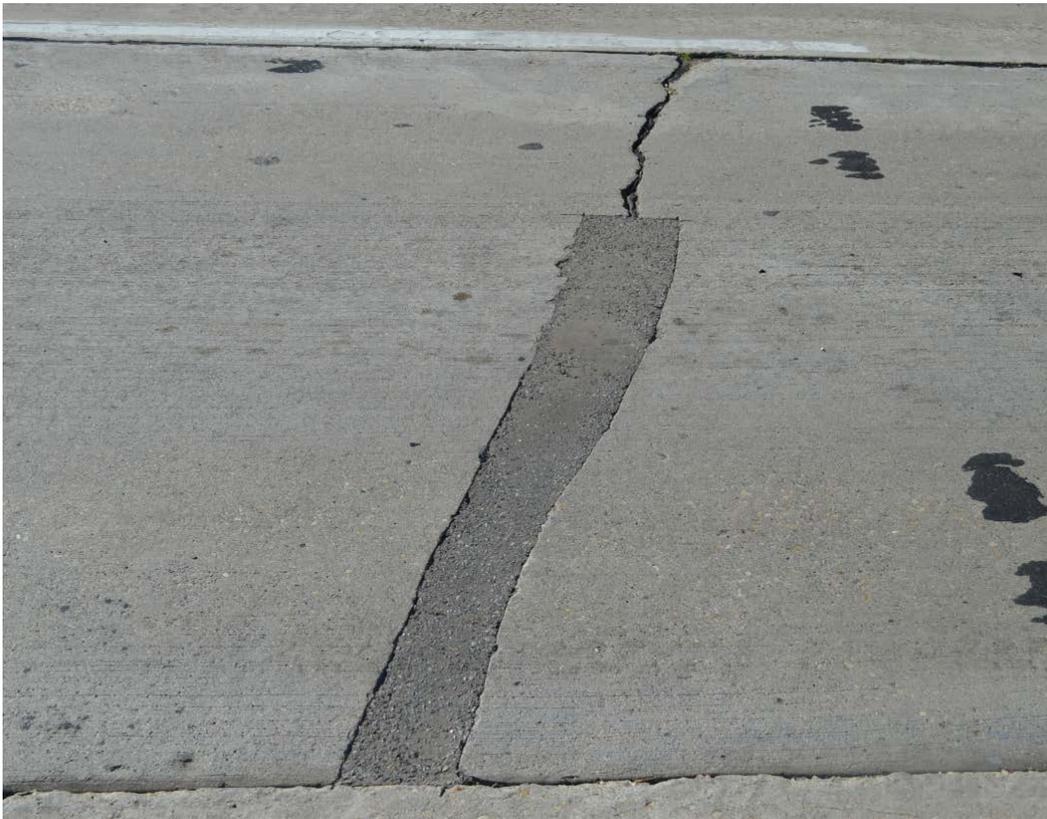
Figure E-3. PDR over a transverse crack
(Site #9, State Road 66, Stevens Point).

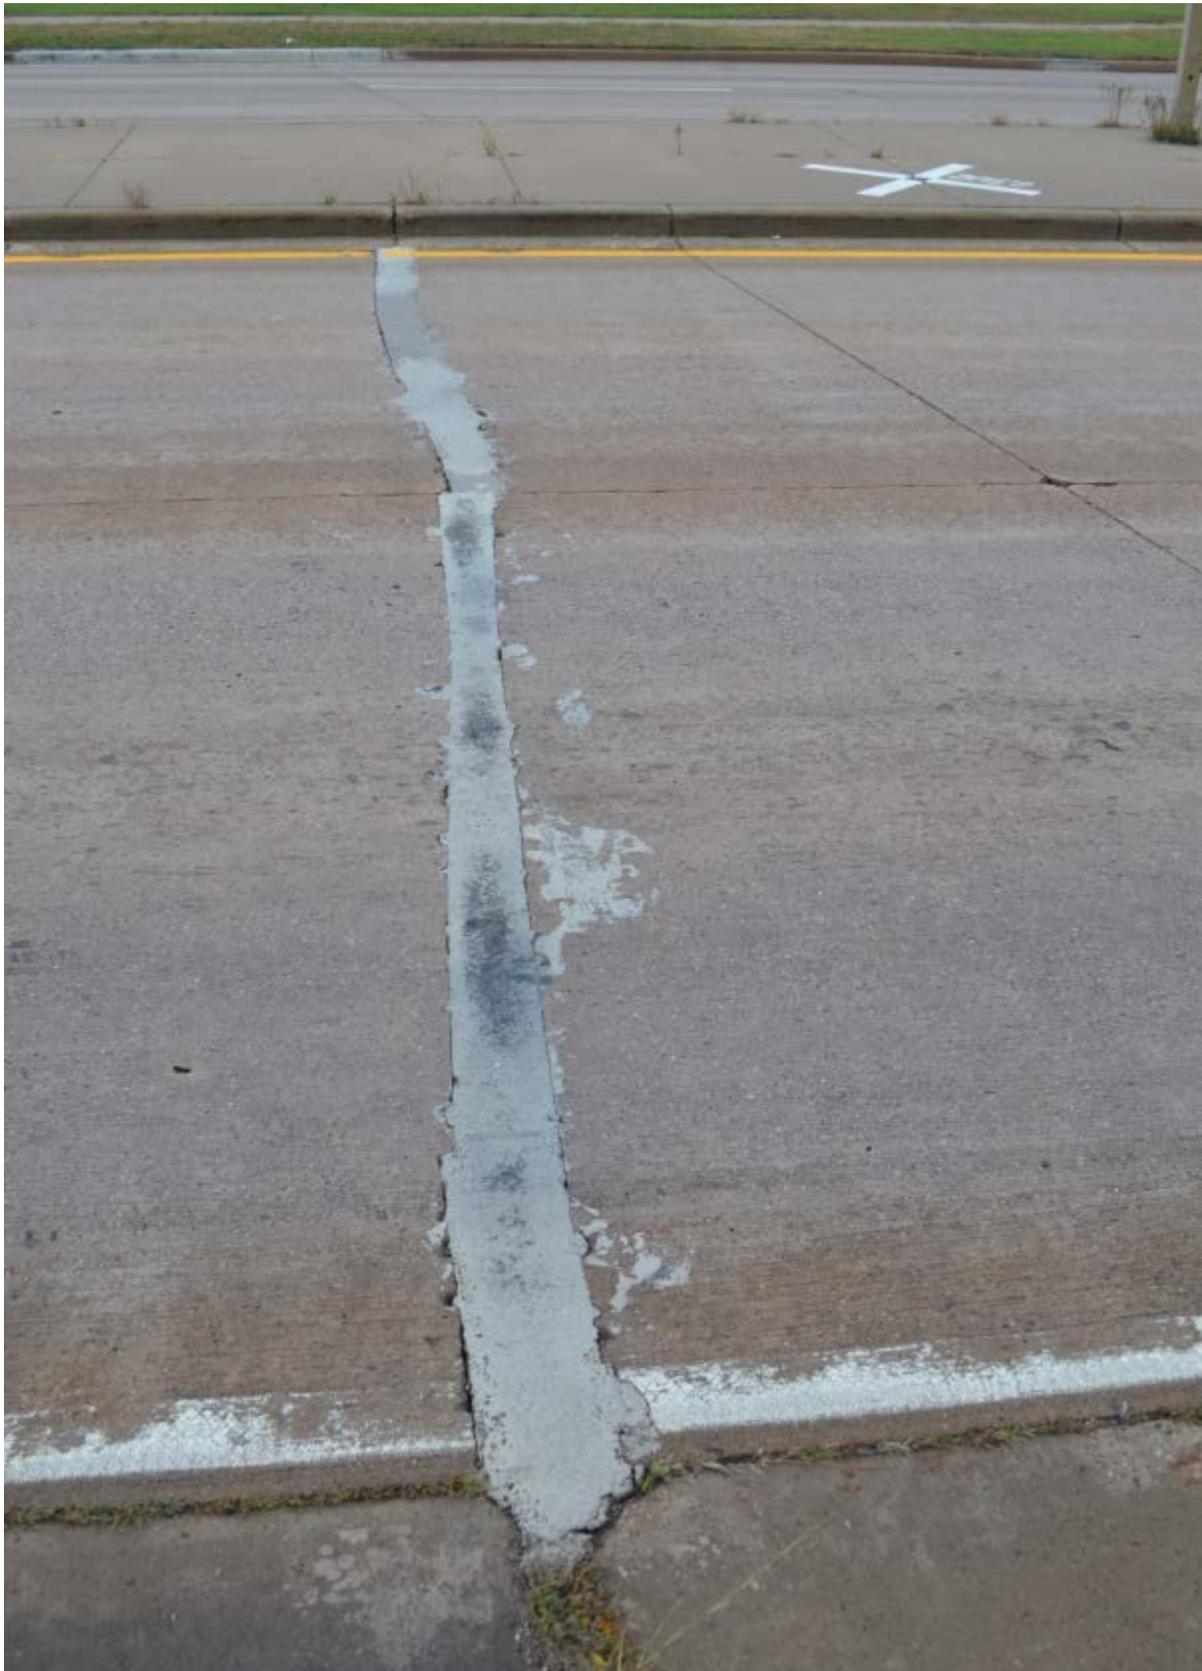
Figure E-9. PDR used to address transverse cracking (Site #11, US 10, Stevens Point).

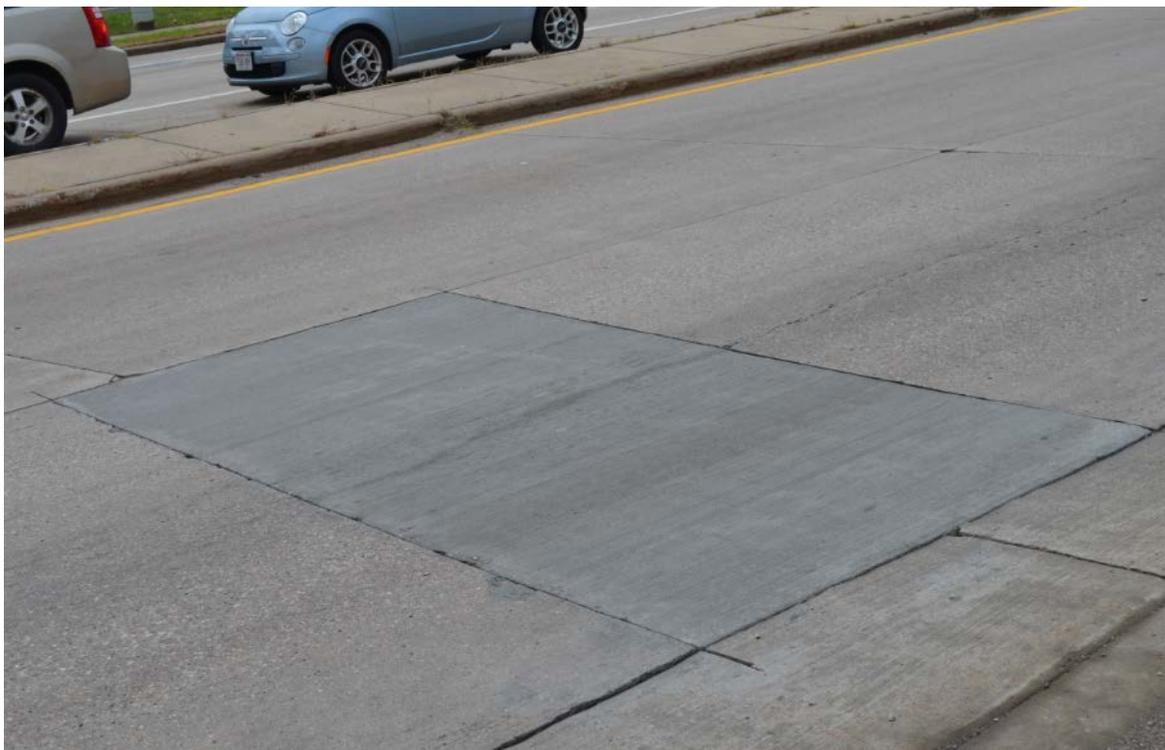
Figure E-11. Full depth repairs in existing concrete pavement (Site #11, US 10, Stevens Point).

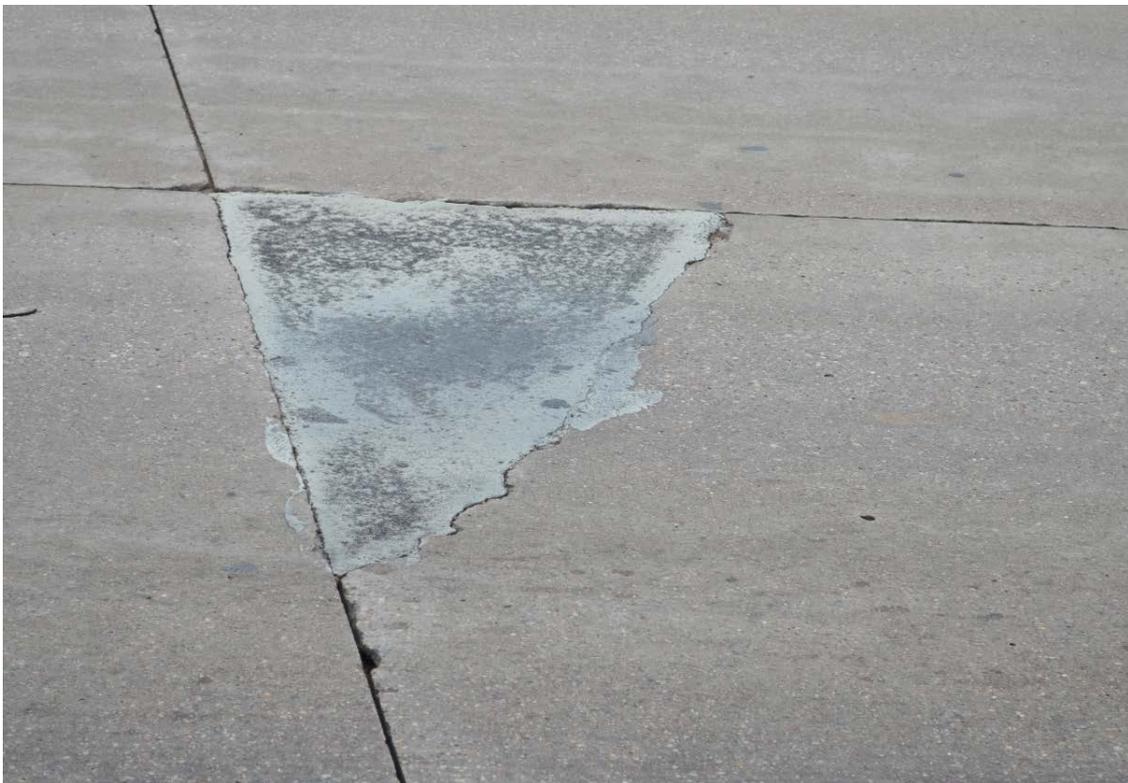
Figure E-13. PDR to address corner break (Site #11, US 10, Stevens Point).

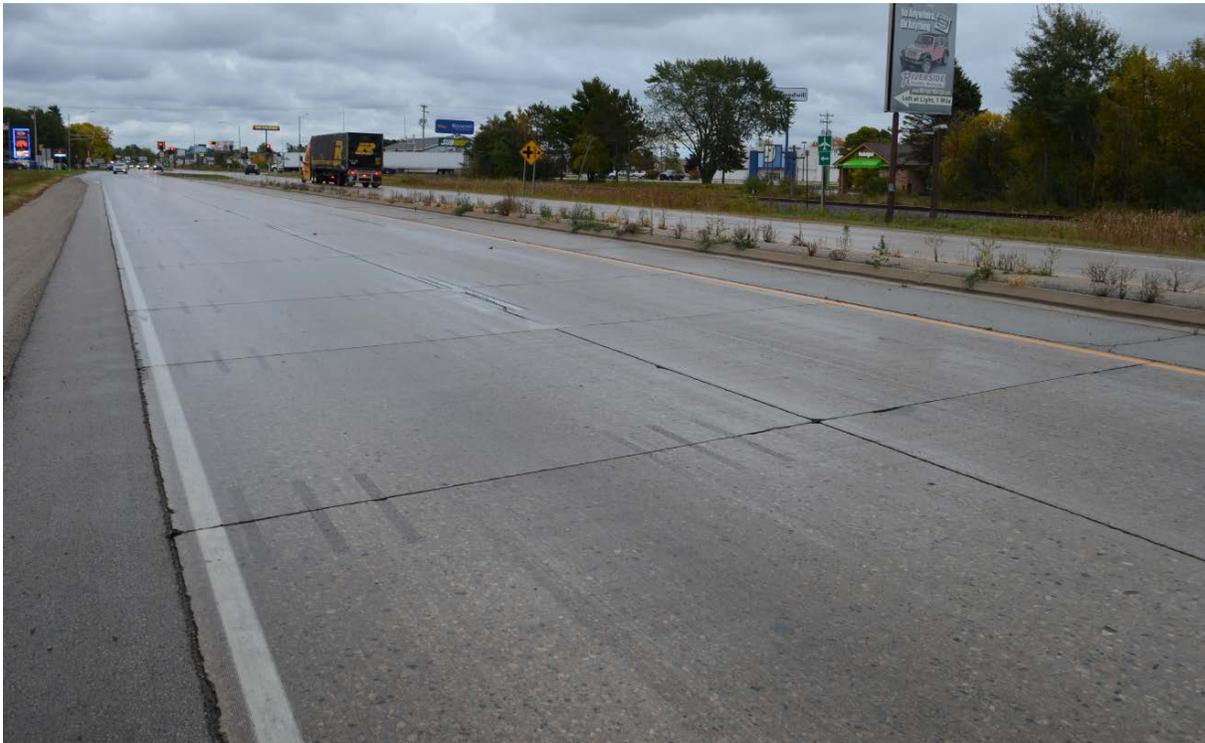
Figure E-14. Overview of existing concrete pavement (Site #12, US 41, Marinette).

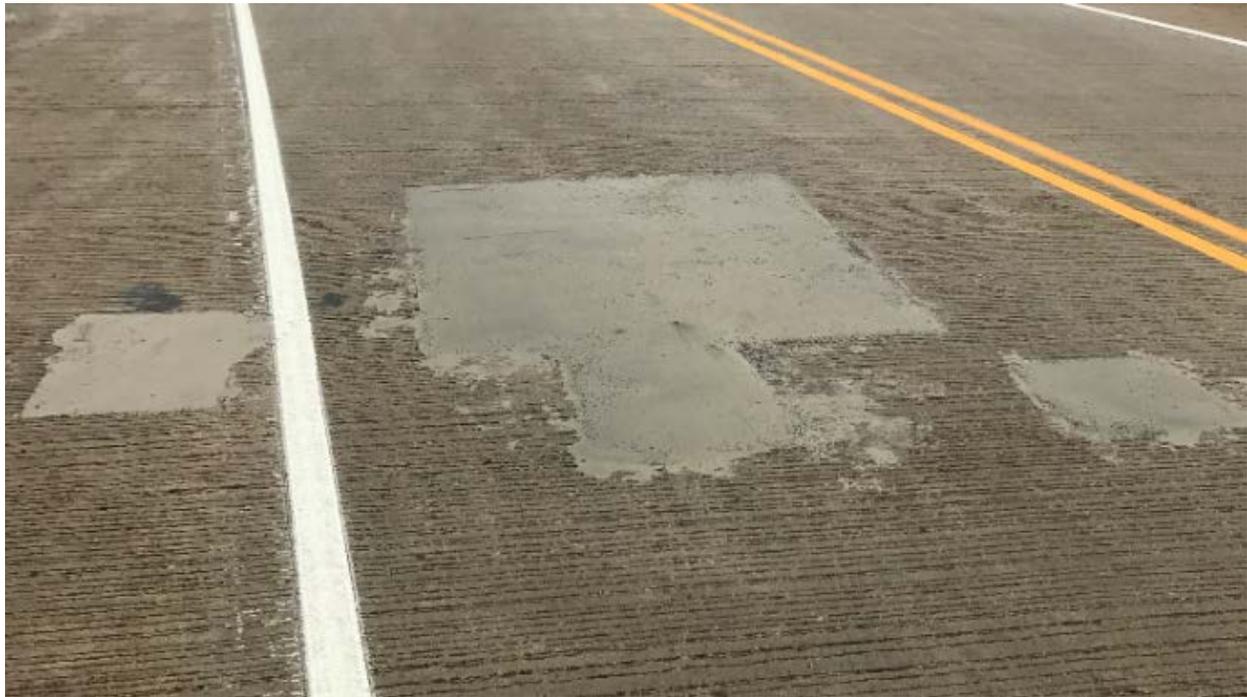
Figure E-18. PDRs on bridge deck (1)
(Site #13, State Road 32, Mountain).

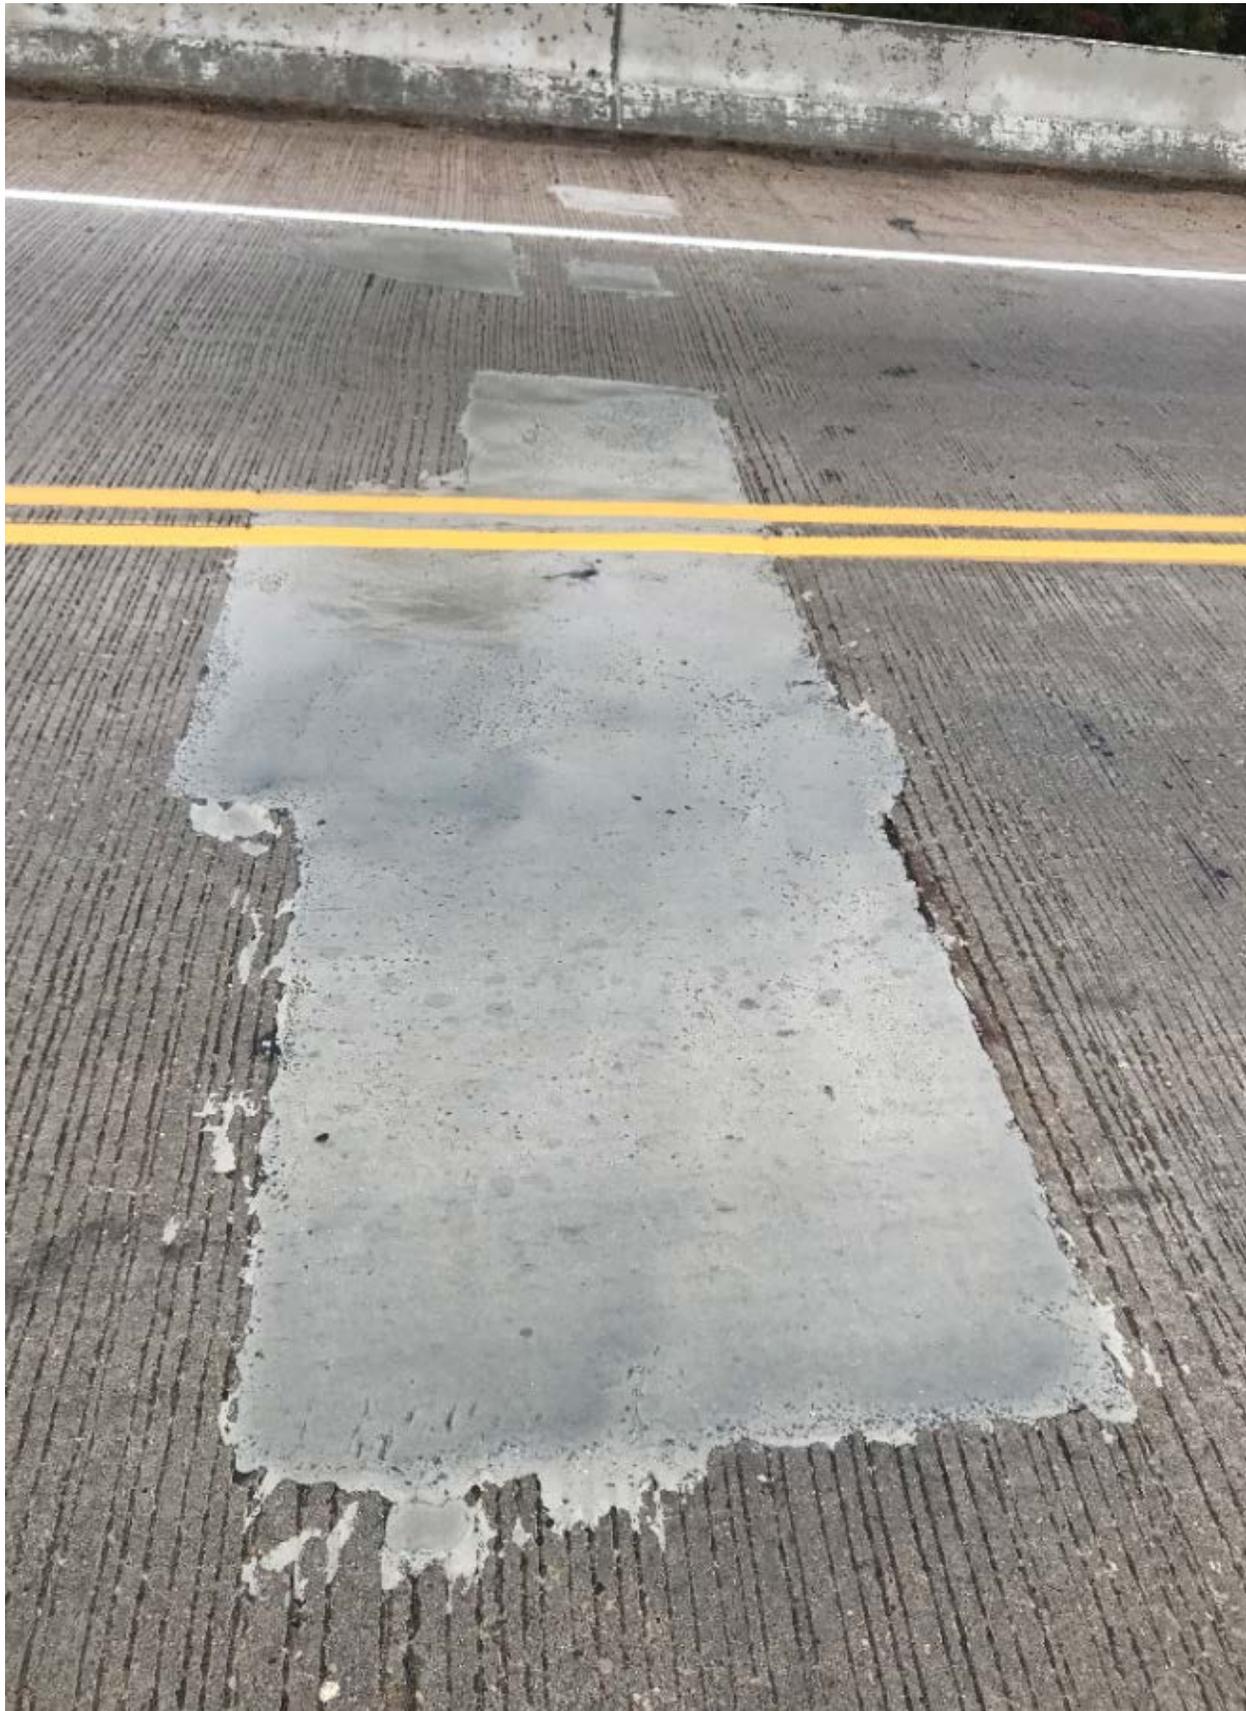
Figure E-20. PDRs on bridge deck (2)
(Site #13, State Road 32, Mountain).

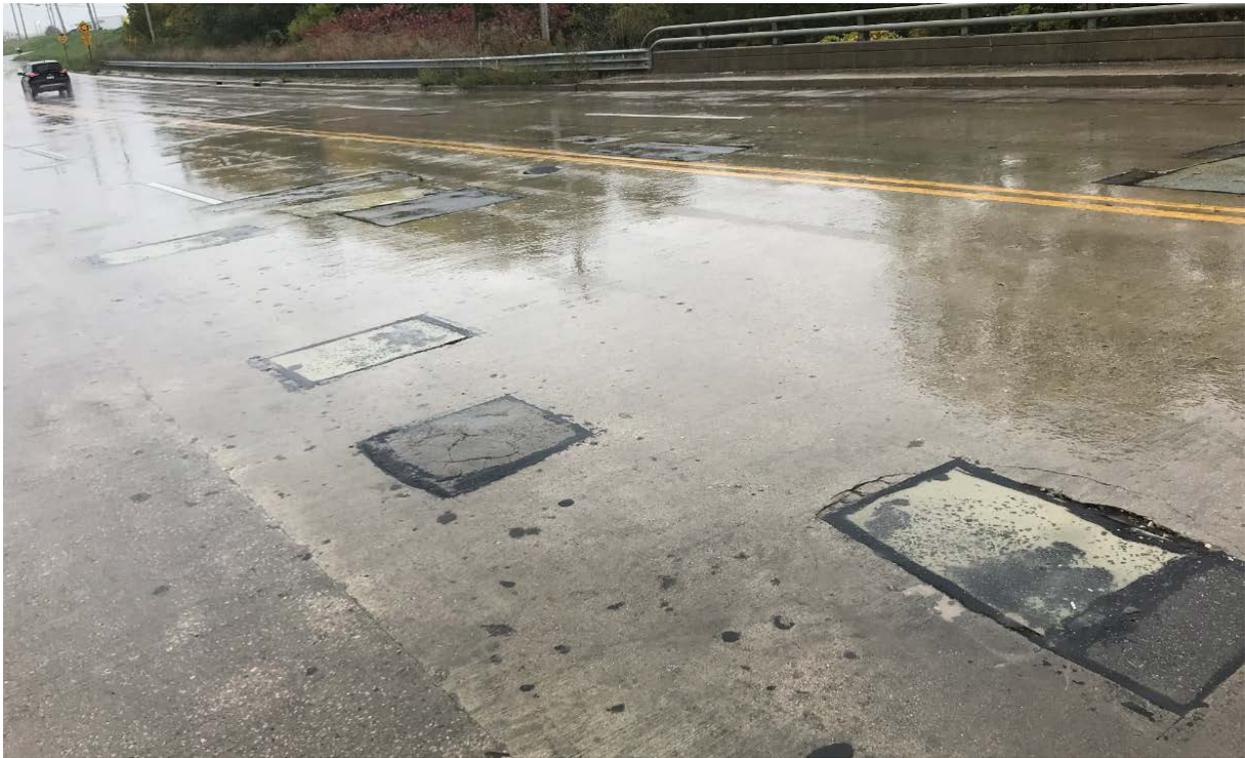
Figure E-24. PDRs on bridge deck
(Site #16, W. Main Ave., Ashwaubenon).

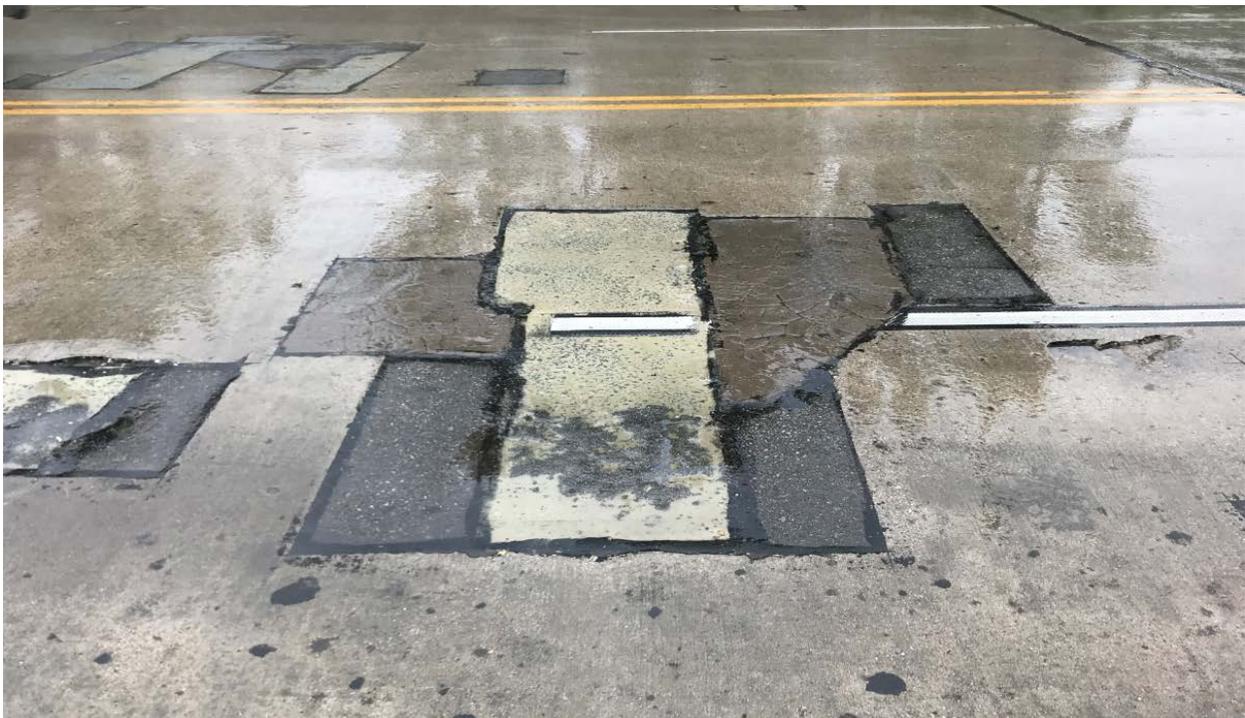
Figure E-25. RM-4 PDRs on bridge deck with starkly different colors
(Site #16, W. Main Ave., Ashwaubenon).

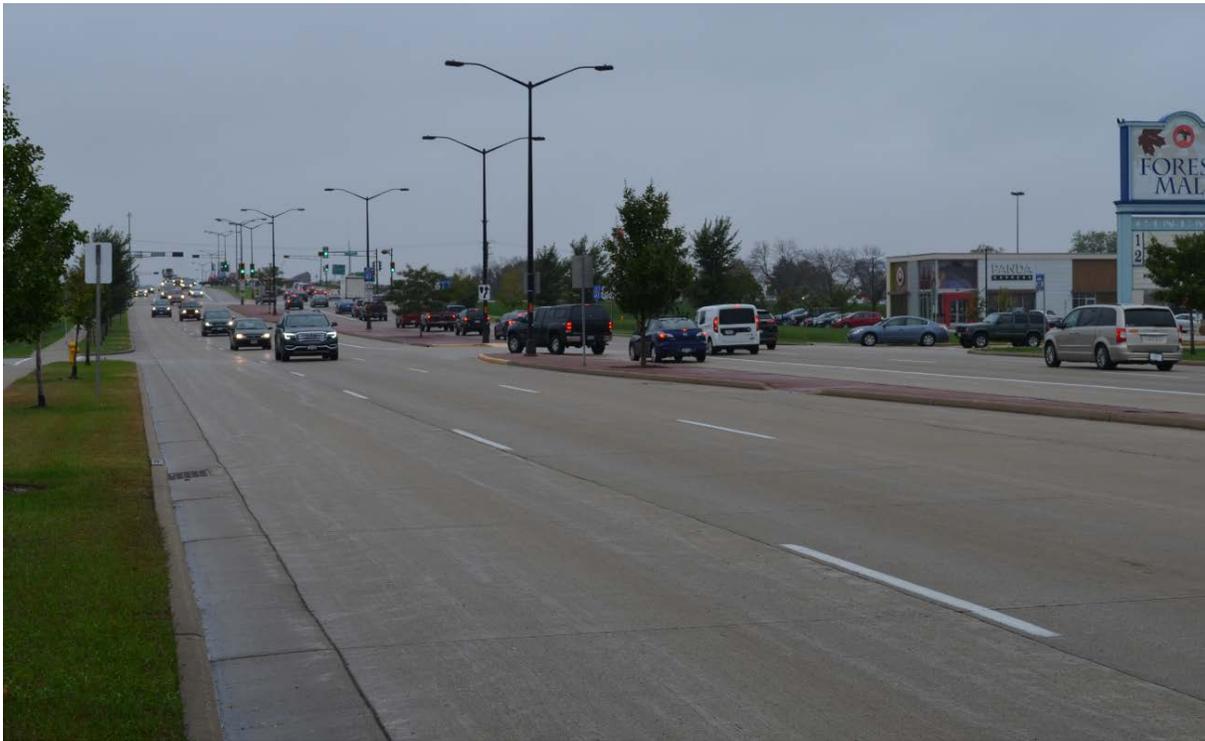
Figure E-26. Overview of existing concrete pavement in very good condition (Site #17, W. Johnson St., Fond du Lac).

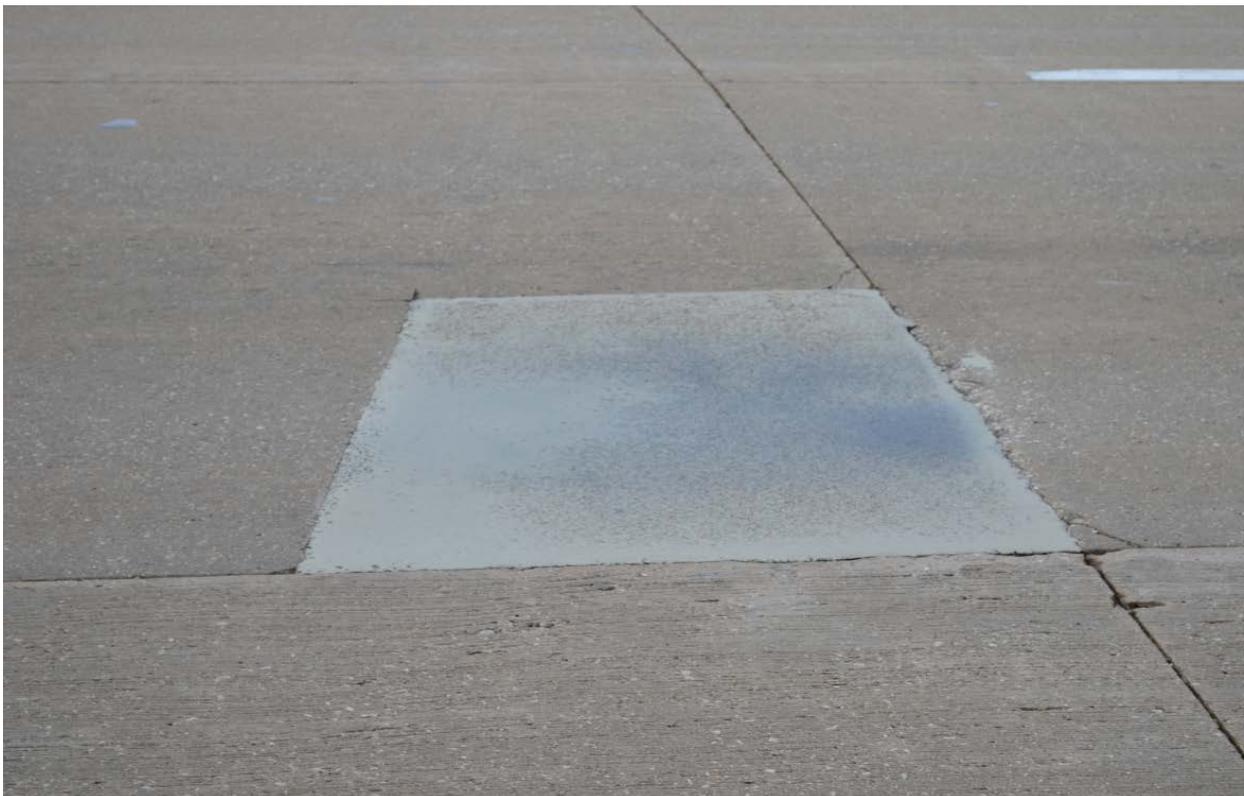
Figure E-27. PDR to address an isolated area of distress in an otherwise distress free pavement (Site #17, W. Johnson St., Fond du Lac).

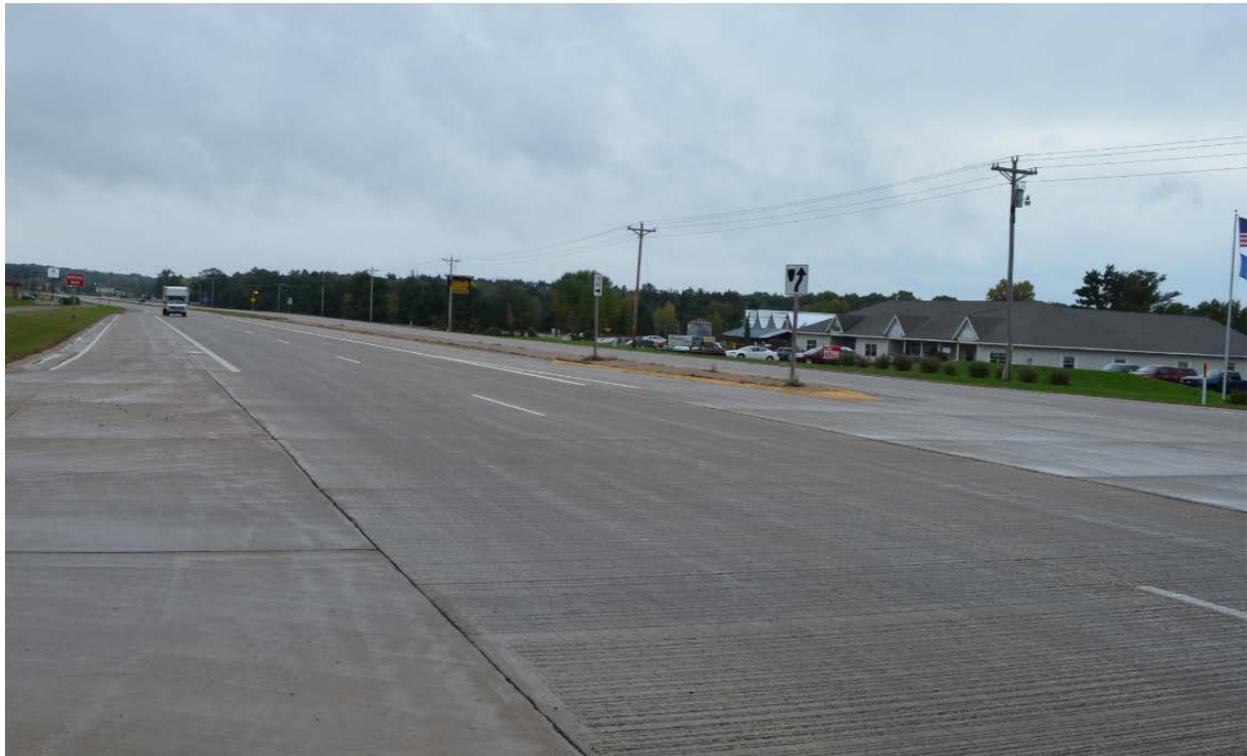
Figure F-2. Overview of generally distress-free surrounding concrete pavement (Site #19, State Road 93, Eau Claire).
