Non-Cementitious Repair Materials Study

Final Report

WisDOT Project No. 0092-18-02
June 2019

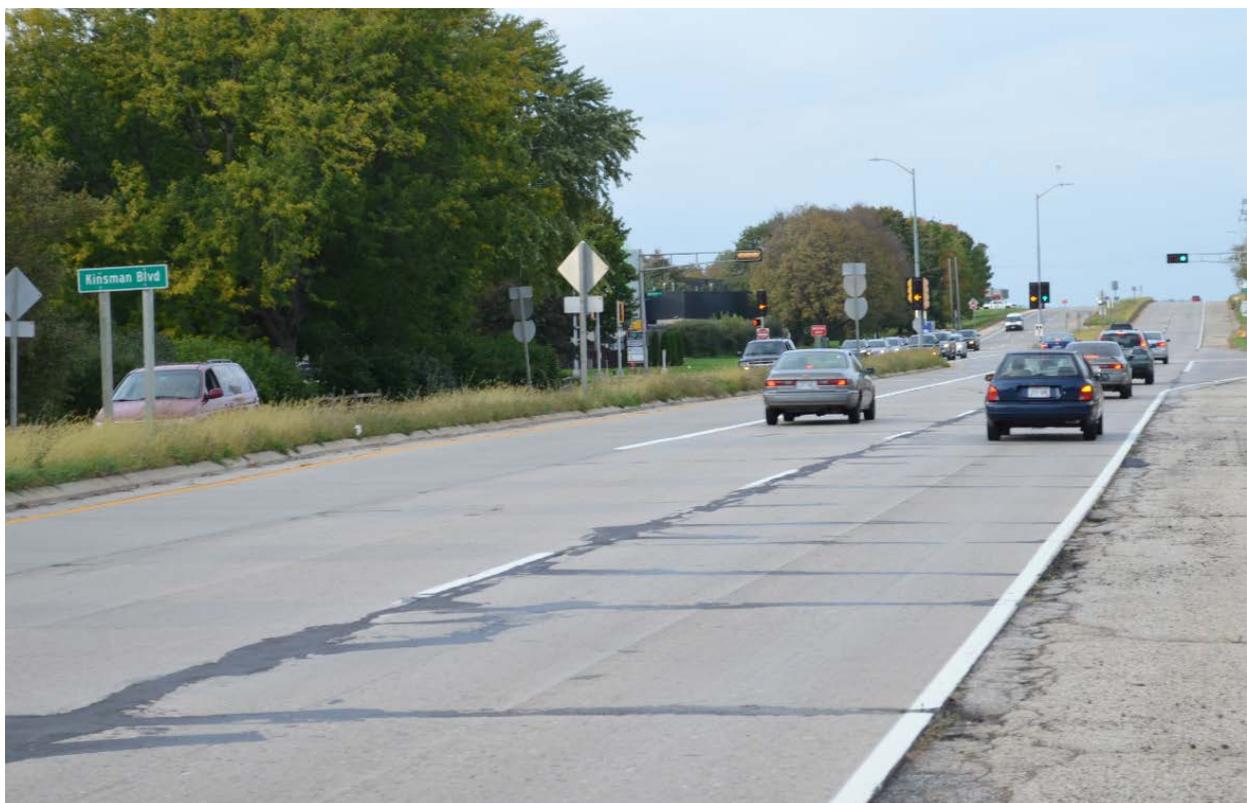
Figure F-3. Overview of existing concrete pavement (Site #20, N. Stoughton Rd., Madison).

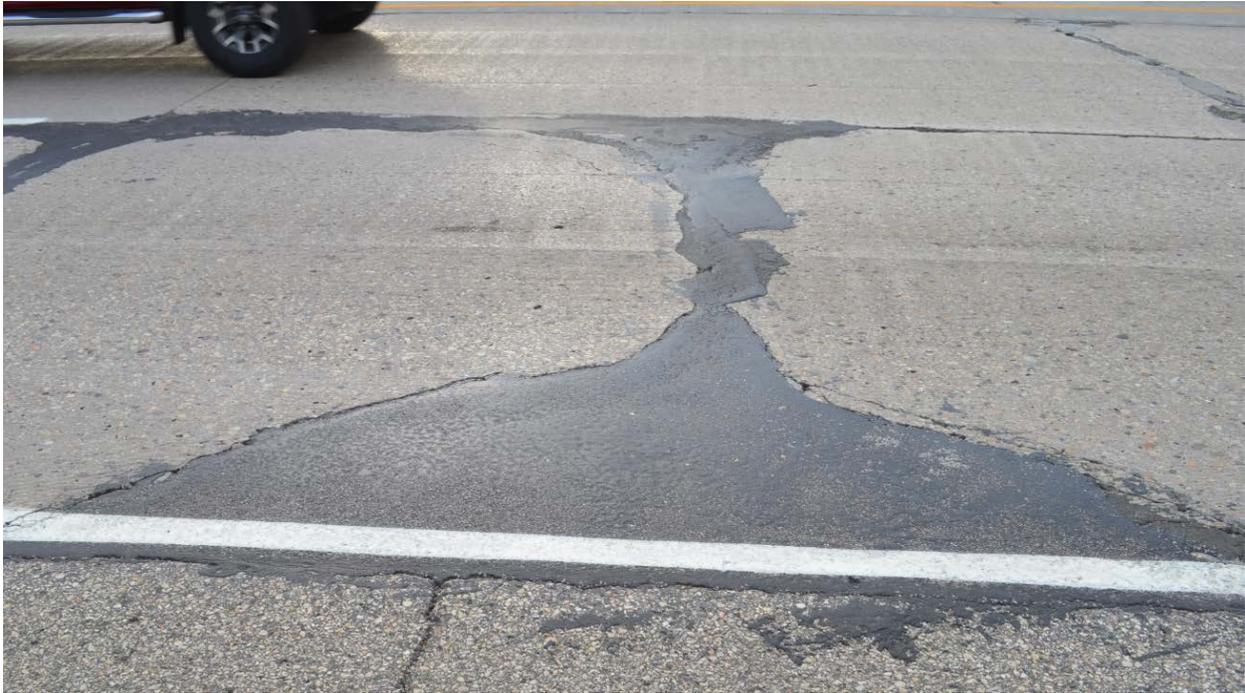
Figure F-4. PDR used to address a severely distressed area (Site #20, N. Stoughton Rd., Madison).

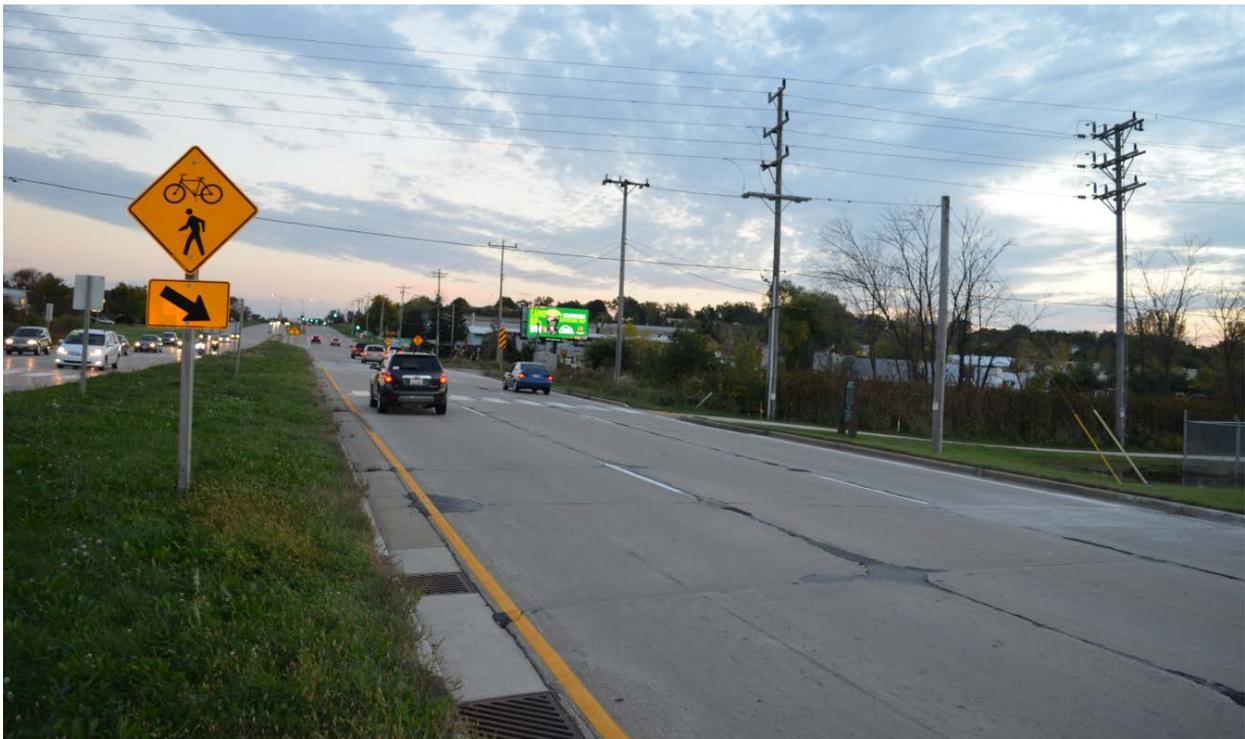
Figure F-5. Overview of existing concrete pavement (Site #21, State Road 59, Waukesha).

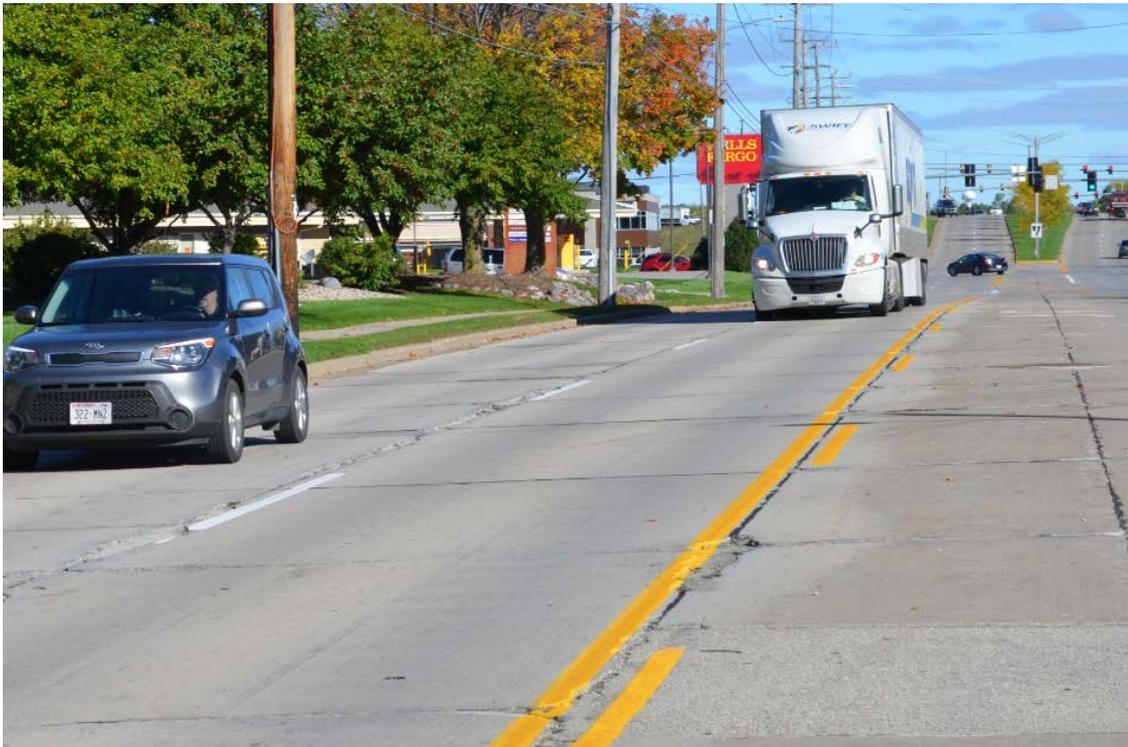
Figure F-8. Overview of existing concrete pavement (Site #22, N. Ballard Rd., Appleton).

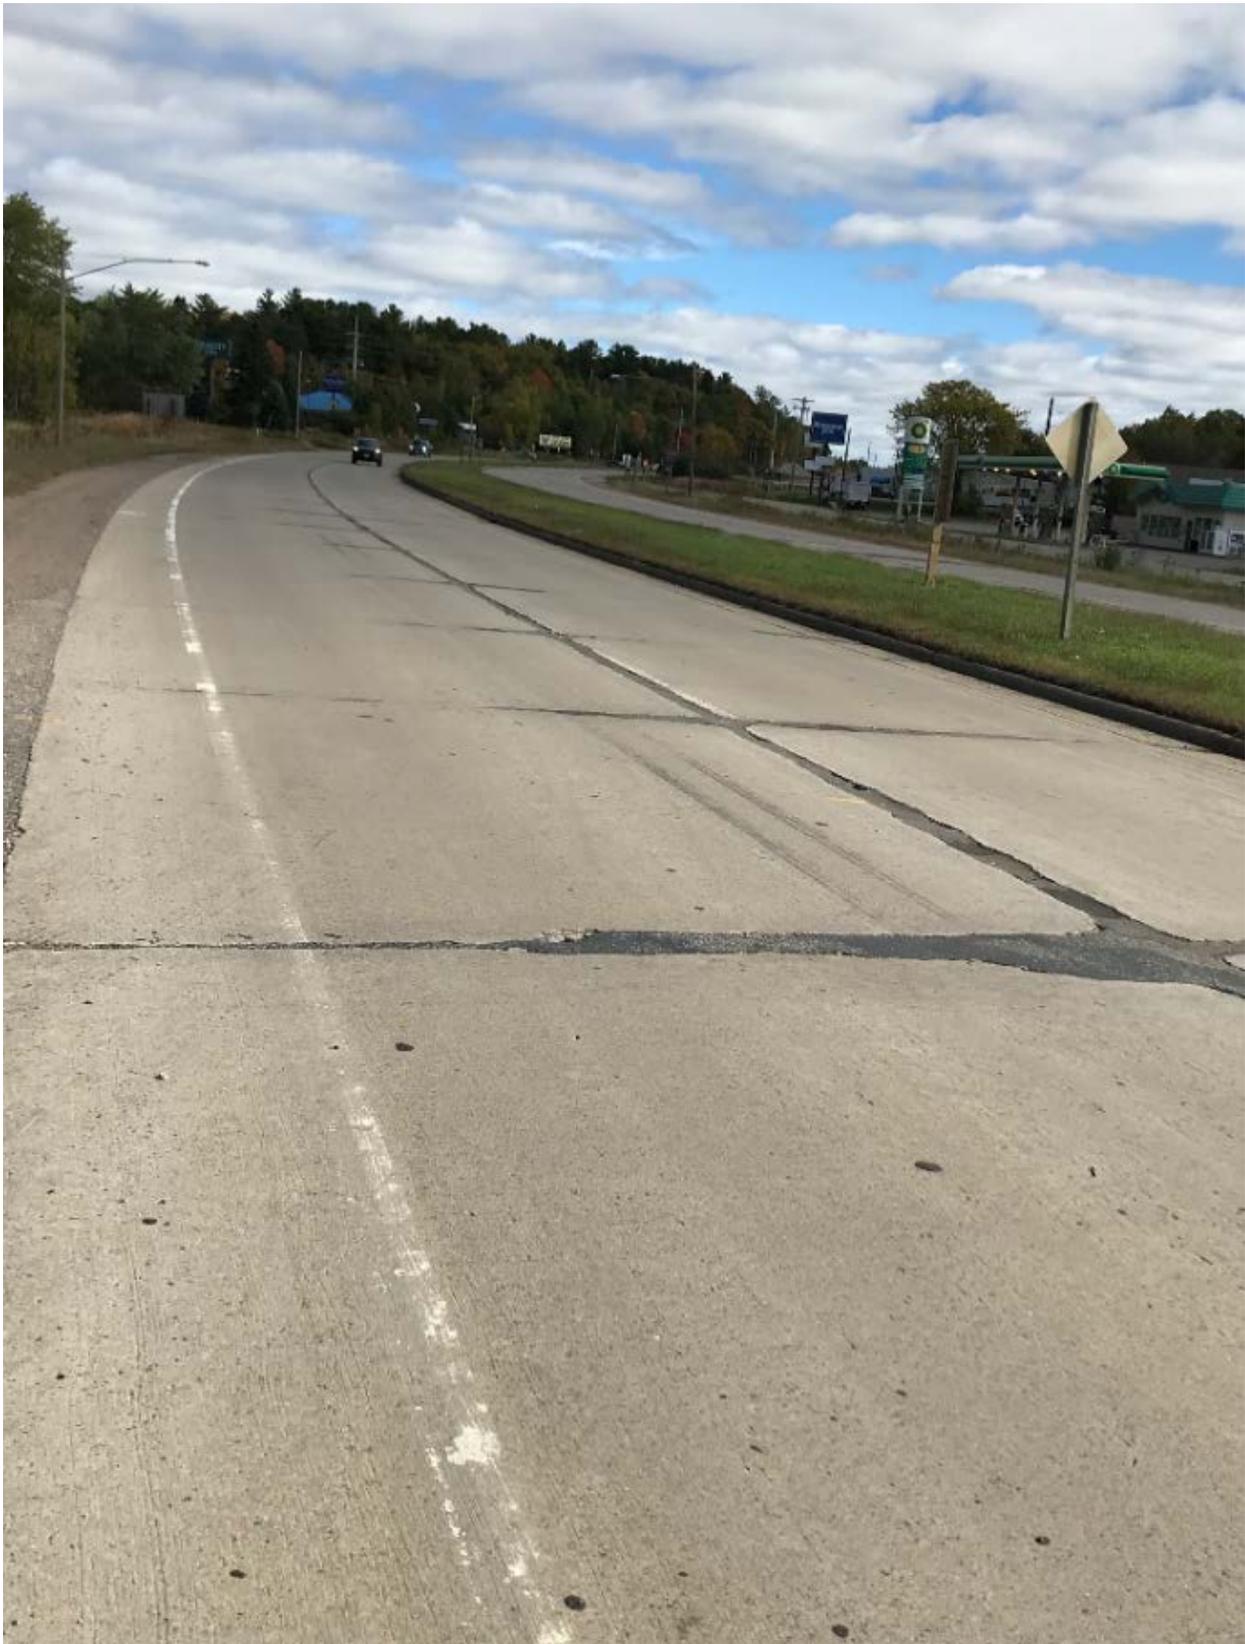
Figure F-11. Overview of existing concrete pavement
(Site #23, W. Kemp St., Rhinelander).
