HIGHWAY WORK PROPOSAL - RAZING AND REMOVING

COUNTY	STATE PROJECT ID	PROJECT DESCRIPTION	HIGHWAY
Milwaukee	1229-04-21, Parcels 5, 10	I-43 North South Freeway Silver Spring to STH 60	IH 43
Ozaukee	1229-04-23, Parcel 55	I-43 North South Freeway County Line Rd to STH 60	IH 43
Milwaukee	1229-04-24, Parcels 3, 8	I-43 North South Freeway Silver Spring to County Line Rd	IH 43

PHOTOS OF THE SUBJECT

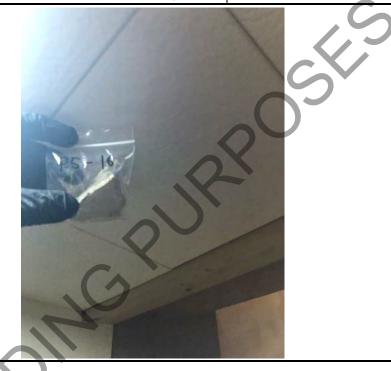
DescriptionCeiling tiles in basement

Non-detect for ACM

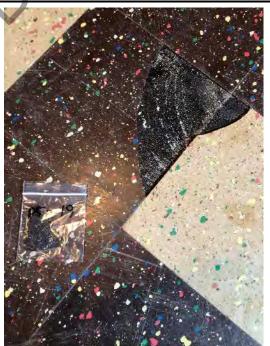
Photo No.	Date
38	8/4/2021
Decembelon

8"x8" vinyl tile and adhesive on basement floor

Adhesive is non-detect for ACM, 8"x8" vinyl tiles contain 10% non-friable ACM

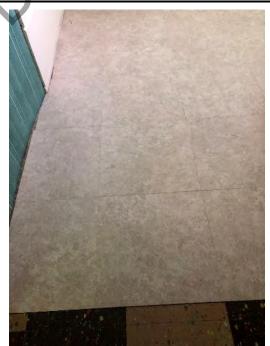
Photo No.	Date
40	8/4/2021

Pad and gray 8"x8" vinyl tile on basement bathroom floor

Both non-detect for ACM

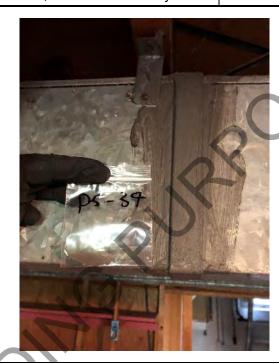
Gray tar/caulk on HVAC ductwork seam

Non-detect for ACM

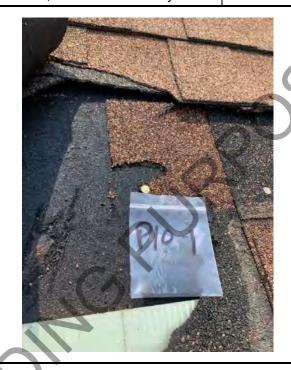
Roofing paper and asphalt shingles on roof

Both non-detect for ACM

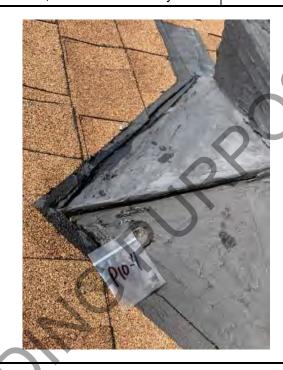
Black caulk around base of chimney

Contains 10% non-friable ACM

All regulated ACM is required to be removed prior to demolition. It will be up to the demolition contractor and their asbestos abatement contractor to determine if the method of demolition will cause any non-friable ACM to become friable. If so, that material would be considered RACM and will be required to be removed prior to demolition. All demolition waste that is commingled with the non-friable asbestos-containing material will be required to be managed as asbestos-containing waste and disposed of at a solid waste landfill permitted to accept such waste.

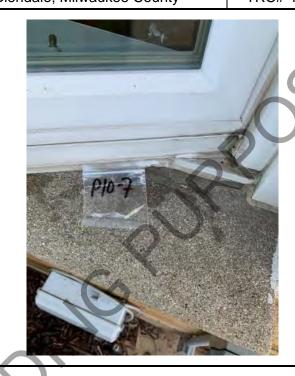
White caulk around exterior window and door frames

Non-detect for ACM

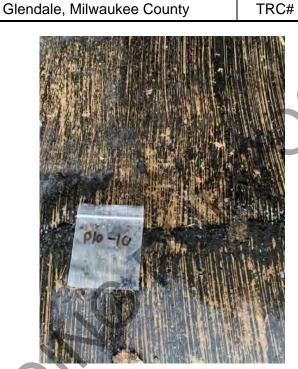
Black mastic on garage floor

Non-detect for ACM

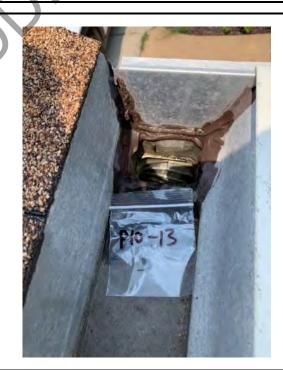
Brown caulk on end of eavestrough

Non-detect for ACM

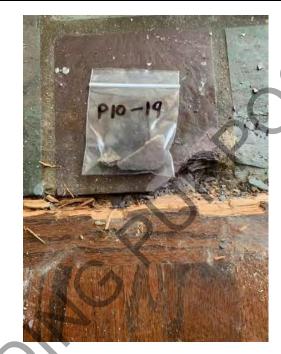
Grout and ceramic tile on front entrance floor

Both non-detect for ACM

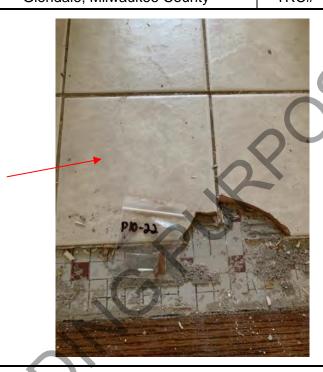
Leveling cement, grout, and 8"x8"ceramic tile (top layer) on Bathroom 1 floor

All non-detect for ACM

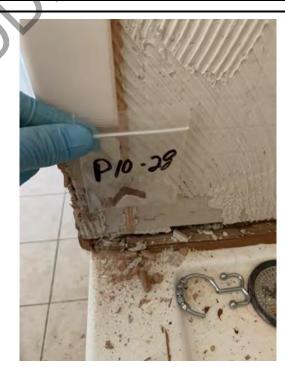
Photo No.	Date
26	8/4/2021

Leveling cement, grout, and 12"x12" ceramic tile on Bathroom 1 tub wall

All non-detect for ACM

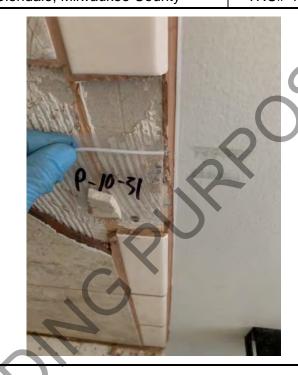
Leveling cement, grout, and 6"x2" ceramic tile on Bathroom 1 tub wall border

All non-detect for ACM

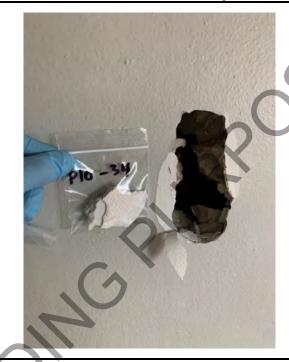
Non-detect for ACM

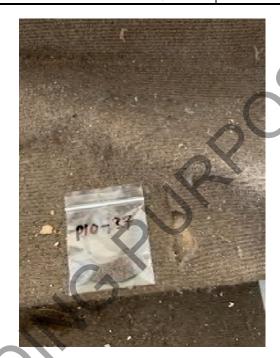
Carpet on basement stairs

Non-detect for ACM

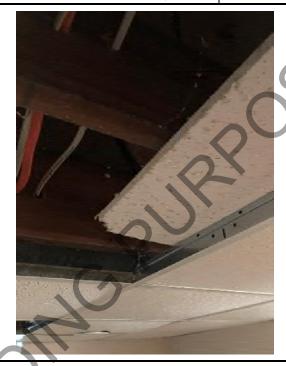
18"x18" drop ceiling tiles in basement

Non-detect for ACM

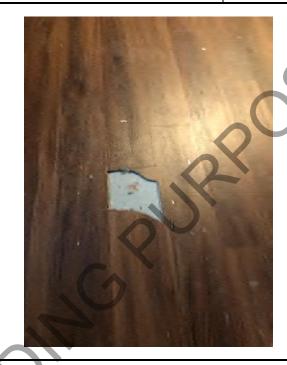
Pad and laminate flooring on basement floor

Both non-detect for ACM

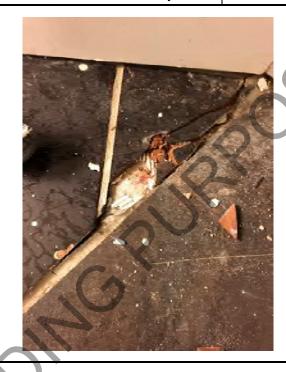
Black ceramic tile on basement bathroom floor (next to utility room)

Non-detect for ACM

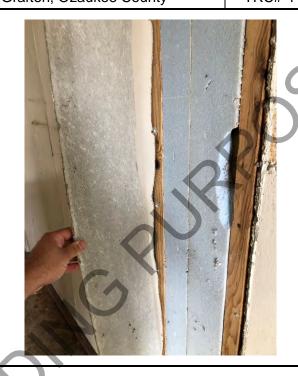
Looking behind fiberboard on interior wall

Fiberboard contains 20% non-friable ACM

All regulated ACM is required to be removed prior to demolition. It will be up to the demolition contractor and their asbestos abatement contractor to determine if the method of demolition will cause any non-friable ACM to become friable. If so, that material would be considered RACM and will be required to be removed prior to demolition. All demolition waste that is commingled with the non-friable asbestos-containing material will be required to be managed as asbestos-containing waste and disposed of at a solid waste landfill permitted to accept such waste.

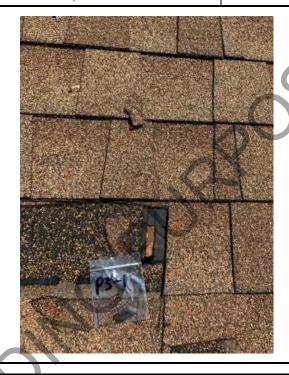
Roofing paper and shingles on roof, both non-detect for ACM

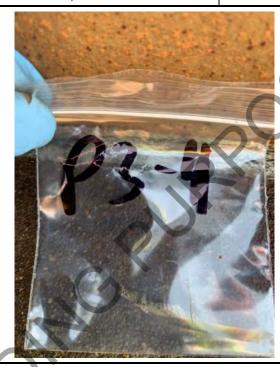
9 **Description**

Chimney flue, non-detect for ACM

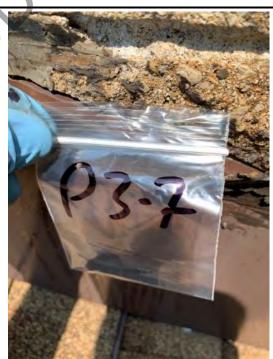
10
 7/21/2021

Brown caulk around base of chimney, non-detect for ACM

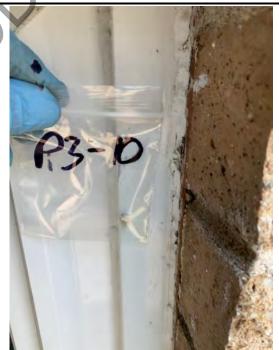
White caulk around exterior window and door frames, non-detect for ACM

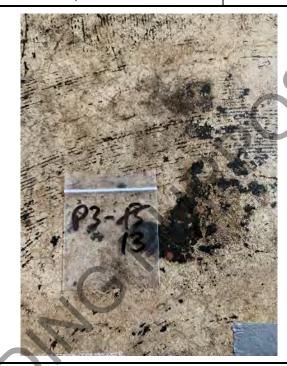
27 **Description**

Black mastic on floor in bathroom 2, contains 10% Cat.I non-friable ACM

All regulated ACM is required to be removed prior to demolition. It will be up to the demolition contractor and their asbestos abatement contractor to determine if the method of demolition will cause any non-friable ACM to become friable. If so, that material would be considered RACM and will be required to be removed prior to demolition. All demolition waste that is commingled with the non-friable asbestos-containing material will be required to be managed as asbestos-containing waste and disposed of at a solid waste landfill permitted to accept such waste.

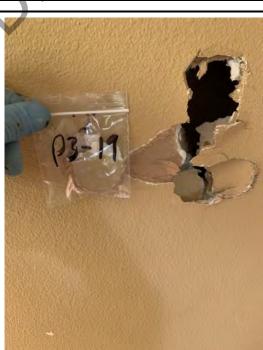
Drywall with texture on walls and ceilings throughout house, non-detect for ACM

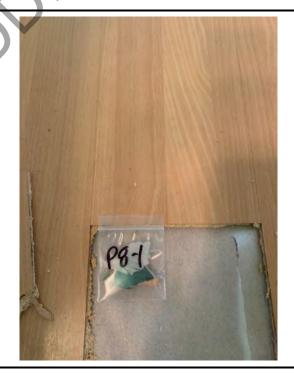
Laminate flooring and foam pad on Living room/Dining room/Kitchen and hallway floor

Non-detect for ACM

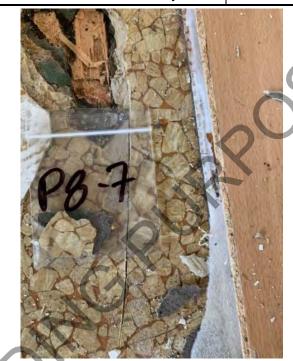
Backing, tan mastic and brown/gray vinyl tile under laminate floor in kitchen (bottom layer)

Backing is non-detect for ACM, mastic contains 10% non-friable ACM, and vinyl tile contains 80% non-friable **ACM**

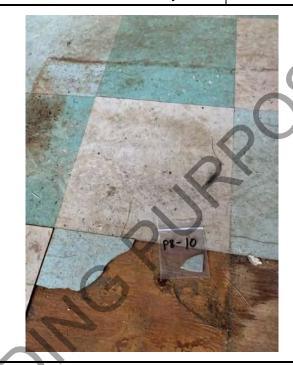
Mastic and 12"x12" vinyl tile in laundry room

Both non-detect for ACM

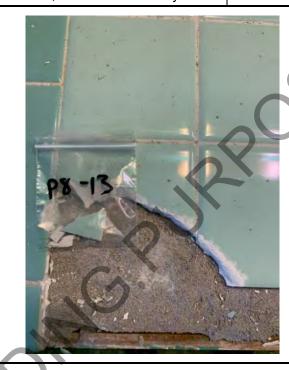
Leveling cement, grout and 4"x4" ceramic tile on bathroom walls and countertop

All non-detect for ACM

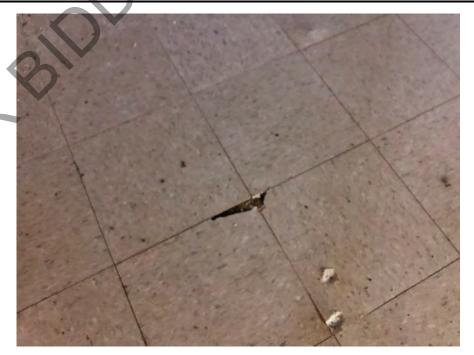
Photo No. Date 28 8/4/2021

Adhesive and 8"x8" gray vinyl tile on floor in basement main area

Both non-detect for ACM

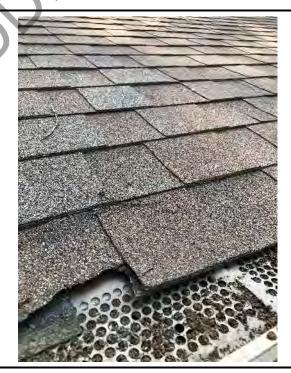
Photo No.	Date
40	8/4/2021

DescriptionShingles on roof

Non-detect for ACM

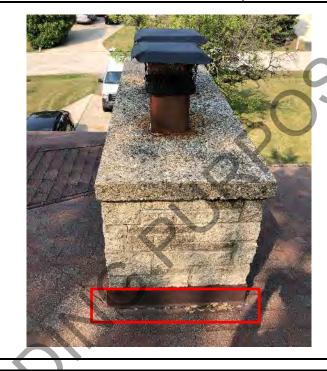
Caulk around base of chimney

Contains 2% and 10% nonfriable ACM
